LAKE WHATCOM WATER & SEWER DISTRICT

1220 Lakeway Drive
Bellingham, WA, 98229

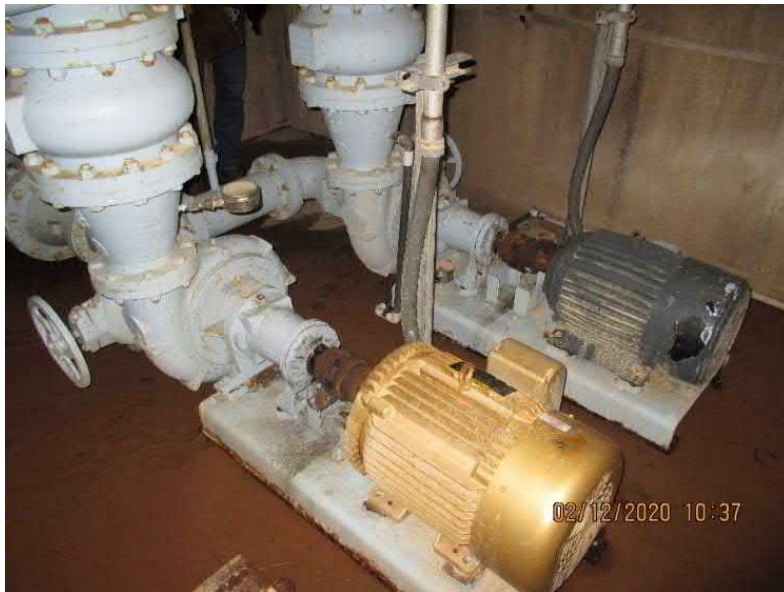
(Shows Slight Signs of Corrosion from Exposure to Chemicals and Moisture, Is Old, and Is No Longer Supported by the Manufacturer)

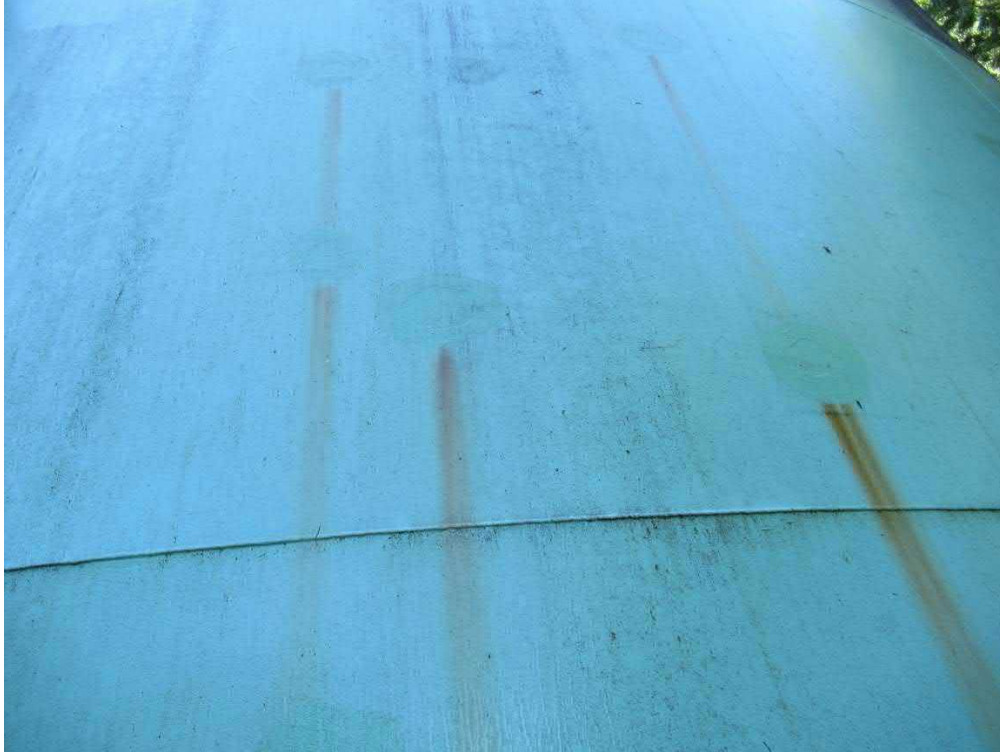
Photo 9: Rust stains from underneath coating patches.

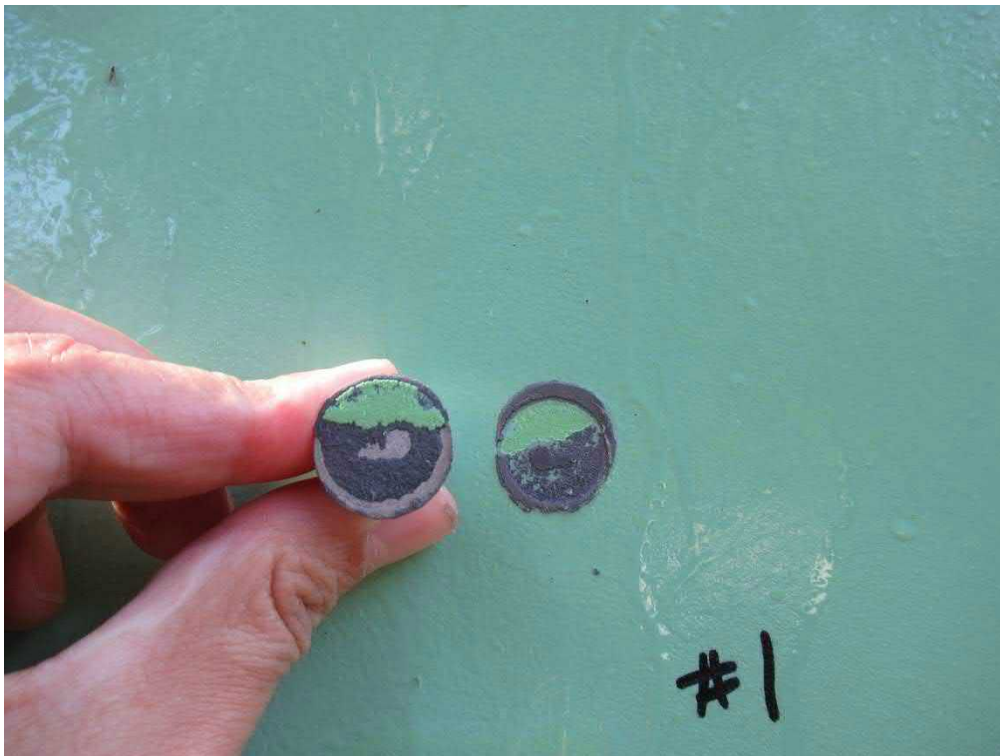
Photo 10: Dolly #1 on the side shell.

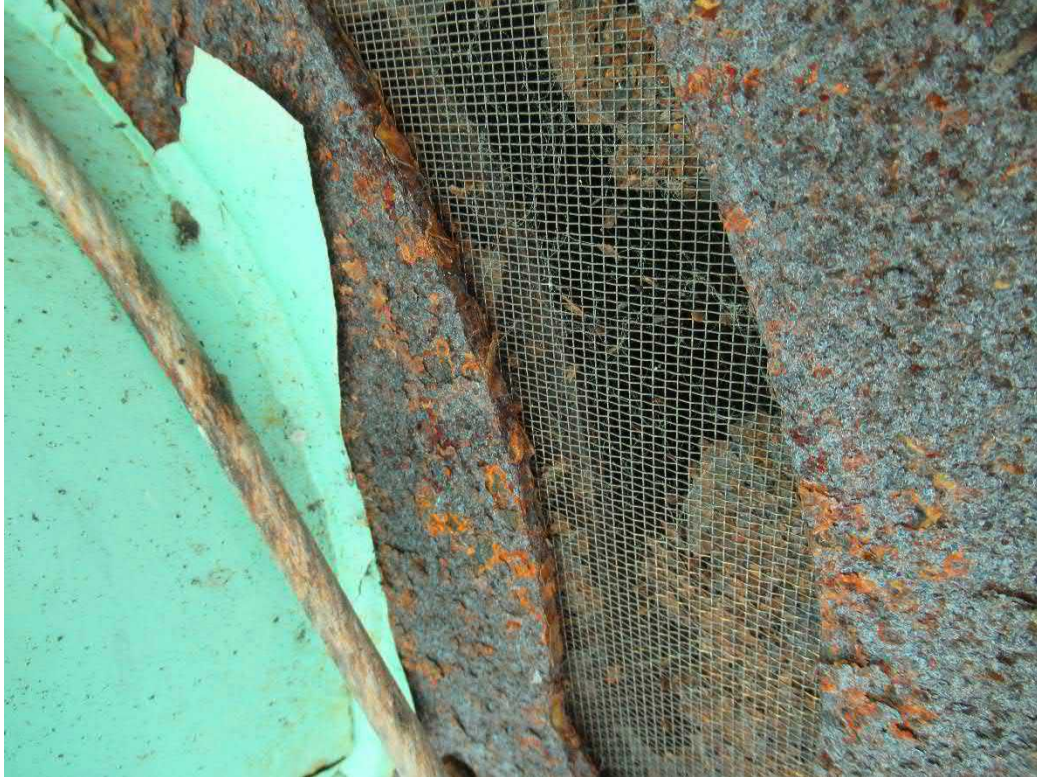
Photo 19: Roof vent with rust on the interior of screen.

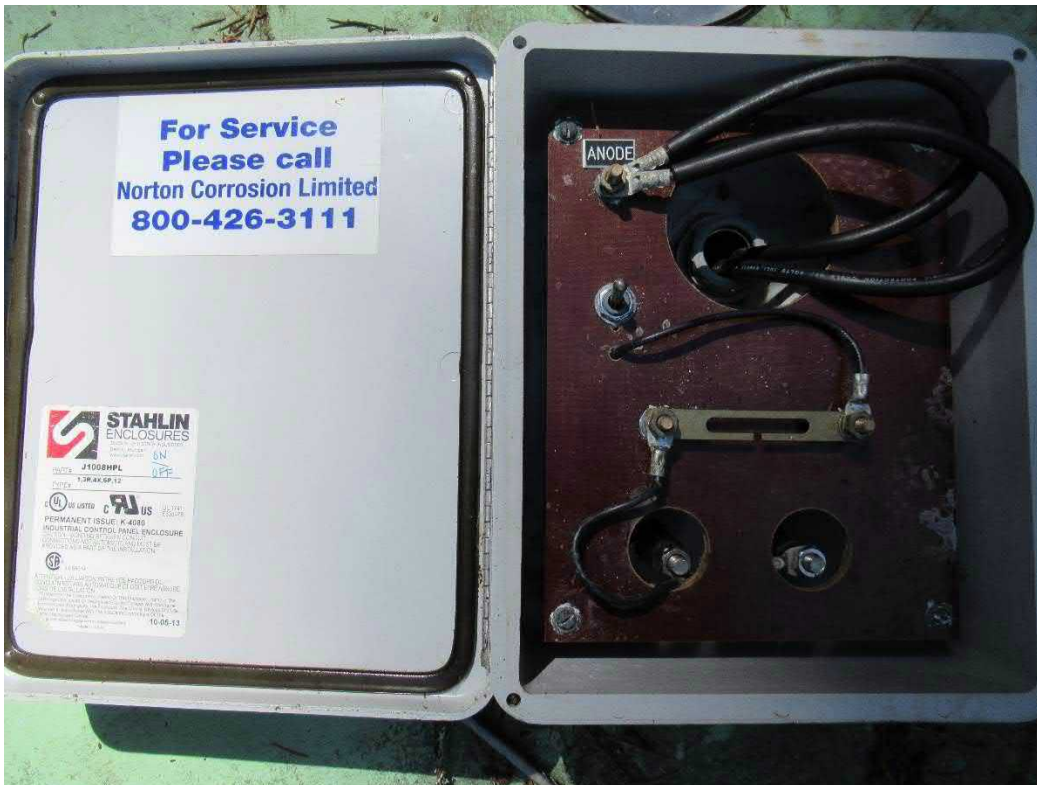
Photo 20: Cathodic protection box.

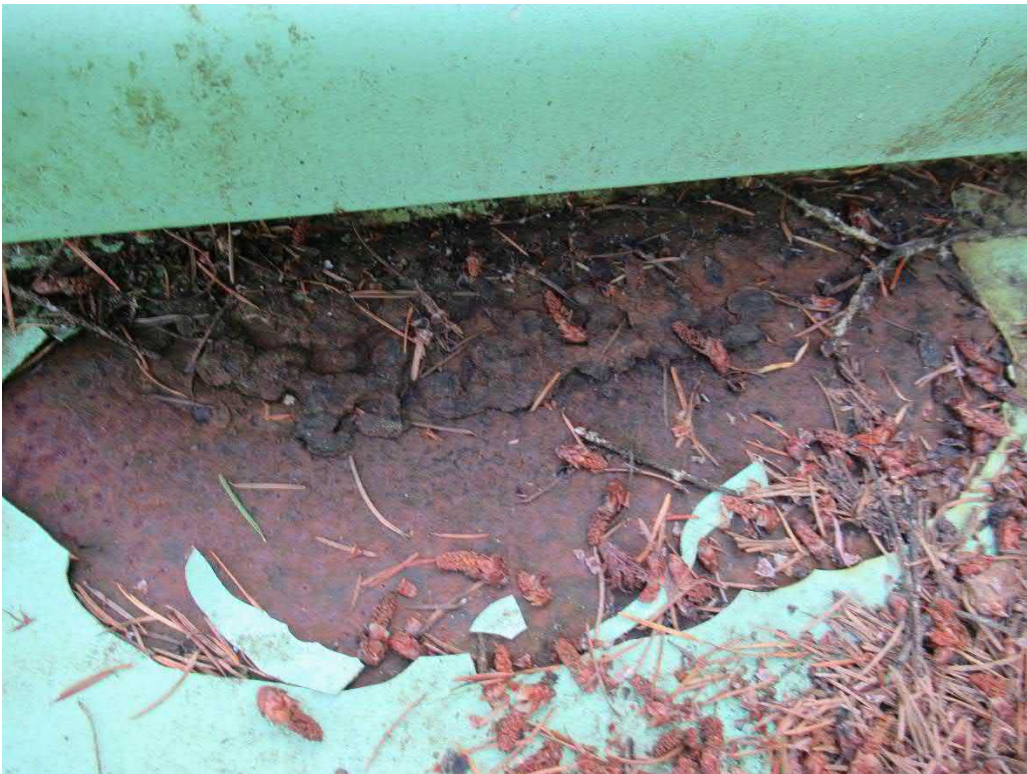
Photo 24: Corrosion adjacent to the access hatch.

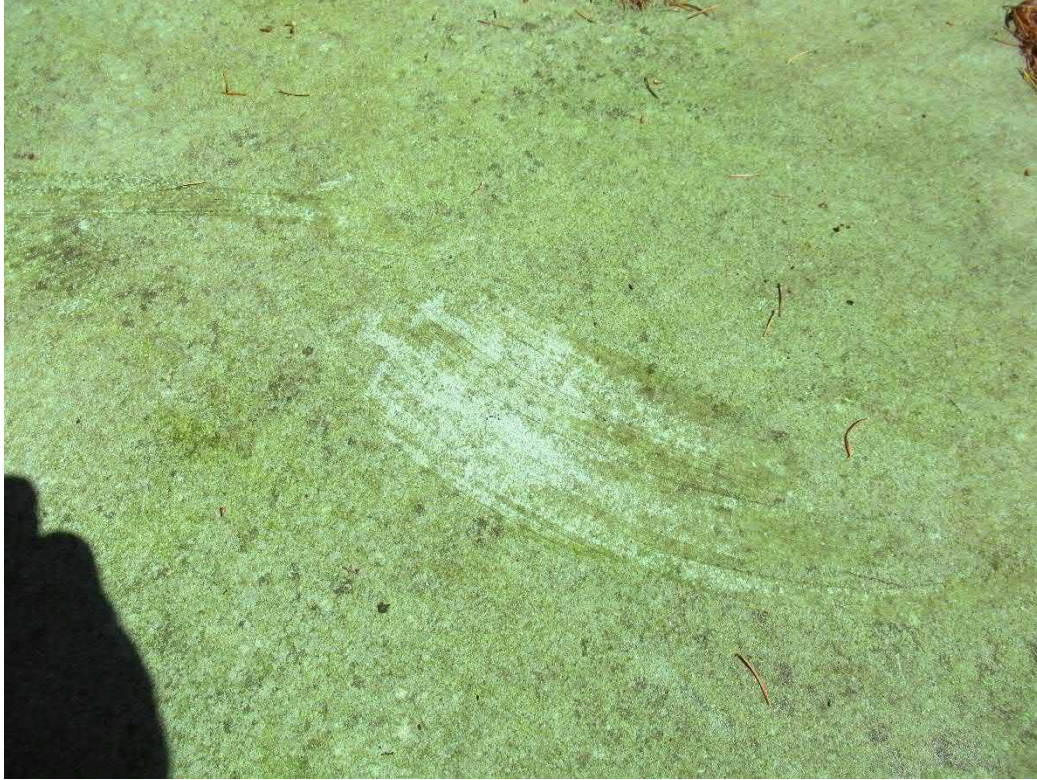
Photo 25: Closeup of the algae on the roof.

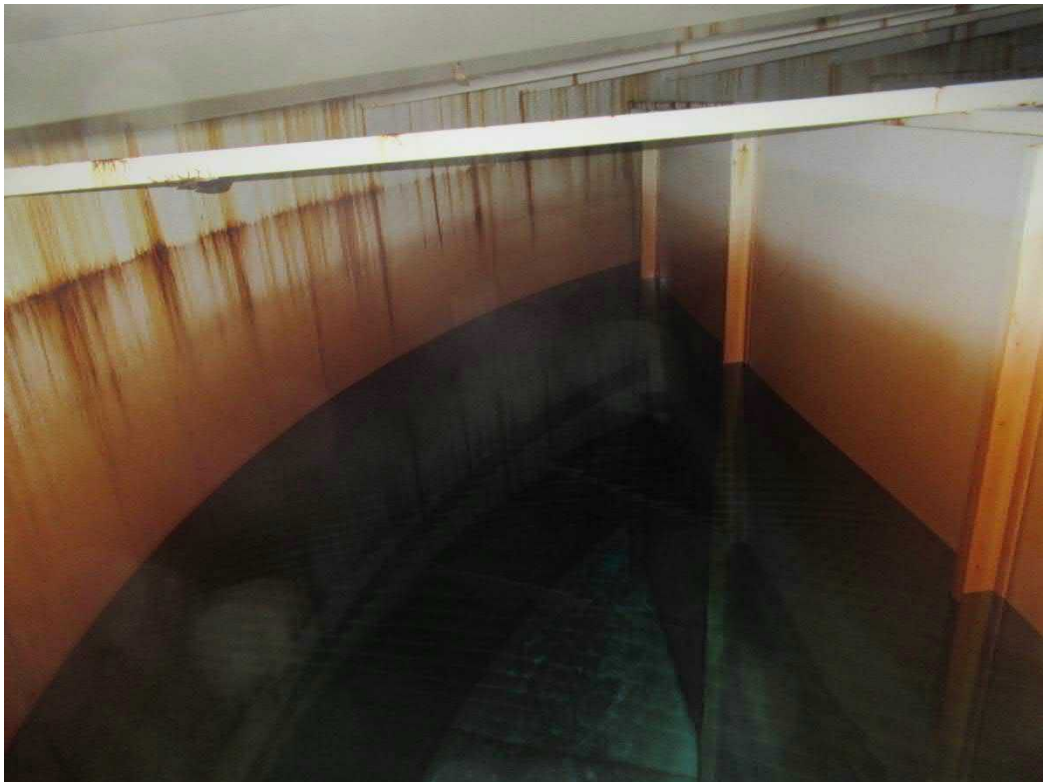
Photo 32: Interior condition.

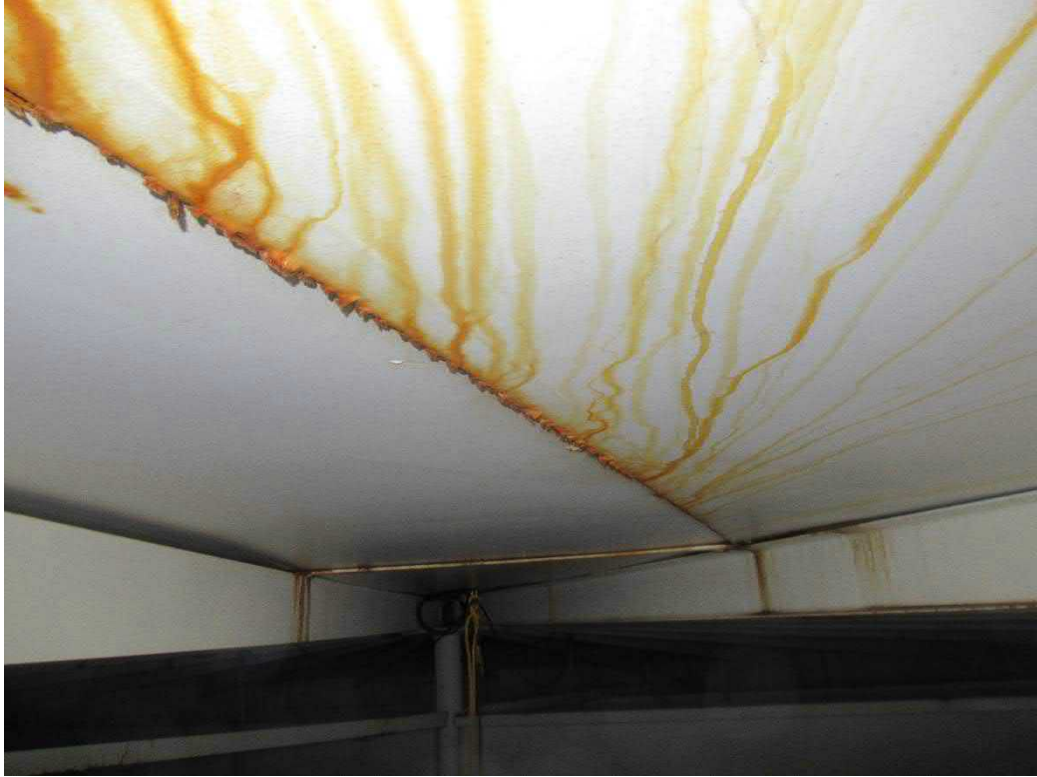
Photo 33: Interior condition.

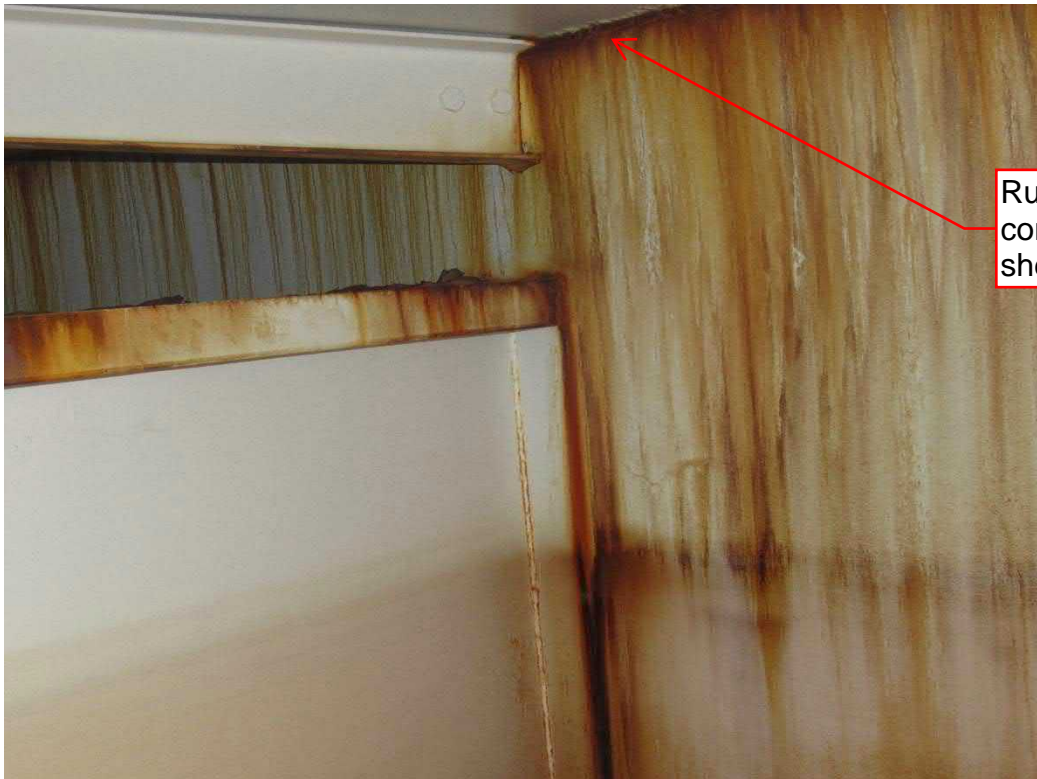
Rust staining from corrosion between shell wall and roof.

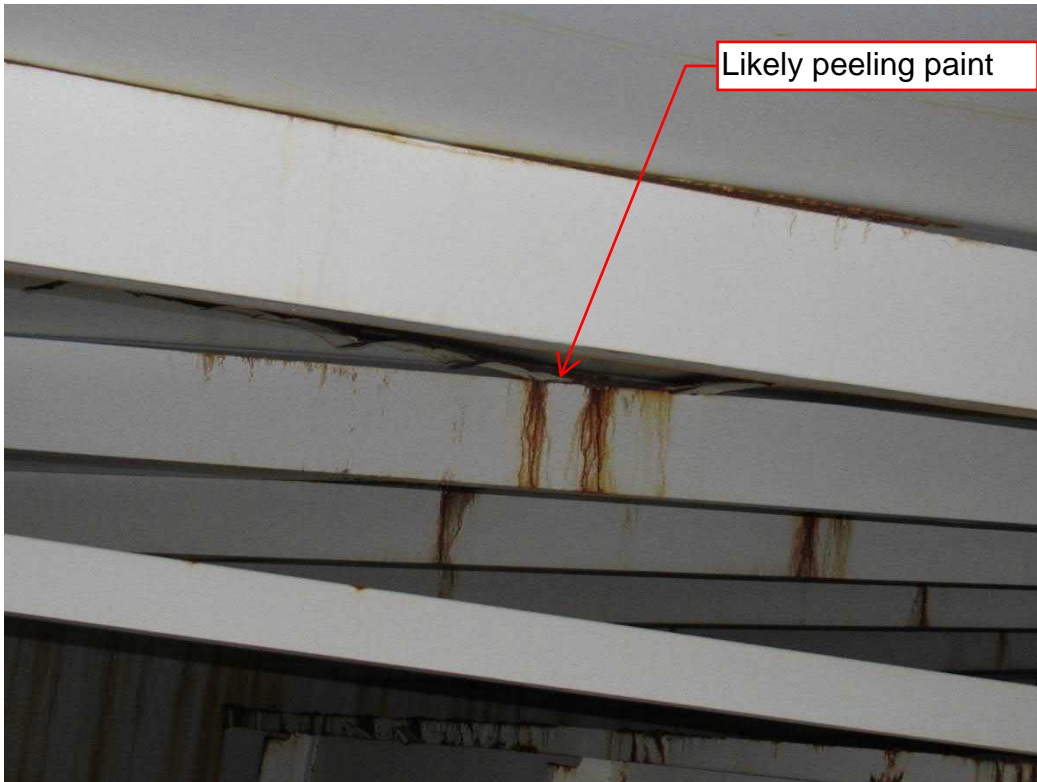
Photo 35: Interior condition. Note delamination in roof.

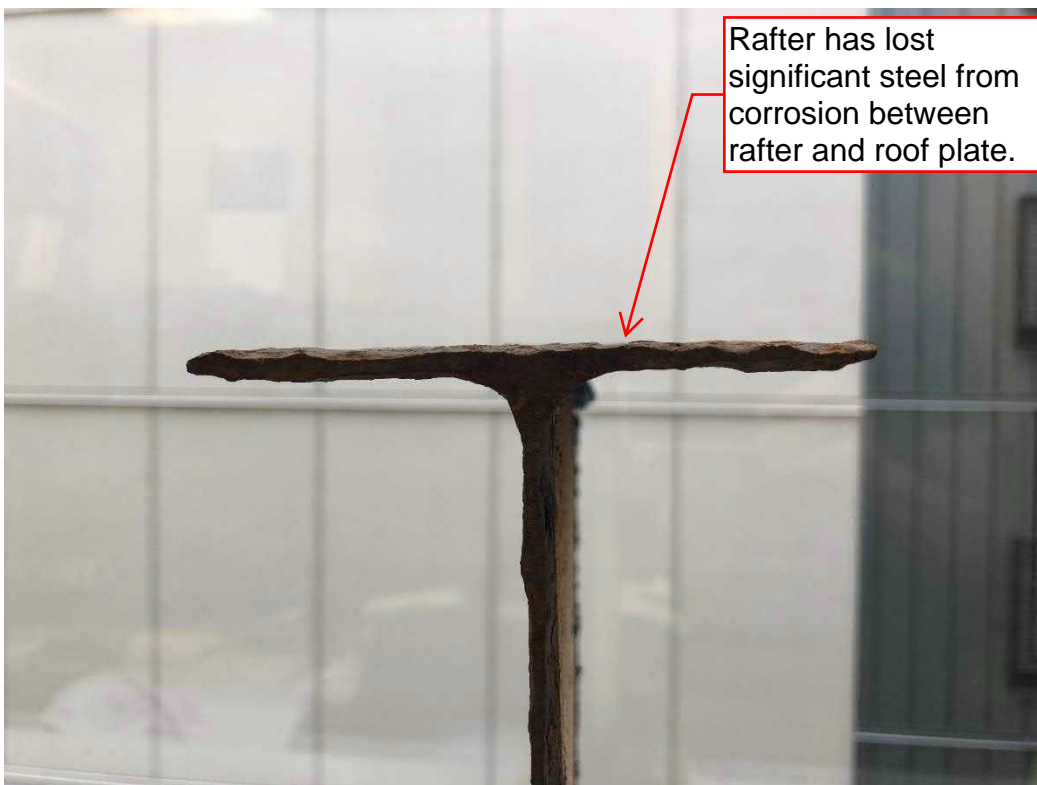
Photo 36: Corroded Rafter

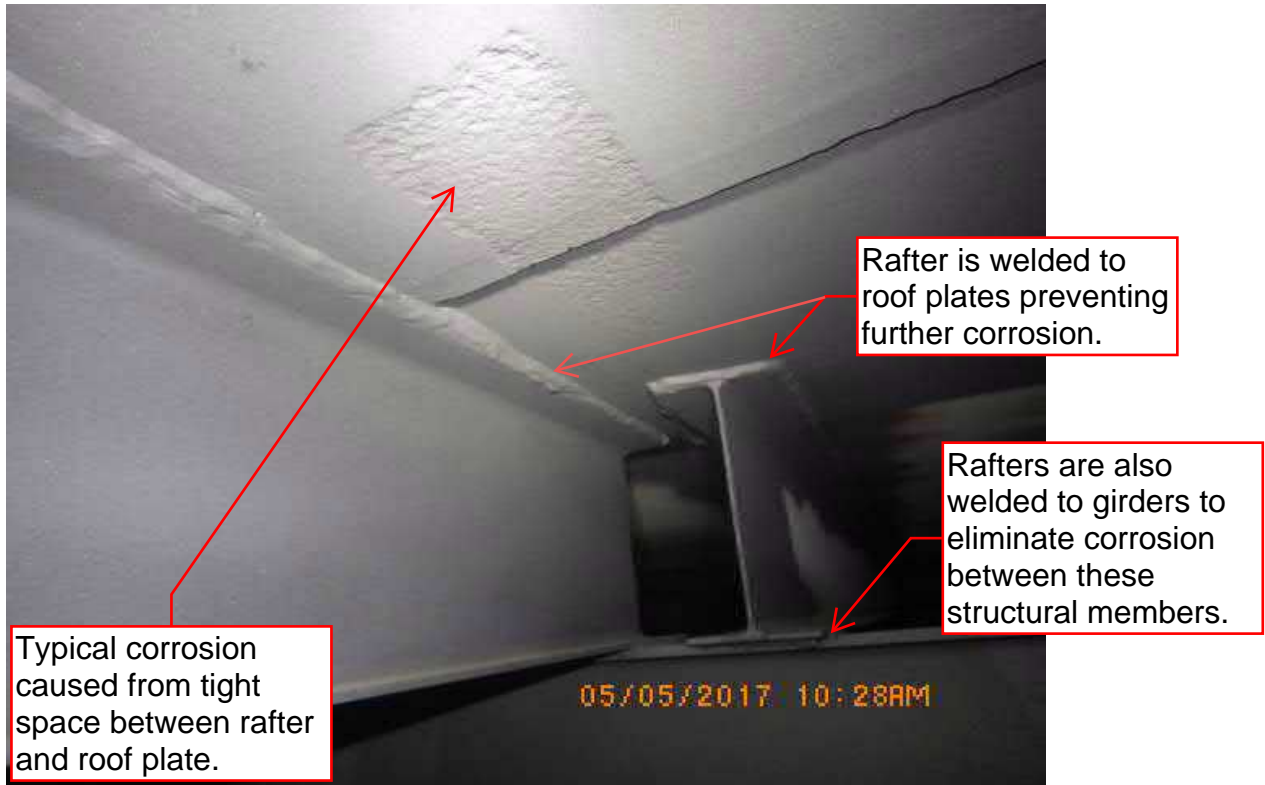
Photo 37: Seal welded rafter cut back from original location.

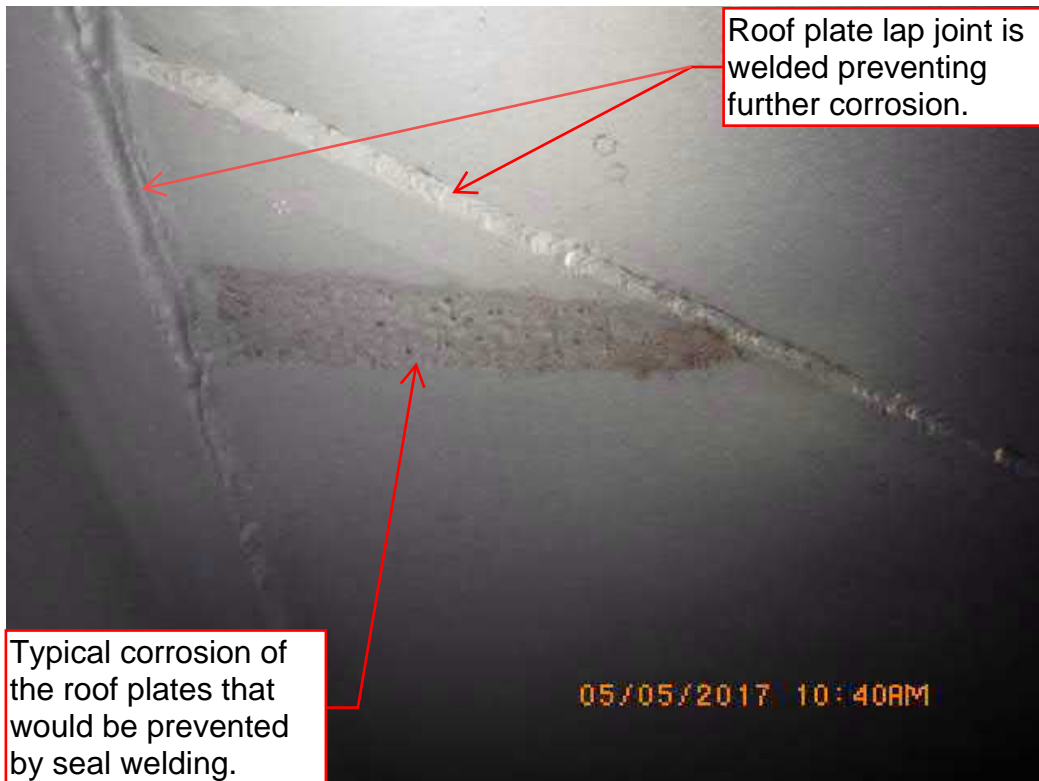
Photo 38: Seal welded roof lap joints. Note the corrosion from the previous rafter location.

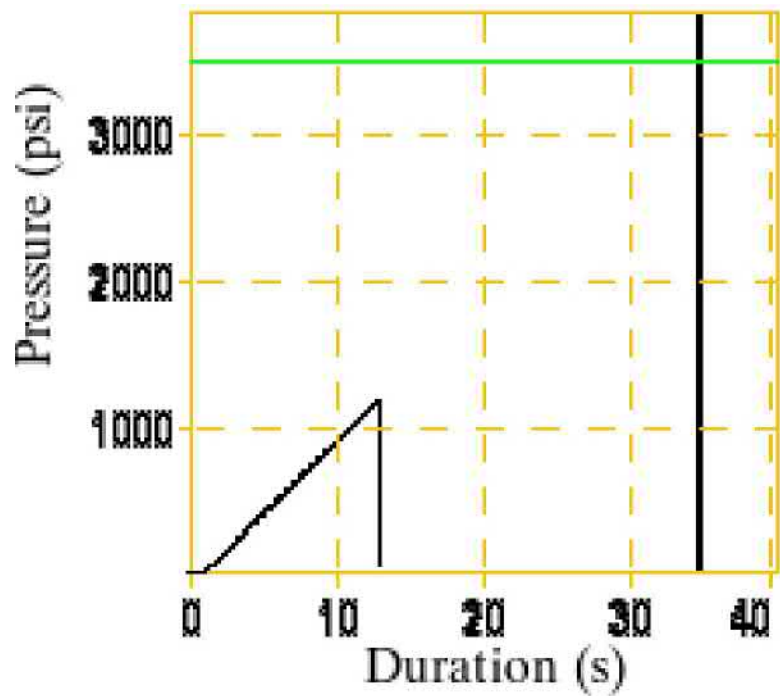
#	Pressure Limit (psi)	Duration Hold Time (s)	Dolly Size (mm)	Rate (psi/s)	Result	Pass/Fail Time
1	1214 3500	12.9 0.0/0.0	20	100	Pulled	X 2020-08-19 12:57:28
	Glue Y: 0	Y/Z Interface: 0				
	Layer 1: B 0	B/Y Interface: 0				
	Substrate: A 0	A/B Interface: 0

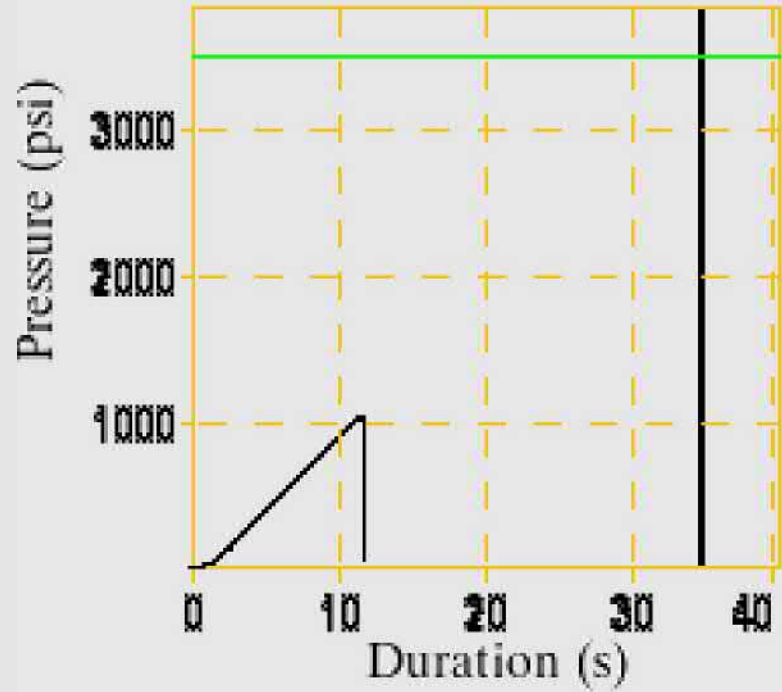
#	Pressure Limit (psi)	Duration Hold Time (s)	Dolly Size (mm)	Rate (psi/s)	Result	Pass/Fail Time
2	1089 3500	11.8 0.0/0.0	20	100	Pulled	X 12:59:25
	Glue Y:	0	Y/Z Interface:	0		
	Layer 1: B	0	B/Y Interface:	0		
	Substrate: A	0	A/B Interface:	0

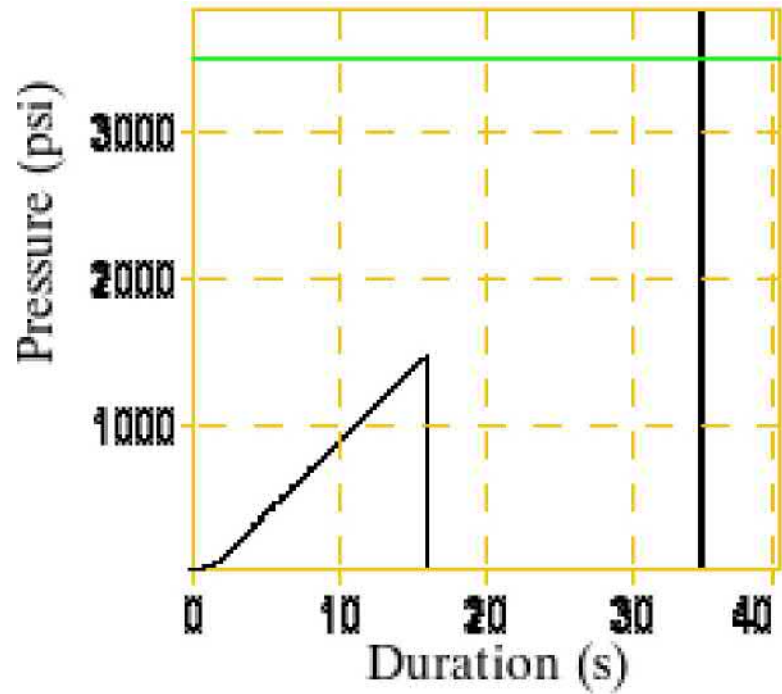
#	Pressure Limit (psi)	Duration Hold Time (s)	Dolly Size (mm)	Rate (psi/s)	Result	Pass/Fail Time
3	1496 3500	16.1 0.0/0.0	20	100	Pulled	X 13:01:21
	Glue Y: 0	Y/Z Interface: 0				
	Layer 1: B 0	B/Y Interface: 0				
	Substrate: A 0	A/B Interface: 0

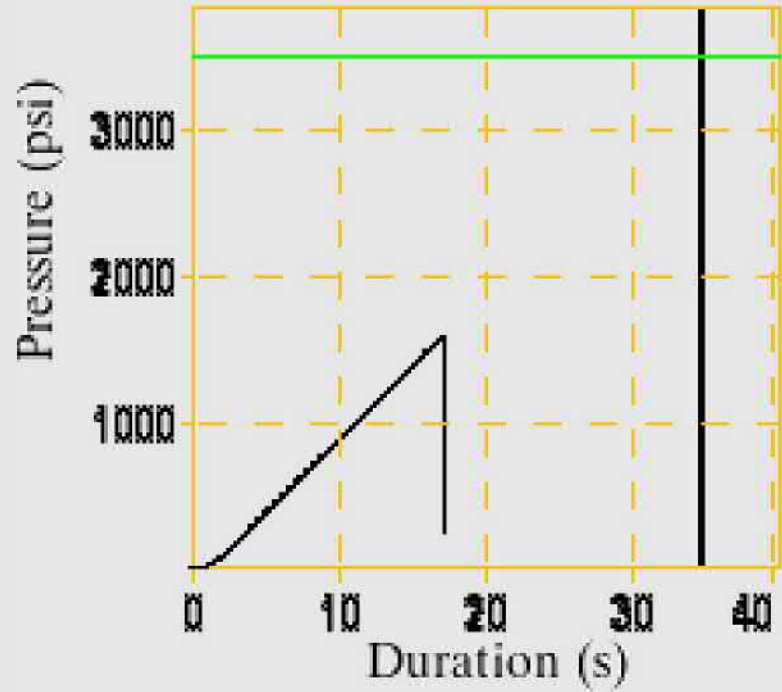
#	Pressure Limit (psi)	Duration Hold Time (s)	Dolly Size (mm)	Rate (psi/s)	Result	Pass/Fail Time
4	1622 3500	17.2 0.0/0.0	20	100	Pulled	X 13:04:38
	Glue Y:	0	Y/Z Interface:	0		
	Layer 1: B	0	B/Y Interface:	0		
	Substrate: A	0	A/B Interface:	0

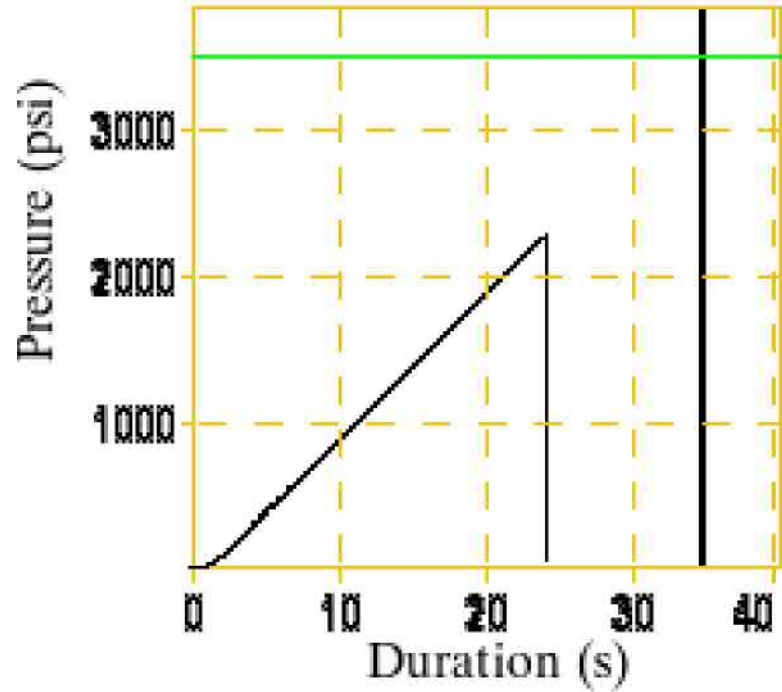
#	Pressure Limit (psi)	Duration Hold Time (s)	Dolly Size (mm)	Rate (psi/s)	Result	Pass/Fail Time
5	2298 3500	24.0 0.0/0.0	20	100	Pulled	X 13:29:03
	Glue Y: 0	Y/Z Interface: 0				
	Layer 1: B 0	B/Y Interface: 0				
	Substrate: A 0	A/B Interface: 0

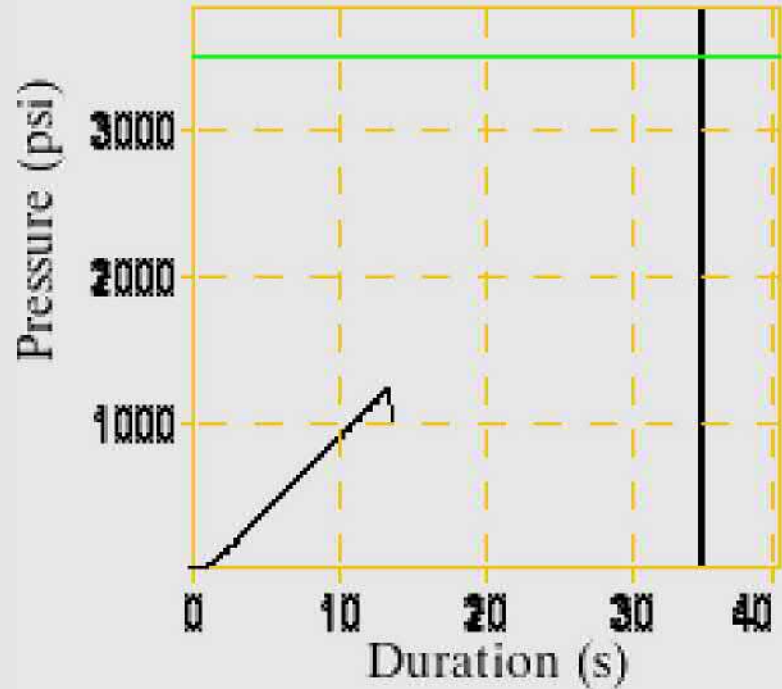
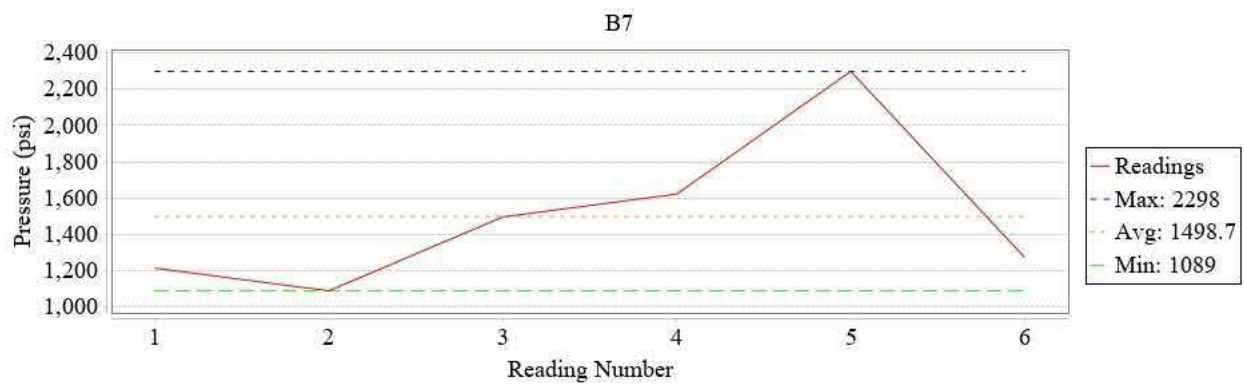
#	Pressure Limit (psi)	Duration Hold Time (s)	Dolly Size (mm)	Rate (psi/s)	Result	Pass/Fail Time
6	1273 3500	13.6 0.0/0.0	20	100	Pulled	X 13:36:11
	Glue Y:	0	Y/Z Interface:	0		
	Layer 1: B	0	B/Y Interface:	0		
	Substrate: A	0	A/B Interface:	0

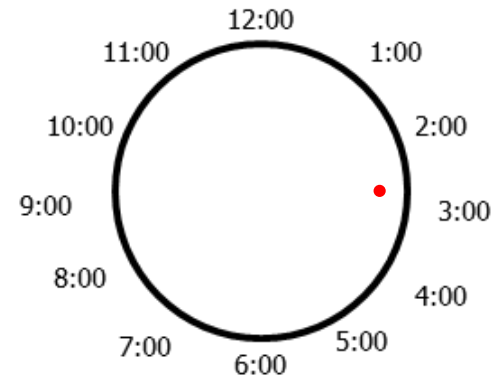
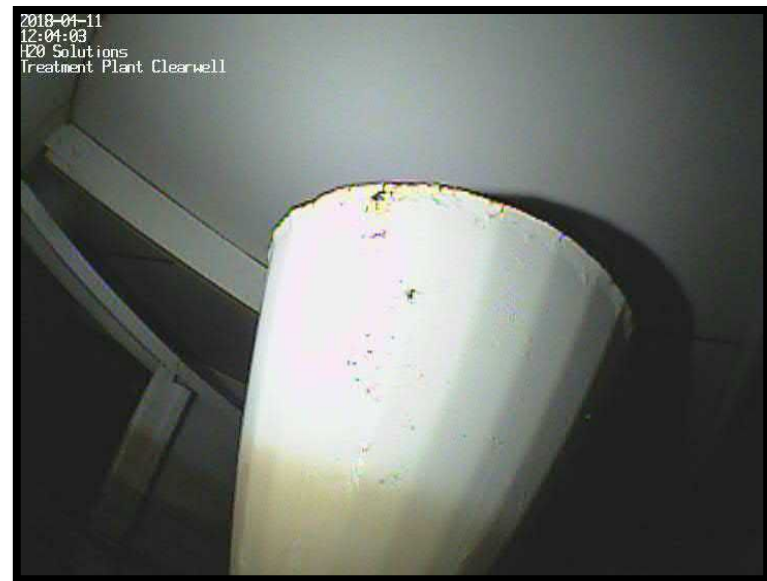
Interior Overflow Base
