## TECHNICAL MEMORANDUM 20434-2

SUBJECT: SUDDEN VALLEY WTP CHLORINE  
CONTACT BASIN COATING ASSESSMENT  
LAKE WHATCOM WATER & SEWER  
DISTRICT, WHATCOM COUNTY,  
WASHINGTON  
G&O #20434.00

Technical Memorandum 20434-2 – Sudden Valley WTP  
Chlorine Contact Basin Coating Assessment  
September 10, 2021

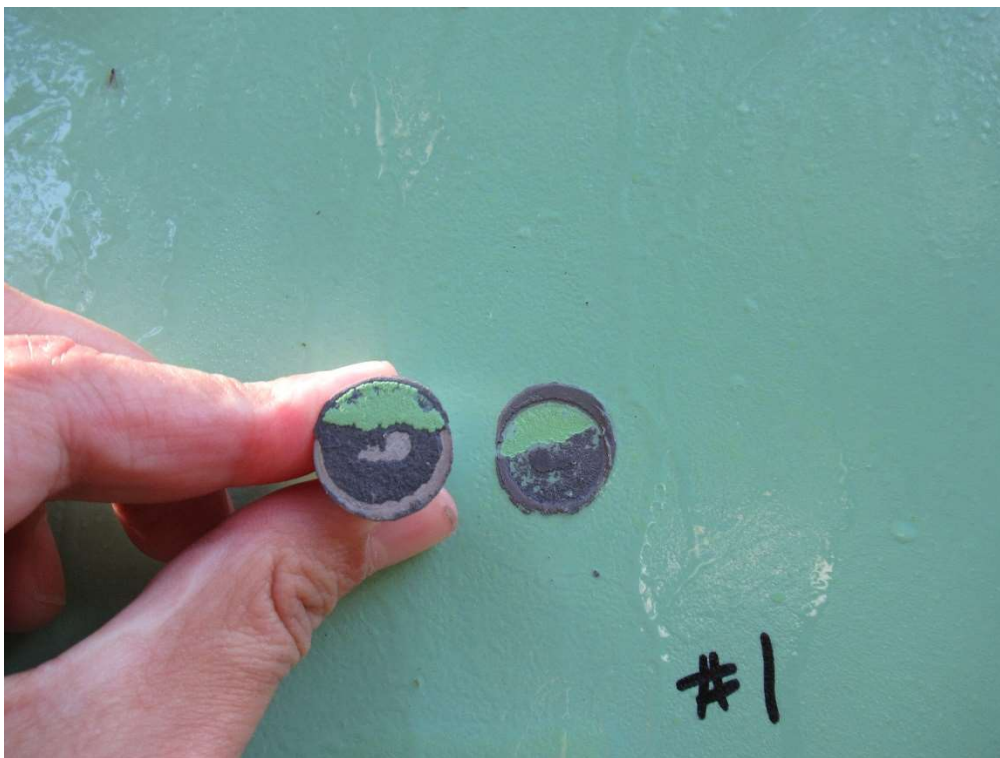
The exterior of the tank is largely protected by the existing coating system but it is beginning to fail. The coating repair patches on the side of the tank are corroding underneath the patches as evidenced by the rust staining leaking from them. The coatings showed strong adhesion as demonstrated in the adhesion tests, however there are some issues with the coatings as they are delaminating in places on the roof. The rooftop areas could likely be pressure washed and prepared via hand tools to remove the loose coatings but some risk could remain that there is a problem that will continue to spread after topcoating if that option was selected. One other problem that was noted while onsite is the moisture in that area. The inspection was conducted in late August which is typically the driest time of the year and the tank was still very wet at noon. This type of moisture would require the use of containment and dehumidification equipment in order to paint the tank and cure the coatings properly. If containment is used, there is no point in top coating the existing system as the costs at that point to remove and replace the coating system would be approximately the same as top coating. The heavy algal growth on the roof and on the sides of the tank show that this moisture is an ongoing issue.

Photo 9: Rust stains from underneath coating patches.

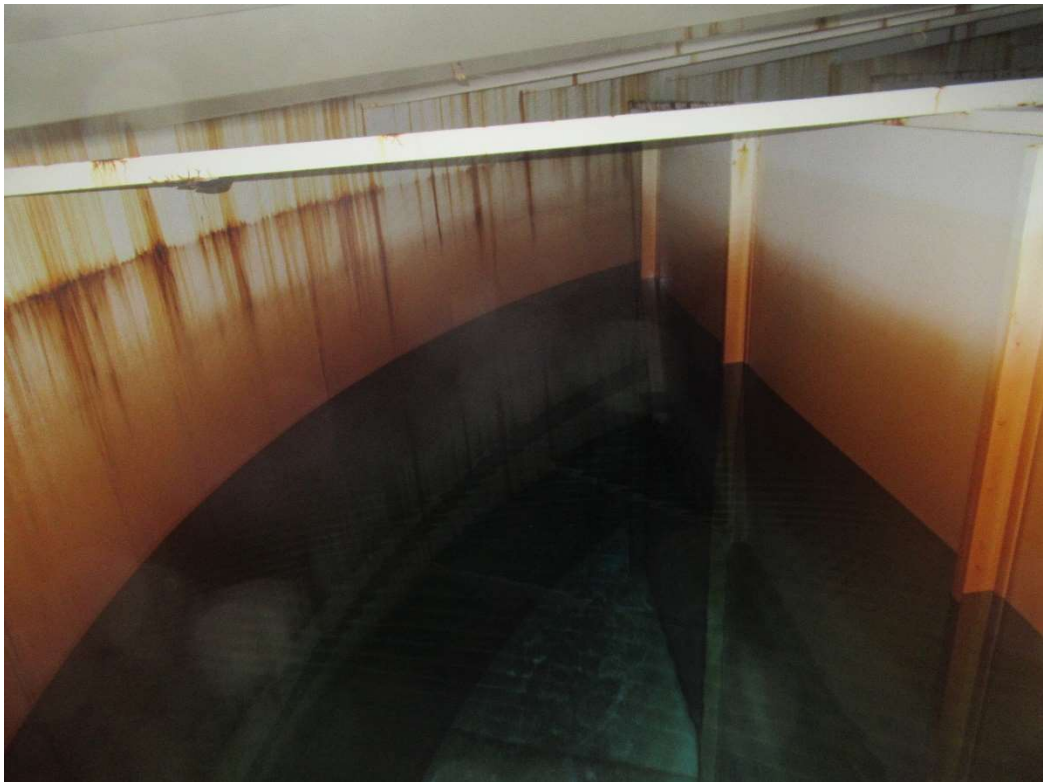
Photo 31: Interior baffle walls.

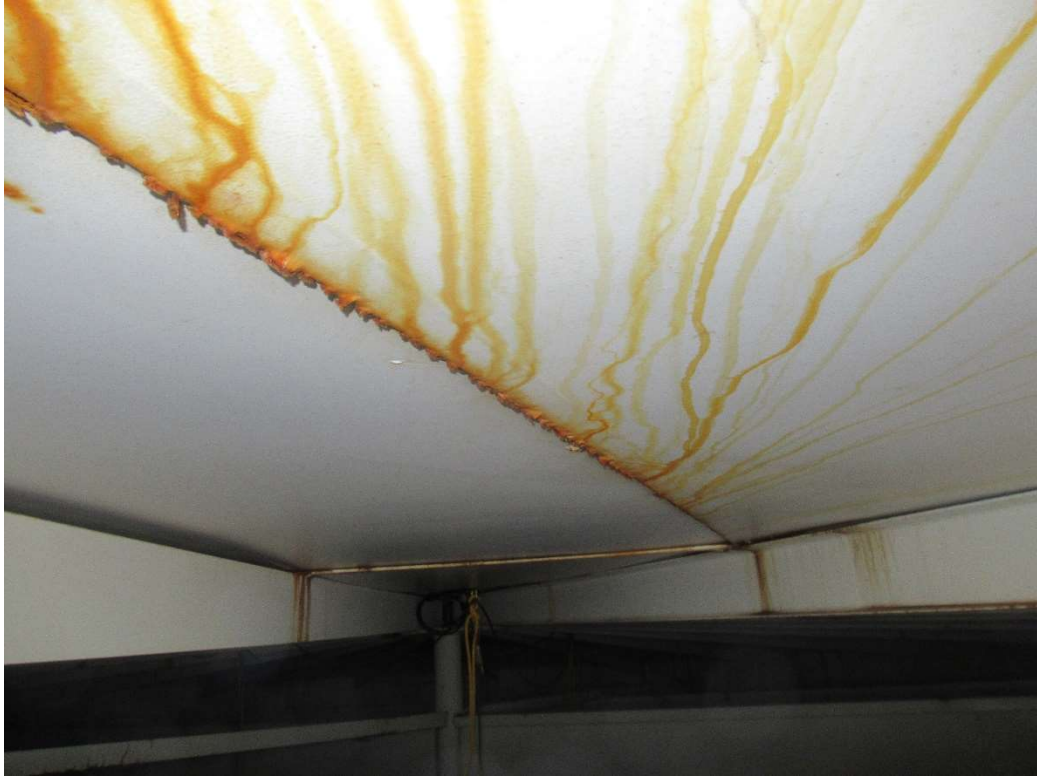
Photo 32: Interior condition.

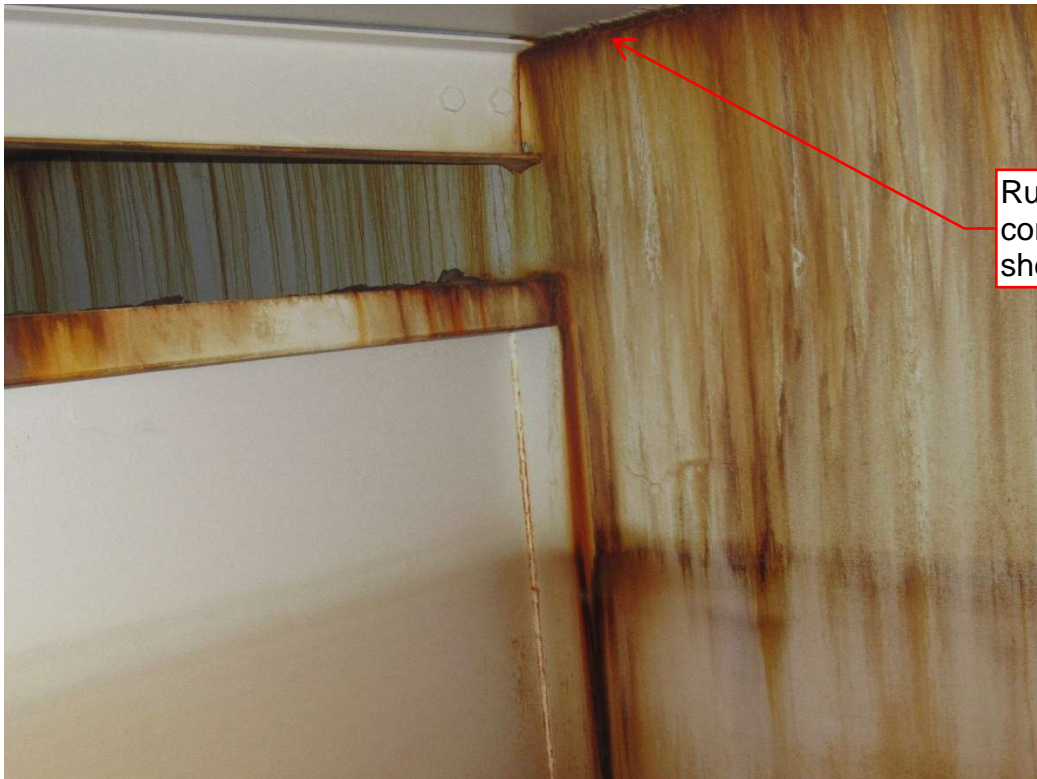
Photo 33: Interior condition.

Rust staining from corrosion between shell wall and roof.

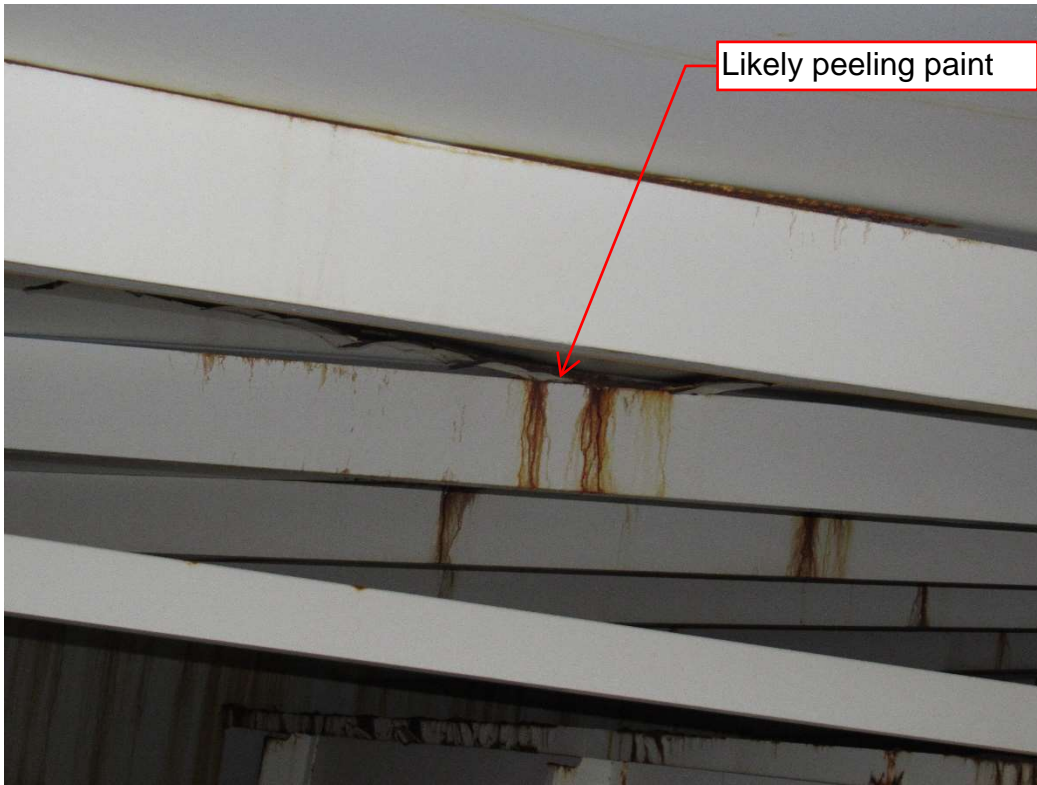
Photo 34: Interior condition.

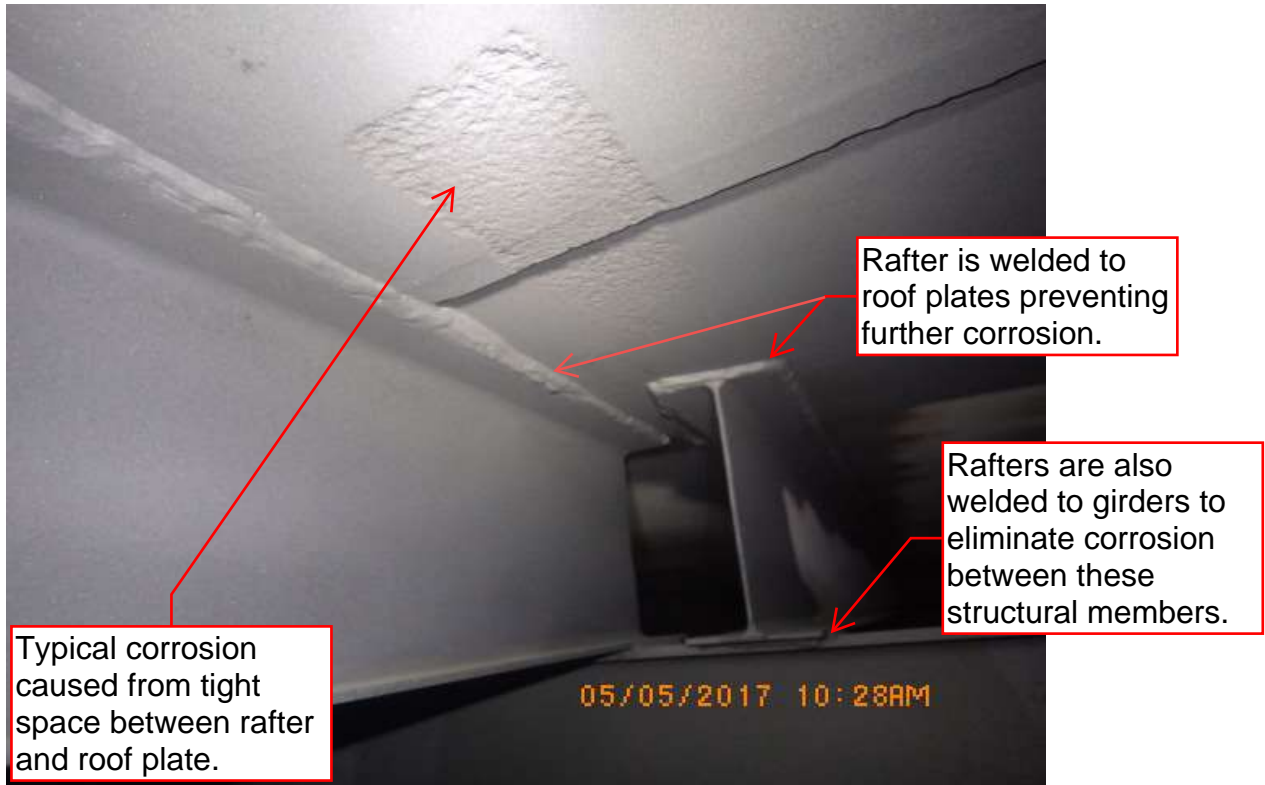
As can be seen in Photo 36 from another reservoir, the flange on a rafter can be severely corroded. Photo 38 shows the seal welded tank that the rafter in Photo 37 was taken from. You can see that the corrosion in the ¼-inch thick roof plate above that rafter was significant with degradation of up to a third of the thickness of that plate having occurred. With the seal welding complete, you can see the rafter to roof plate gap has been welded shut. Photo 38 shows the roof plate lap welded shut. The coatings can now be applied as a complete film across those areas and the amount of corrosion that the tank will undergo from this point forward has been significantly reduced, thereby extending the lifespan of the tank. Seal welding the tank during the next recoating project will extend the service life of the structure and will also extend the maximum life that can be obtained from a coating system. The corrosion seen on the edges of the roof plates and the vast majority of the staining seen in the roof of the tank are all issues that are eliminated by seal welding and stripe coating and all things being equal, will typically extend the life of a recoating project by five or more years. The cost to seal weld the interior of Tank 1 is approximately \$75,000.

Photo 36: Corroded Rafter

We highly recommend seal welding as it will extend the lifespan of the tank as well as each coating system applied to the tank for the rest of its service life.

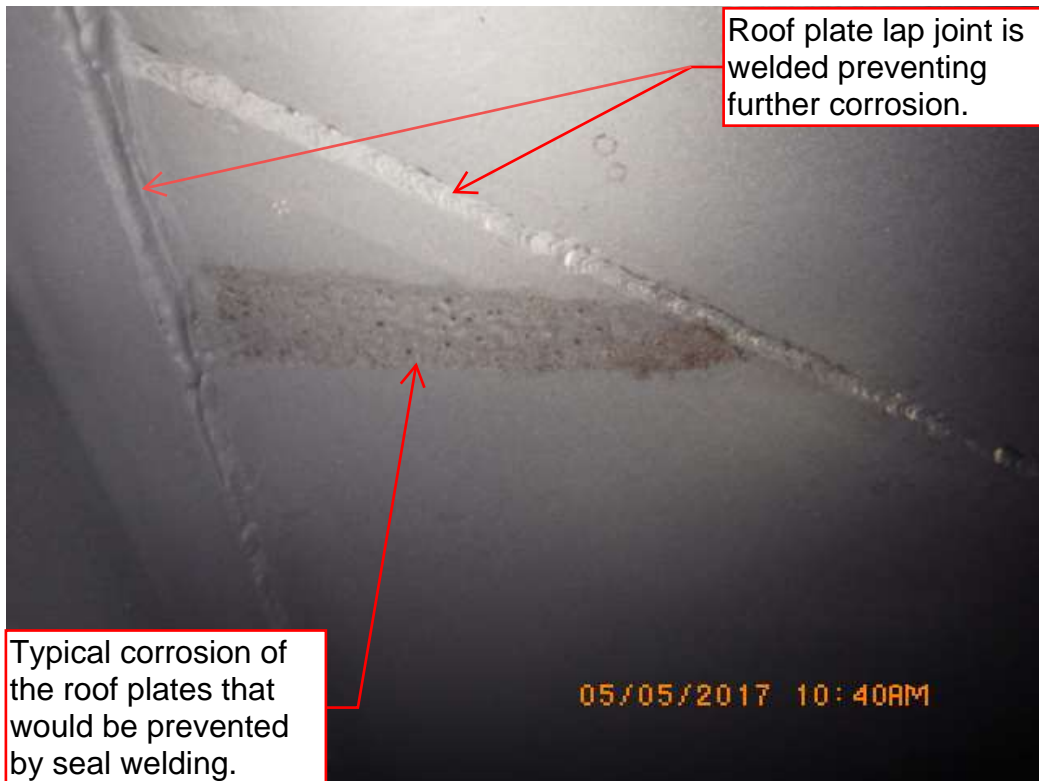
Photo 37: Seal welded rafter cut back from original location.

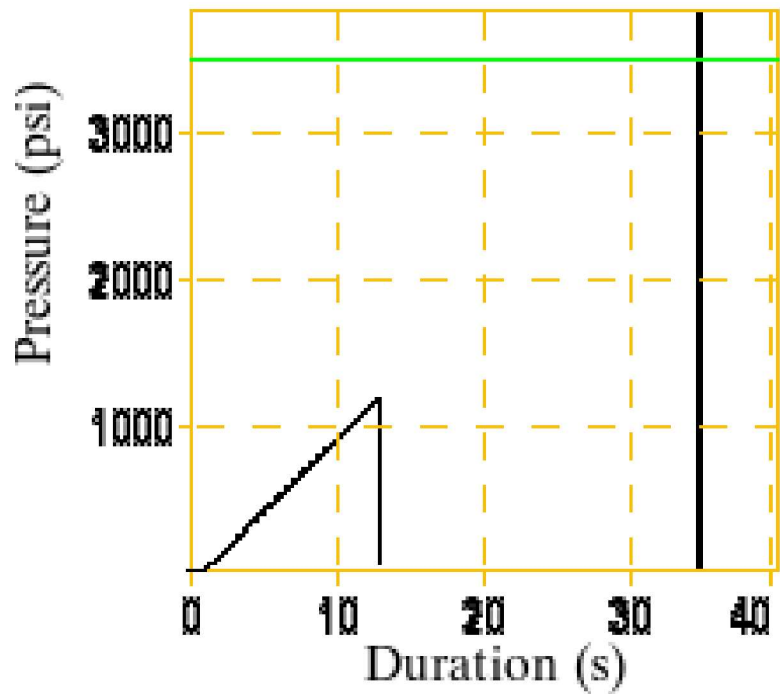
#	Pressure Limit (psi)	Duration Hold Time (s)	Dolly Size (mm)	Rate (psi/s)	Result	Pass/Fail Time
1	1214 3500	12.9 0.0/0.0	20	100	Pulled	<b>X</b> 2020-08-19 12:57:28
	Glue Y: 0	Y/Z Interface: 0				
	Layer 1: B 0	B/Y Interface: 0				
	Substrate: A 0	A/B Interface: 0

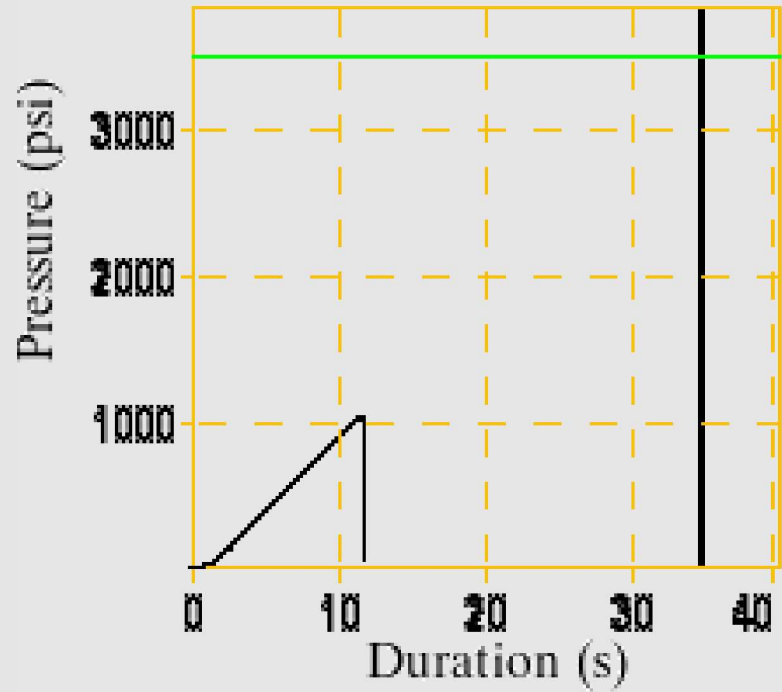
#	Pressure Limit (psi)	Duration Hold Time (s)	Dolly Size (mm)	Rate (psi/s)	Result	Pass/Fail Time
2	1089 3500	11.8 0.0/0.0	20	100	Pulled	<b>X</b> 12:59:25
	Glue Y:	0	Y/Z Interface:	0		
	Layer 1: B	0	B/Y Interface:	0		
	Substrate: A	0	A/B Interface:	0

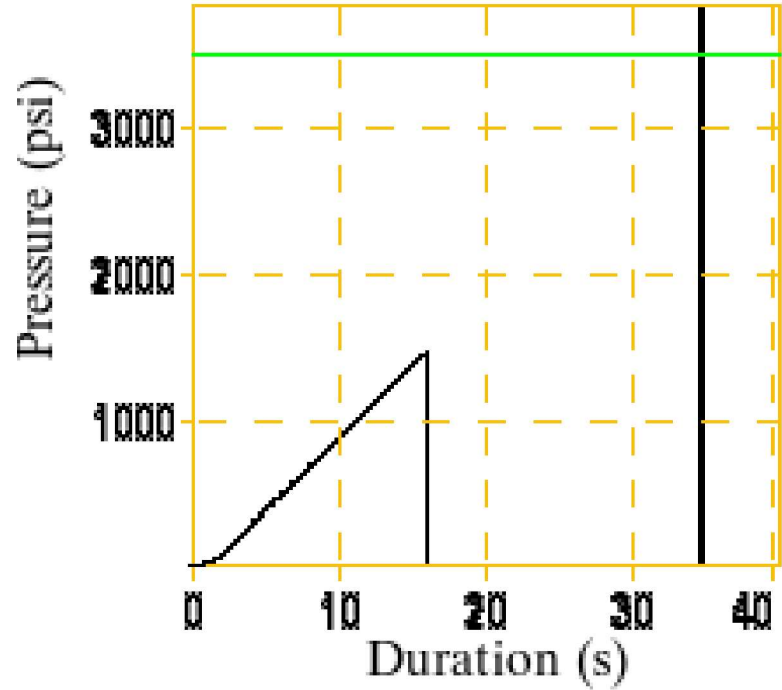
#	Pressure Limit (psi)	Duration Hold Time (s)	Dolly Size (mm)	Rate (psi/s)	Result	Pass/Fail Time
3	1496 3500	16.1 0.0/0.0	20	100	Pulled	<b>X</b> 13:01:21
	Glue Y: 0	Y/Z Interface: 0				
	Layer 1: B 0	B/Y Interface: 0				
	Substrate: A 0	A/B Interface: 0

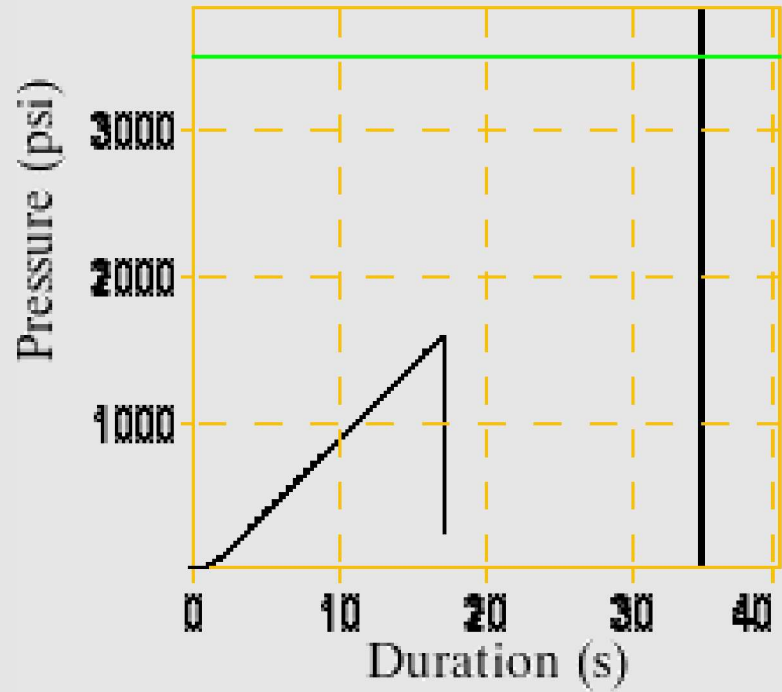
#	Pressure Limit (psi)	Duration Hold Time (s)	Dolly Size (mm)	Rate (psi/s)	Result	Pass/Fail Time
4	1622 3500	17.2 0.0/0.0	20	100	Pulled	<b>X</b> 13:04:38
	Glue Y: 0	Y/Z Interface: 0				
	Layer 1: B 0	B/Y Interface: 0				
	Substrate: A 0	A/B Interface: 0

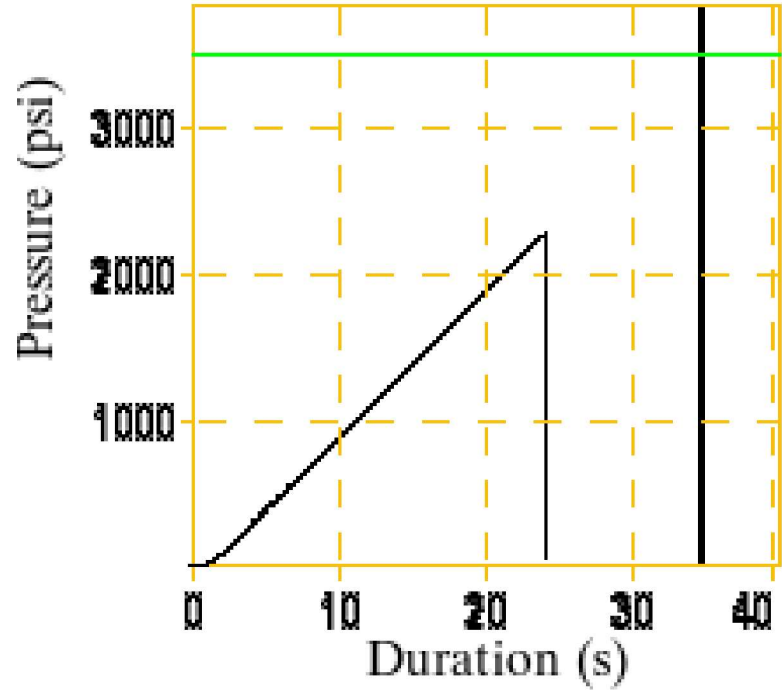
#	Pressure Limit (psi)	Duration Hold Time (s)	Dolly Size (mm)	Rate (psi/s)	Result	Pass/Fail Time
5	2298 3500	24.0 0.0/0.0	20	100	Pulled	<b>X</b> 13:29:03
	Glue Y: 0	Y/Z Interface: 0				
	Layer 1: B 0	B/Y Interface: 0				
	Substrate: A 0	A/B Interface: 0

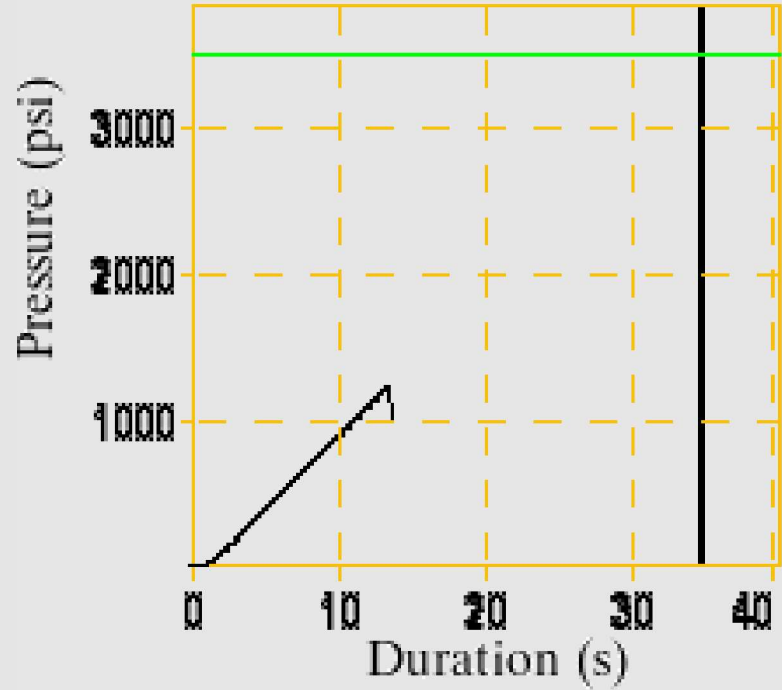
#	Pressure Limit (psi)	Duration Hold Time (s)	Dolly Size (mm)	Rate (psi/s)	Result	Pass/Fail Time
6	1273 3500	13.6 0.0/0.0	20	100	Pulled	<b>X</b> 13:36:11
	Glue Y:	0	Y/Z Interface:	0		
	Layer 1: B	0	B/Y Interface:	0		
	Substrate: A	0	A/B Interface:	0
