TECHNICAL MEMORANDUM 20434-3

SUBJECT: SUDDEN VALLEY WTP TIER 2/TIER 3
SEISMIC EVALUATION
LAKE WHATCOM WATER & SEWER
DISTRICT, WHATCOM COUNTY,
WASHINGTON
G&O #20434.00

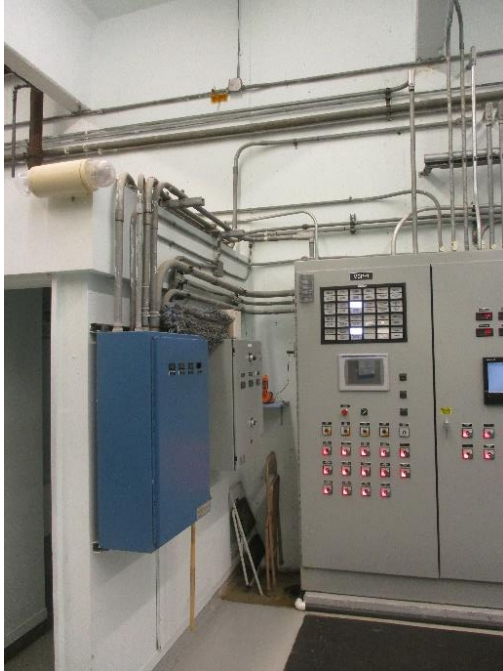
FIGURE A-1

- The wall framing at the restroom area has equipment attached to it that may result in failure of the wall during seismic shaking (Figure A-1). The proposed retrofit involves bracing the tops of the walls against the concrete ceiling of the building.

Restroom Wall Framing

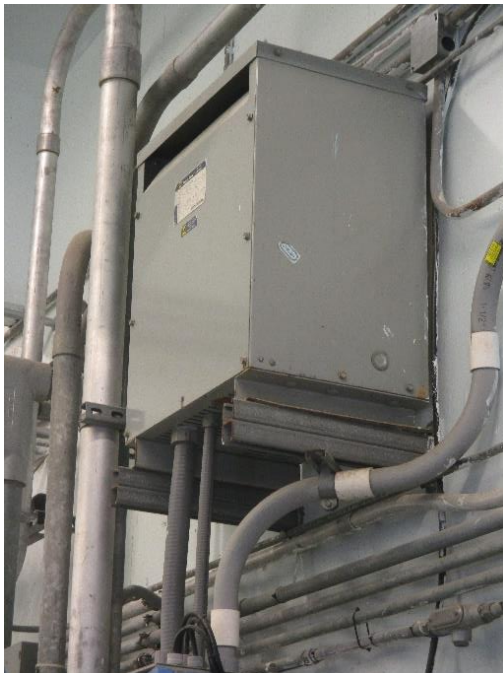
FIGURE A-2

Wall-Mounted Transformer

- The transformer mounted to the west wall (Figure A-2) requires seismic bracing in each lateral direction fastening back to the concrete wall in order to provide proper restraint.

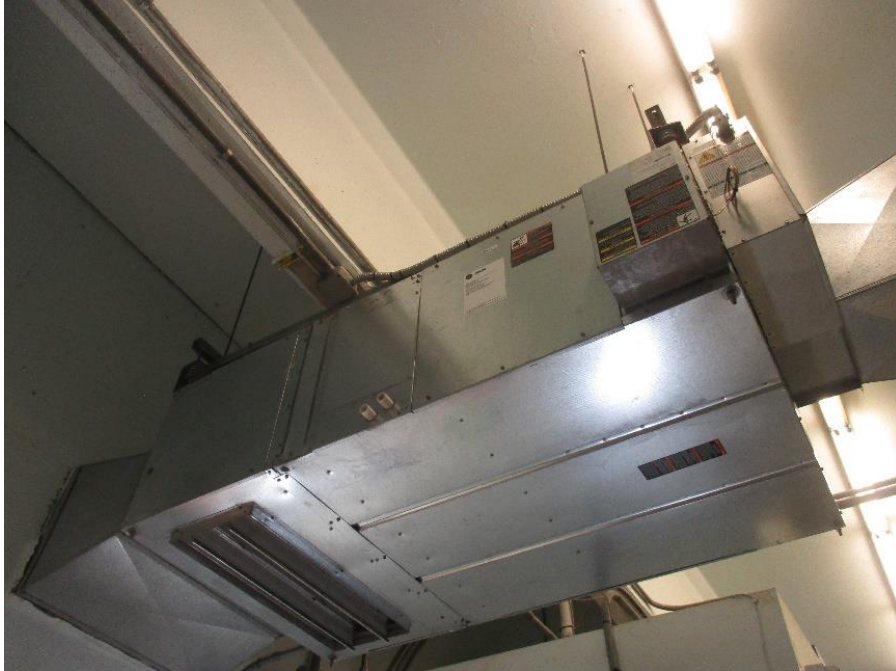
FIGURE A-3

HVAC Unit

- The suspended HVAC unit (Figure A-3) requires bracing in each lateral direction running back to the ceiling. These braces could consist of tension cables in all four directions or steel struts in two lateral directions.

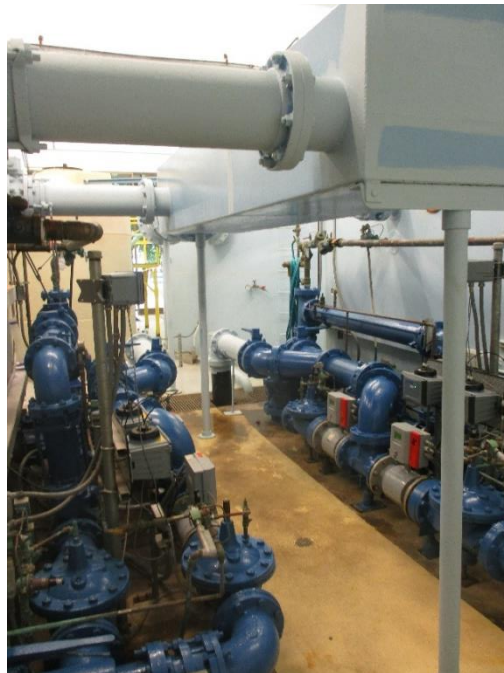
FIGURE A-4

Fluid Piping

- The fluid piping (Figure A-4) requires seismic bracing at regular spacing throughout the structure along the runs of each pipe.
- The piping from the various fluid-filled tanks (filters, flocculation tank, soda ash tank, and alum tank) that are supported from the floor of the building require flexible connections in order to mitigate any damage caused by differential movement between the tanks and the building during an earthquake. This applies to all tanks where differential movement poses a risk of significant damage.

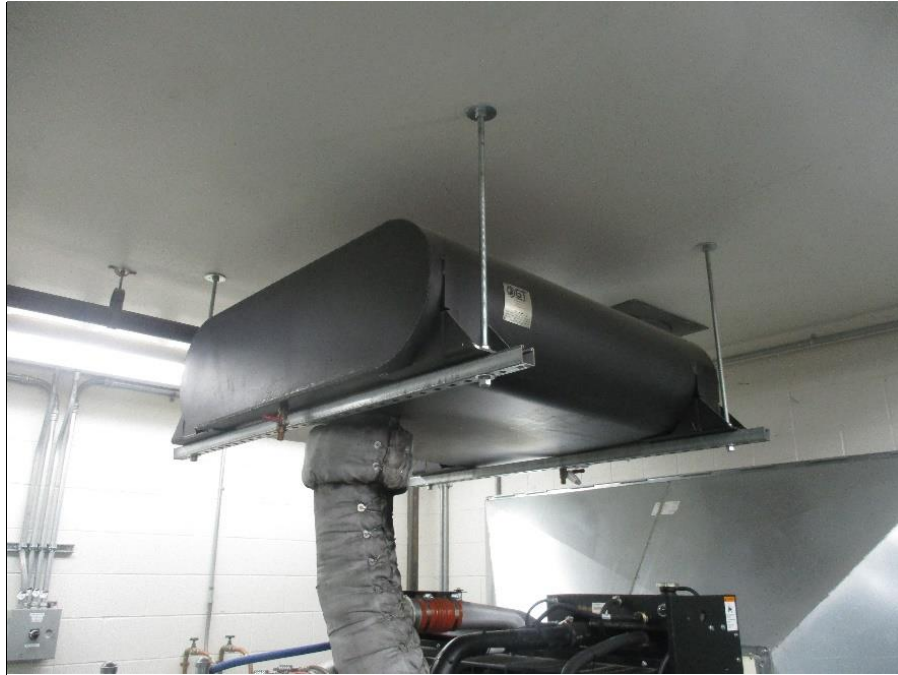
FIGURE B-1
Generator Exhaust

- The generator exhaust (Figure B-1) is unbraced and could become disconnected from the unit during an earthquake. The proposed retrofit is to install a brace in each lateral direction that brace it against the wall.

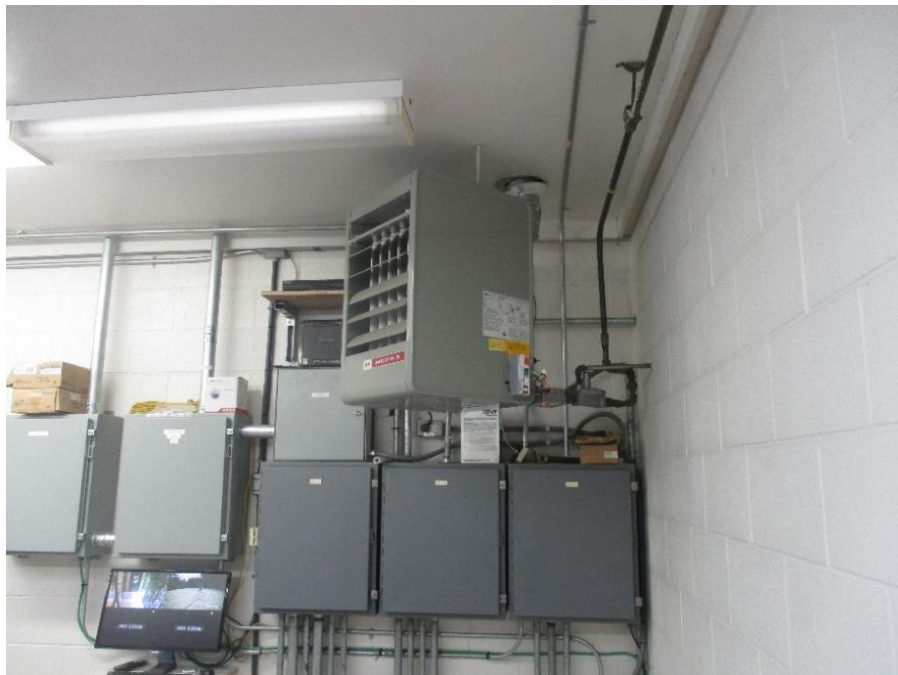
FIGURE B-2
Gas Heating Unit

- The gas heating unit (Figure B-2) is unbraced and new seismic bracing should be installed in each lateral direction and attached to the ceiling.
- The natural gas piping, fluid piping, and conduit runs (Figures B-3, B-4, and B-8) require seismic bracing at regular spacing installed throughout the structure along the runs to each component.

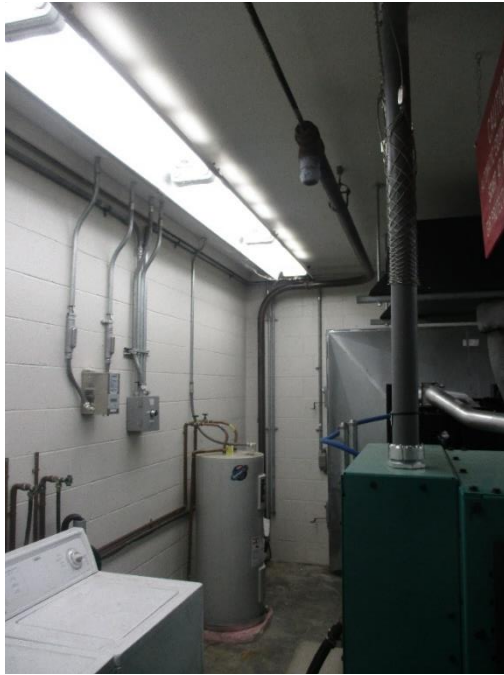
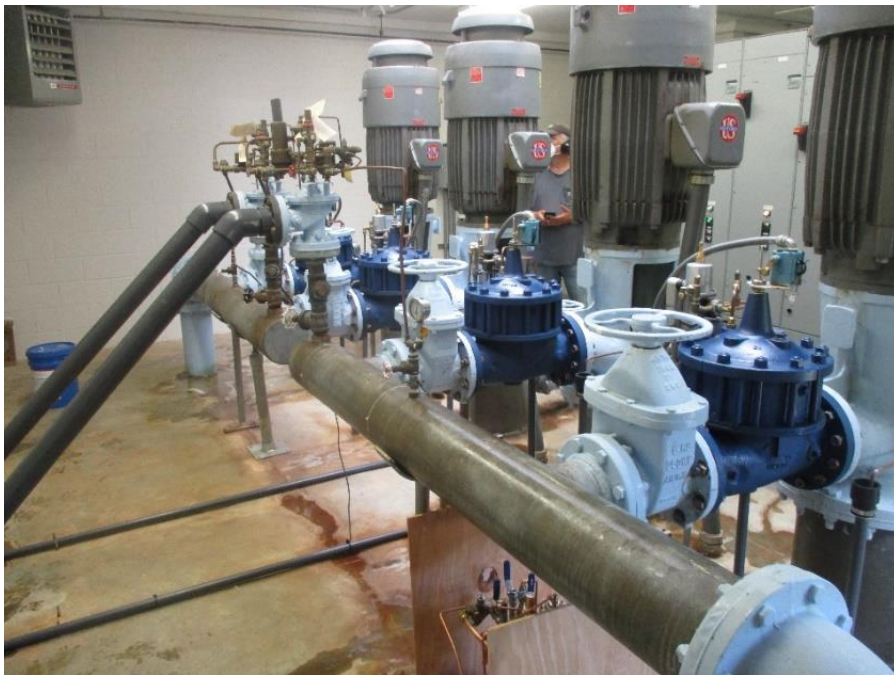
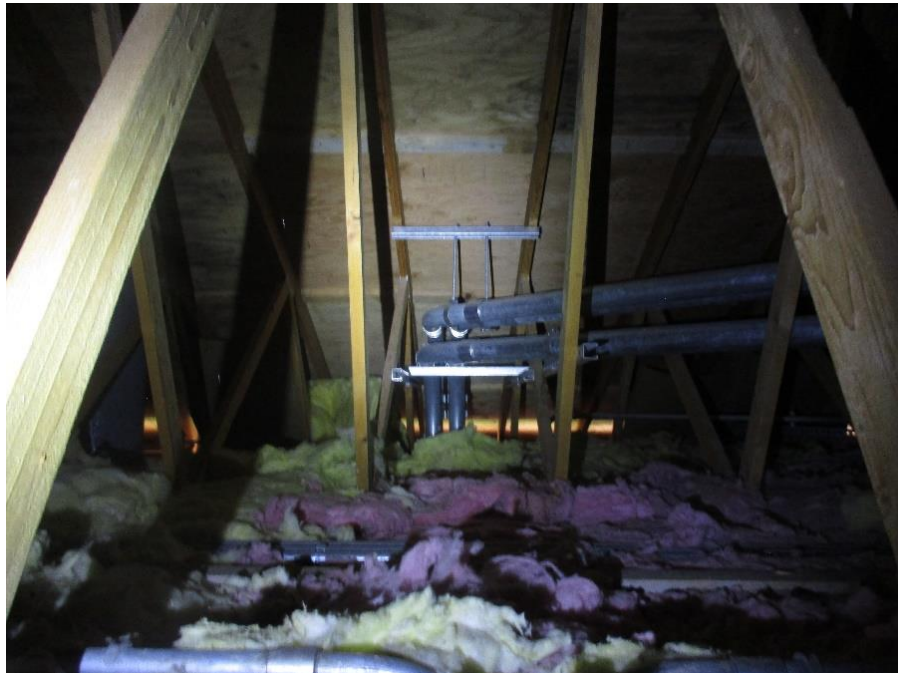
FIGURE B-3
Natural Gas Piping

FIGURE B-4
Fluid Piping

FIGURE B-8
Conduit Runs

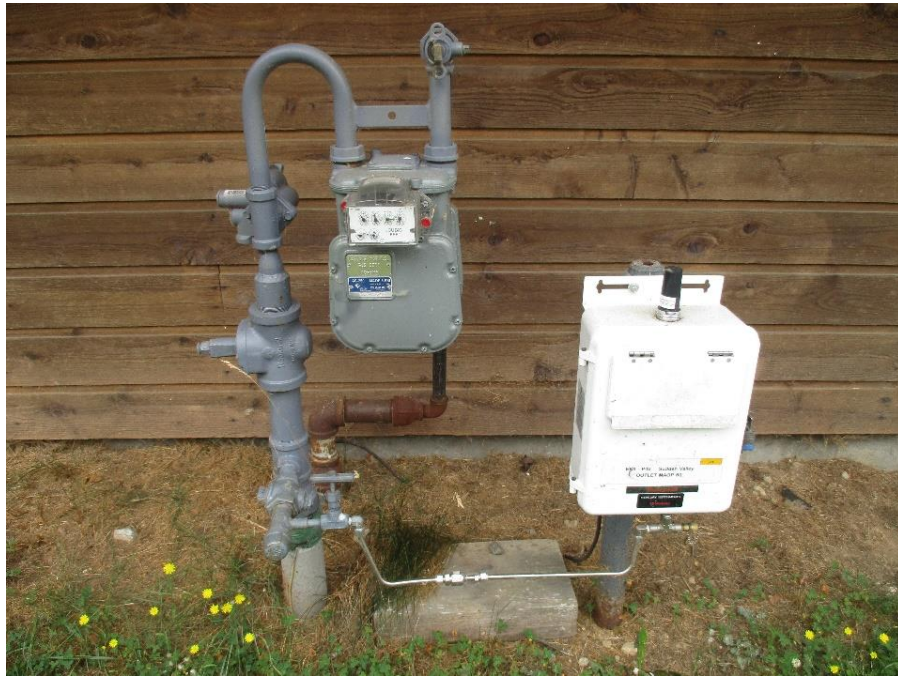
FIGURE B-5

- The gas meter (Figure B-5) just outside the structure has piping that runs from the ground through the wall of the building. Differential movement could cause this line to rupture during an earthquake. It is recommended to install a flexible coupling in the line to accommodate any movement.

Gas Meter

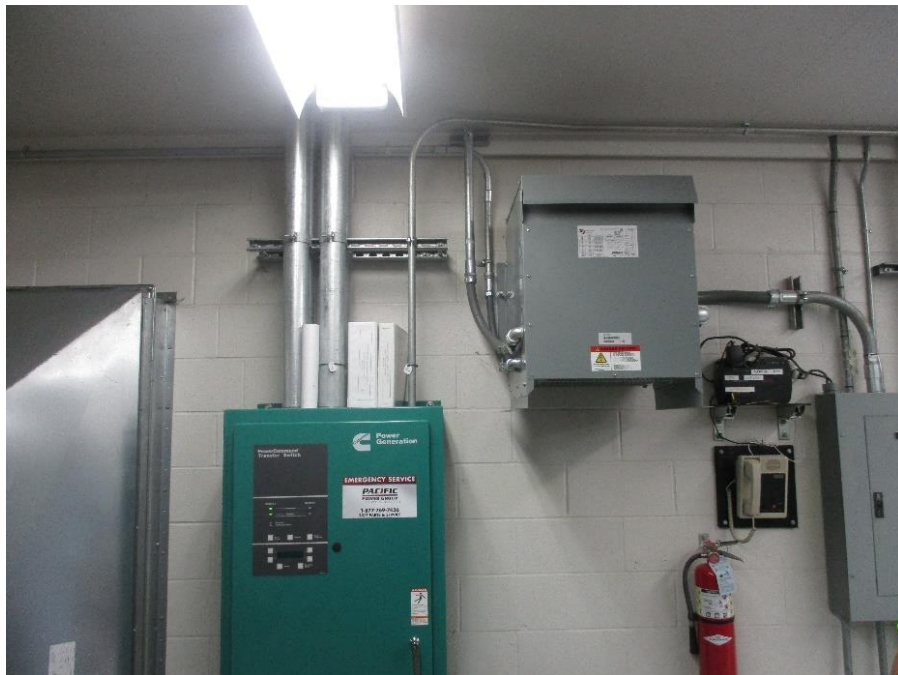
FIGURE B-6

- The transformer mounted on the north interior wall (Figure B-6) may shake loose during an earthquake. The proposed retrofit is to install lateral bracing back to the walls.

Wall-Mounted Transformer

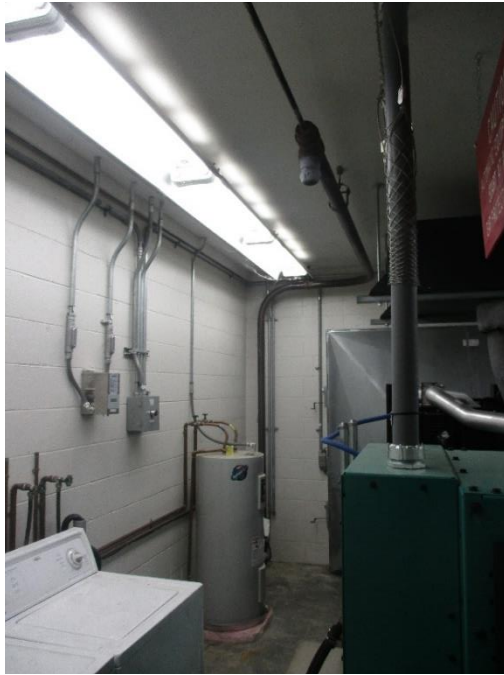
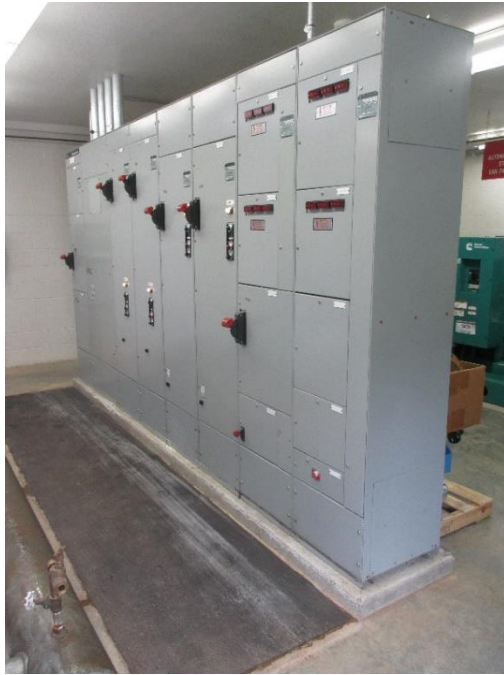
FIGURE B-7
Water Heater

Electrical Panels

- The water heater (Figure B-7) does not appear to be properly restrained. It is recommended that the water heater be strapped to the adjacent wall.
- The electrical panels in the building (Figure B-9) require additional seismic anchorage in order to comply with the selected performance level. This involves installing additional dowels that fasten each panel to the supporting slab to prevent the panels from overturning.
