#### Lake Whatcom Water and Sewer District

Sudden Valley WTP Assessment Project

June 29, 2021

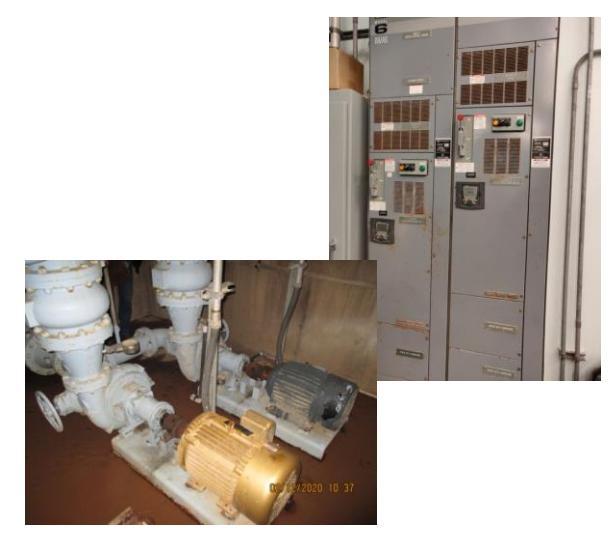
**Raw Water Pumps** – Raw Water Pump 2 is original (1972) and near the end of its recommended useful life.

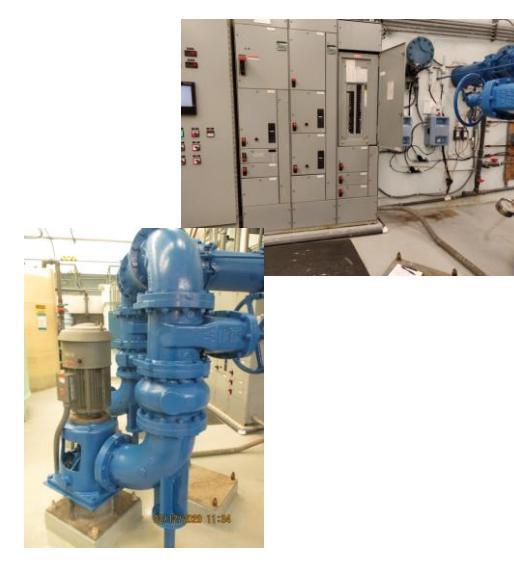
**Transfer Pumps** – Pumps are original (1992) and near the end of their recommended useful life.

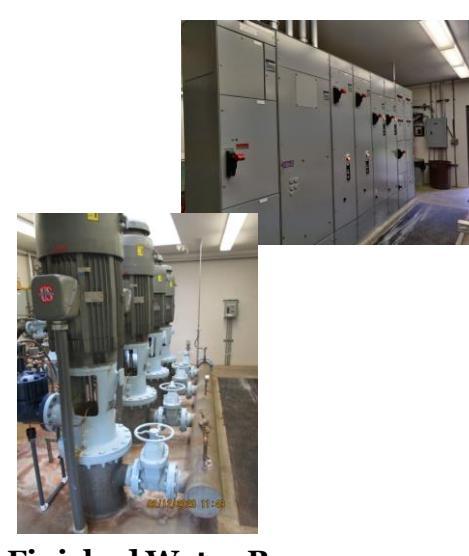
**Finished Water Pumps** – Pumps are original (1992) and near the end of their recommended useful life.

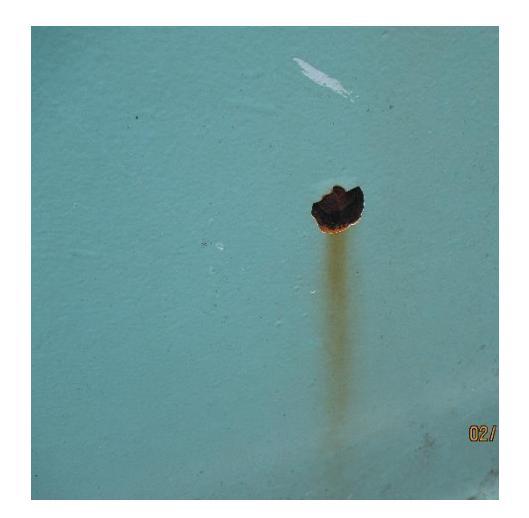
**Corrosion** – Tank has several corrosion spots, some of which have been repaired.

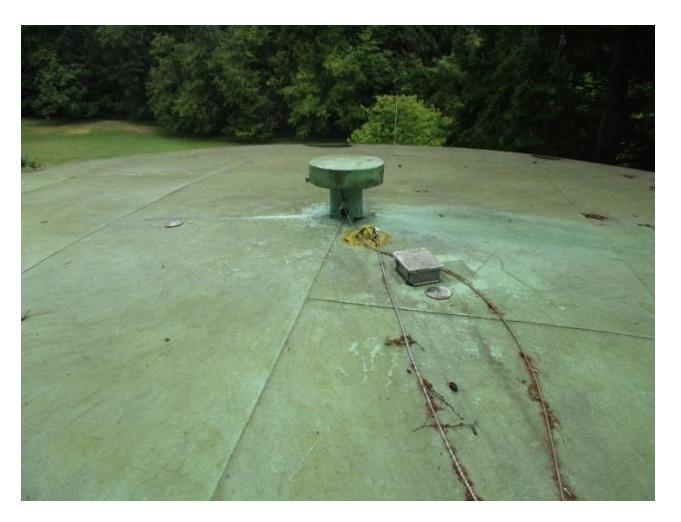
**Algae** – Roof exhibits lichen and algae growth, both of which may have damaged the coatings.

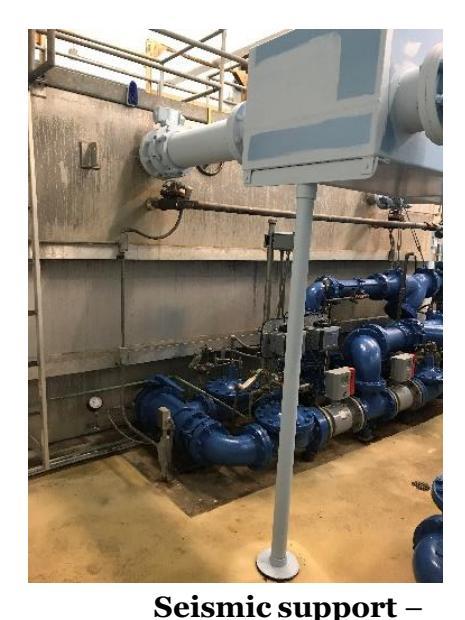
Example of piping with

insufficient seismic support

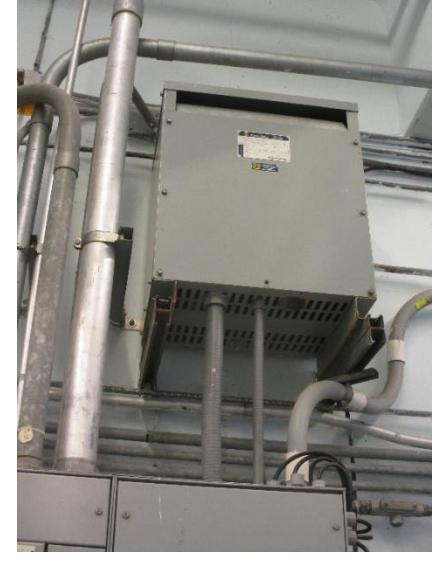
**Seismic support** – Example of equipment with insufficient seismic support

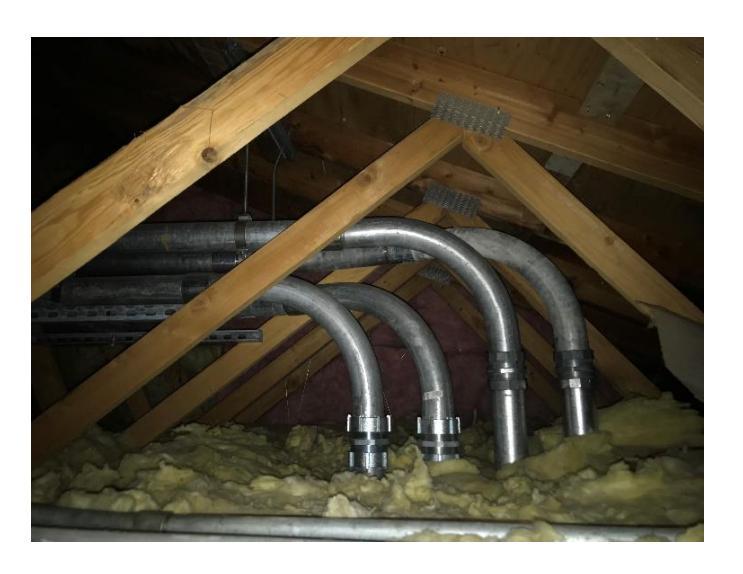
**Seismic Support** – Conduit within the FWP Building with insufficient seismic bracing.

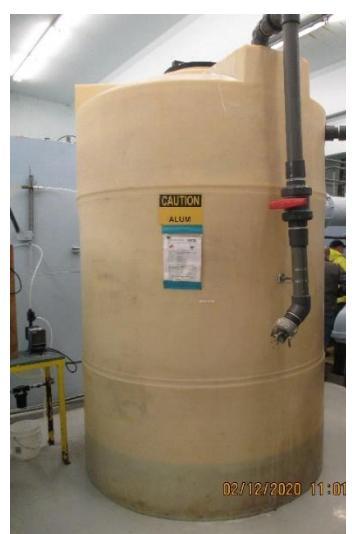
**Alum Storage Tank** – HPDE. Installed in 1992 and beyond its recommended useful life (15-17 years).

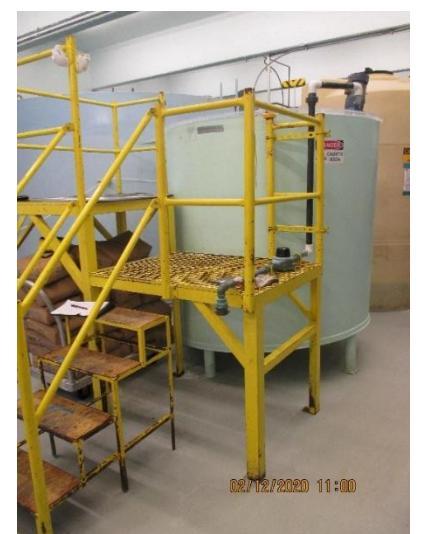
**Soda Ash Storage Tank & Platform** – Welded steel. Installed in 1992 and in good condition. Platform in fair condition while the mixer is in poor condition

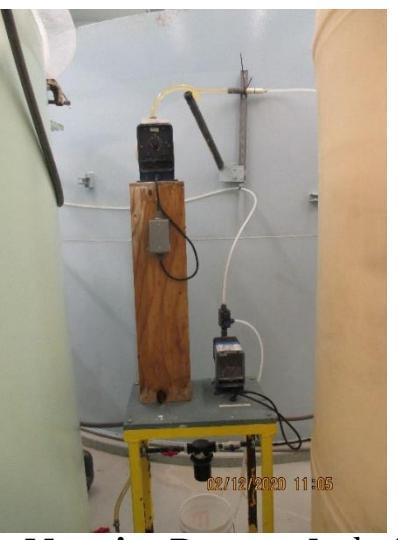
**Metering Pumps** – Lack of features requires daily manual calibration.
