Lake Whatcom Water and Sewer District Division 22-1 Reservoir Replacement

ADDENDUM NO. 2 March 25, 2025

Division 22-1 Reservoir Inspection Report April 1, 2024

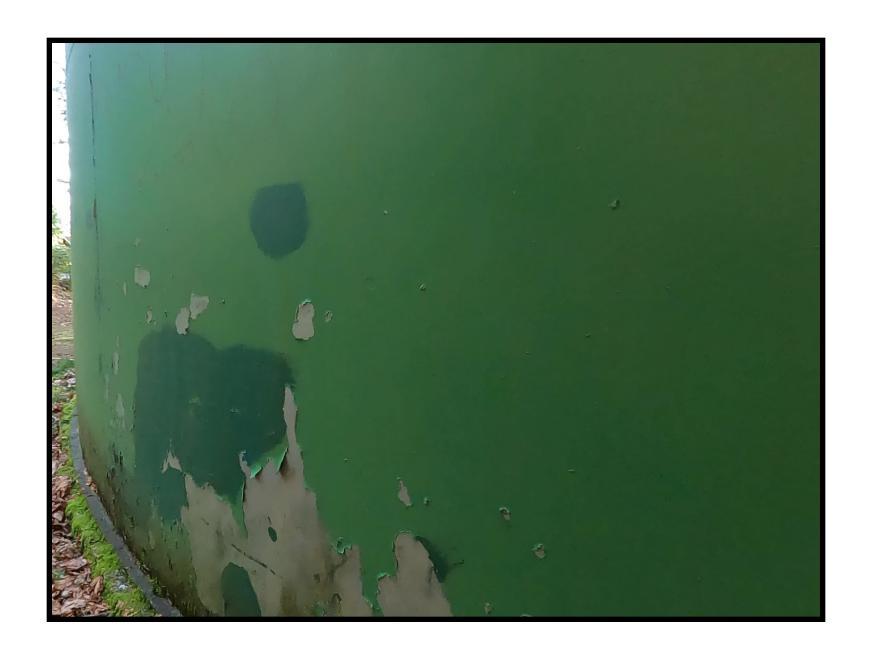
Exterior Wall

Appeared to be in good condition with no visible signs of corrosion.

Appeared to be in good condition with signs of staining, delamination and areas of mossy overgrowth.

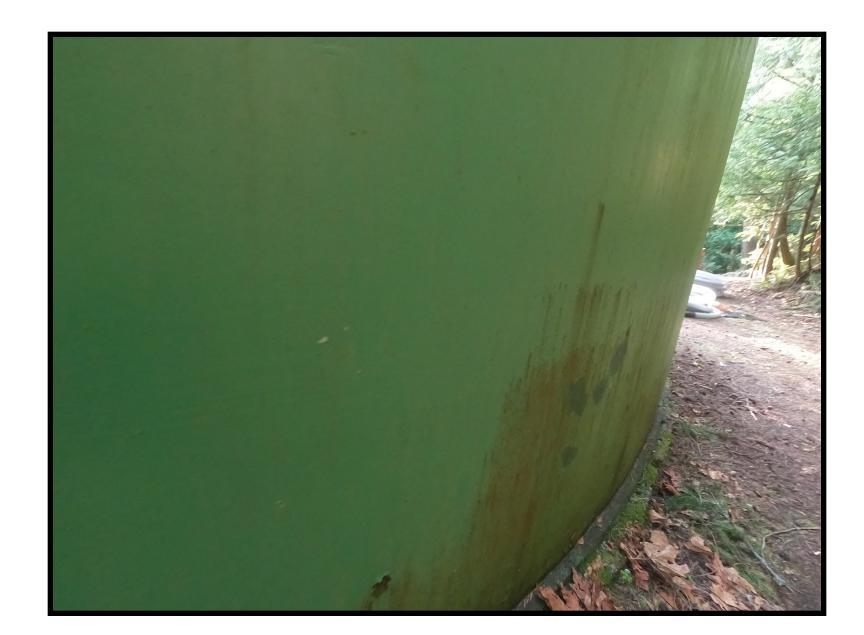
Exterior Wall

Appeared to be in good condition with no visible signs of corrosion.

Appeared to be in good condition with signs of staining, delamination and areas of mossy overgrowth.

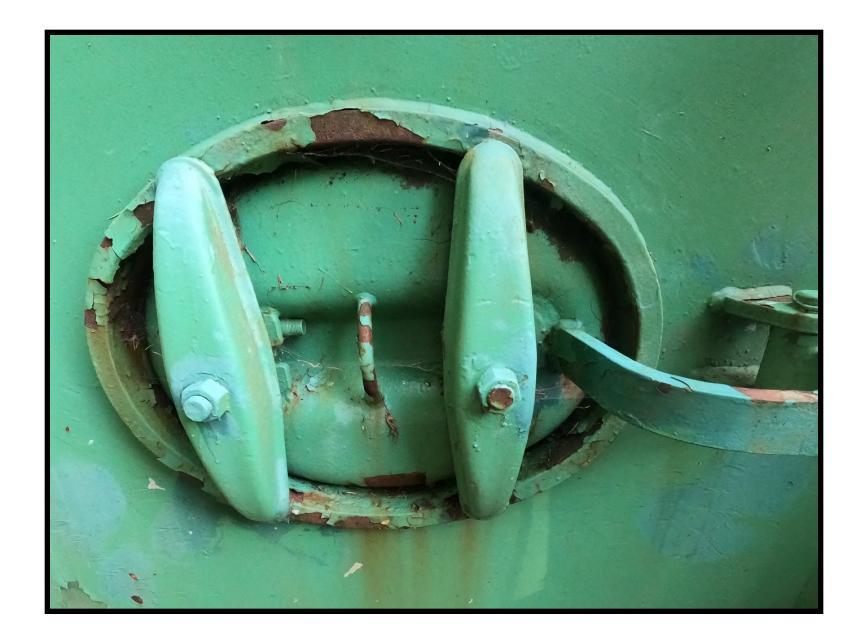
Exterior Manway

The gasket appeared to be fully intact and the hatch appeared to be in good working condition with corrosion present.

Appeared to be in fair condition with delamination present.

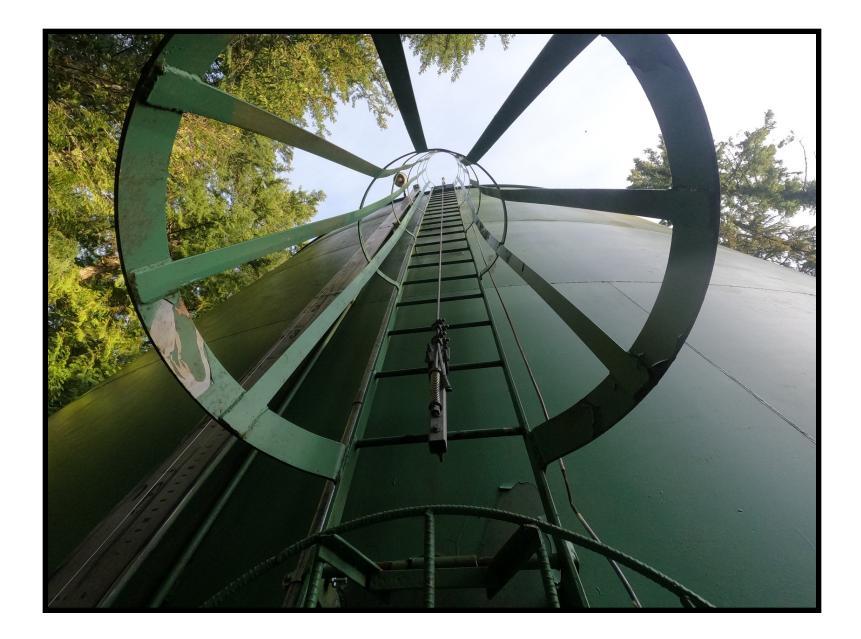
Exterior Ladder

Appeared to be structurally sound and in good condition with no visible signs of corrosion.

Appeared to be in good condition with signs of staining, delamination and areas of mossy overgrowth.

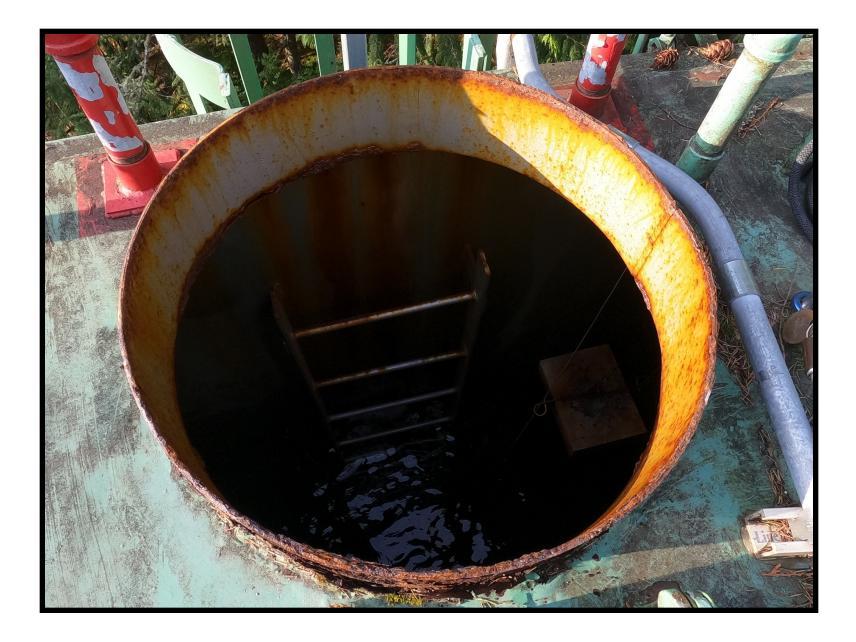
Exterior Hatch

Appeared to be in fair condition with corrosion present.

Appeared to be in fair condition with rust staining and delamination present.

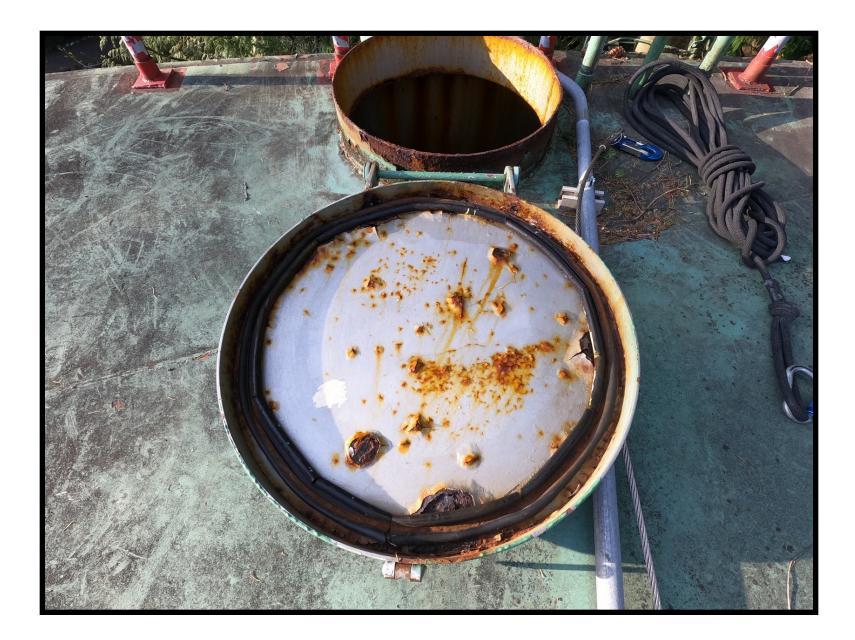
Exterior Hatch Lid

Appeared to be in fair working condition with corrosion present.

Appeared to be in fair condition with rust staining and delamination present.

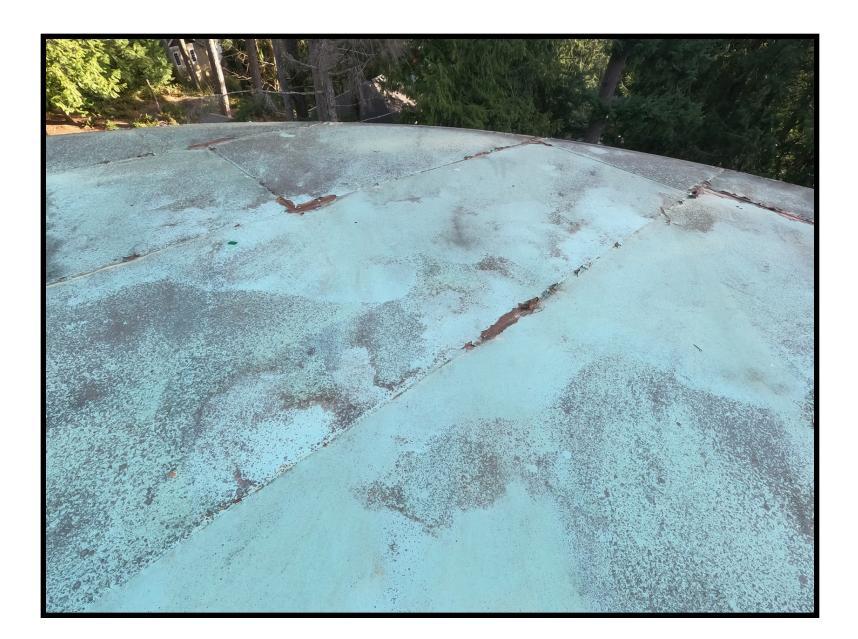
Exterior Roof

Appeared to be in good condition with no visible signs of corrosion.

Appeared to be in good condition with signs of staining and areas of mossy overgrowth.

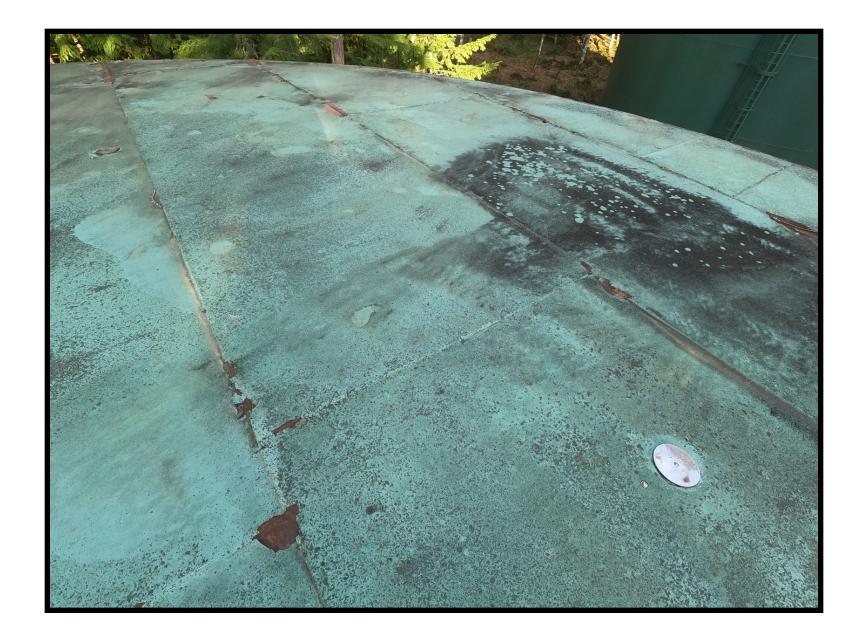
Exterior Roof

Appeared to be in good condition with no visible signs of corrosion.

Appeared to be in good condition with signs of staining and areas of mossy overgrowth.

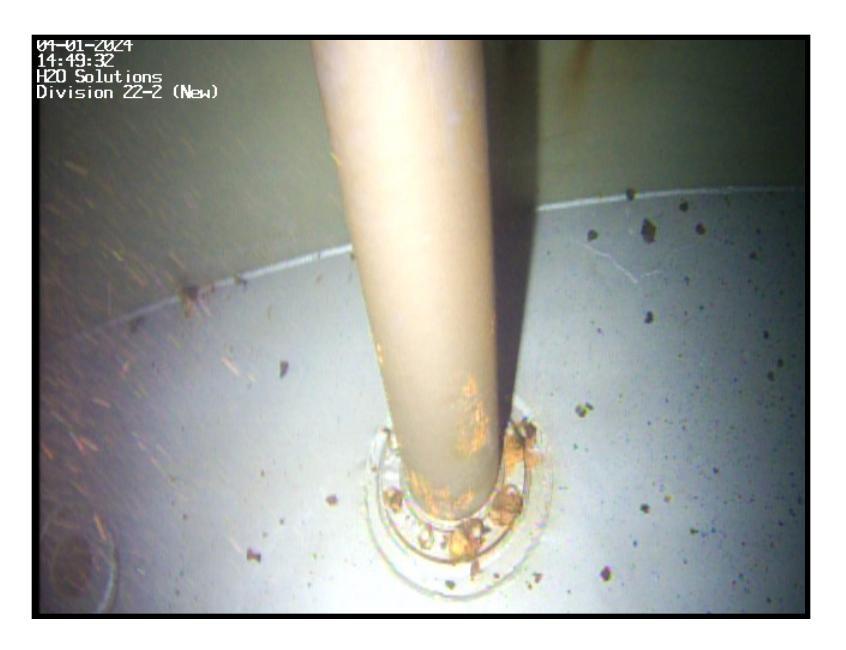
Interior High-Fill Inlet

Appeared to be in good working condition with corrosion present.

Appeared to be in good condition with rust staining and delamination present.

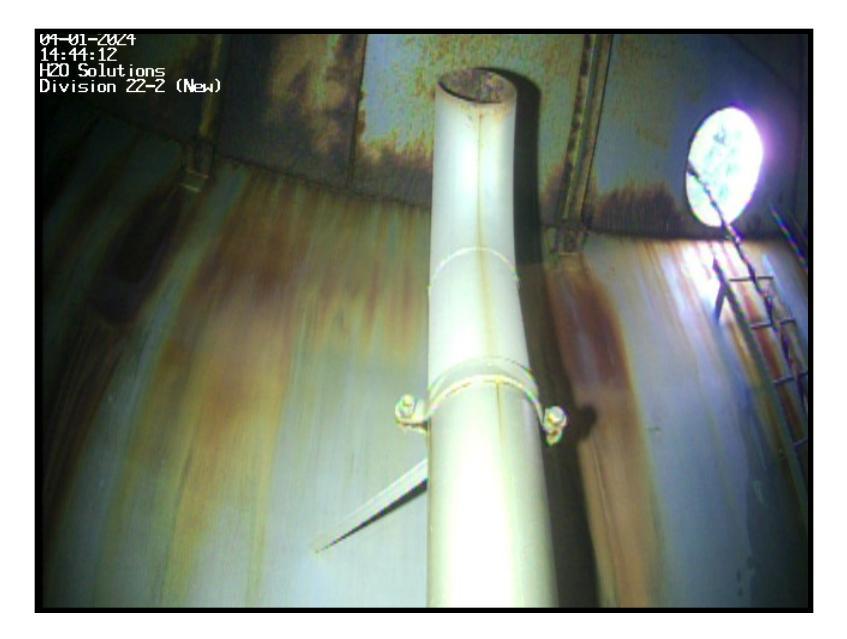
Interior High-Fill Inlet

Appeared to be in good working condition with corrosion present.

Appeared to be in good condition with rust staining and delamination present.

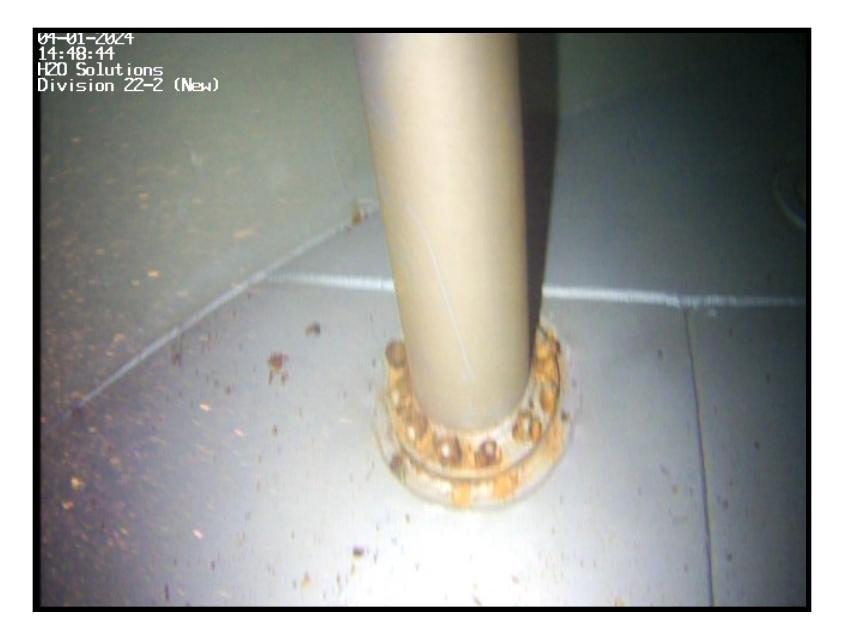
Interior Overflow

Appeared to be in good working condition with corrosion present.

Appeared to be in good condition with rust staining and delamination present.

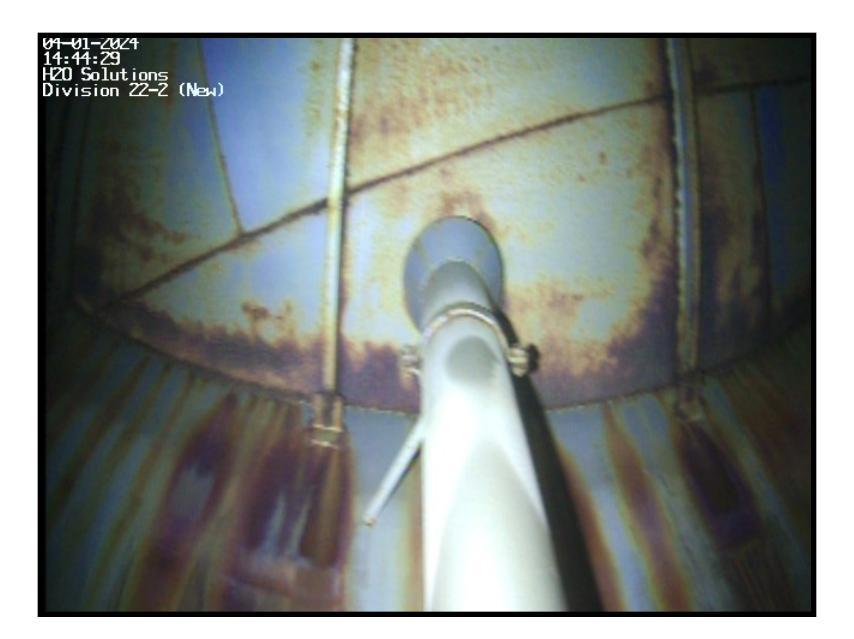
Interior Overflow

Appeared to be in good working condition with corrosion present.

Appeared to be in good condition with rust staining and delamination present.

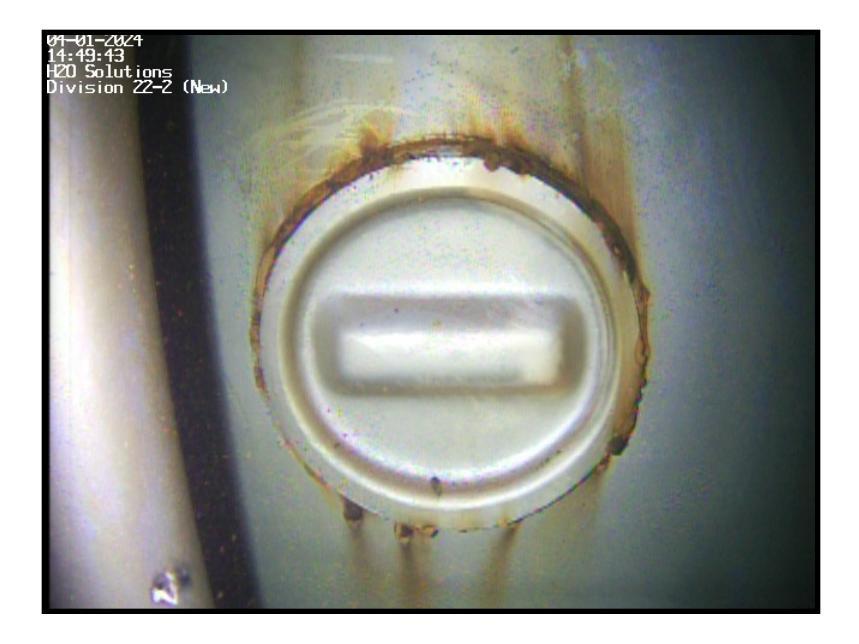
Interior Manway

The gasket appeared to be fully intact and the hatch appeared to be in good working condition with corrosion present.

Appeared to be in good condition with rust staining present.

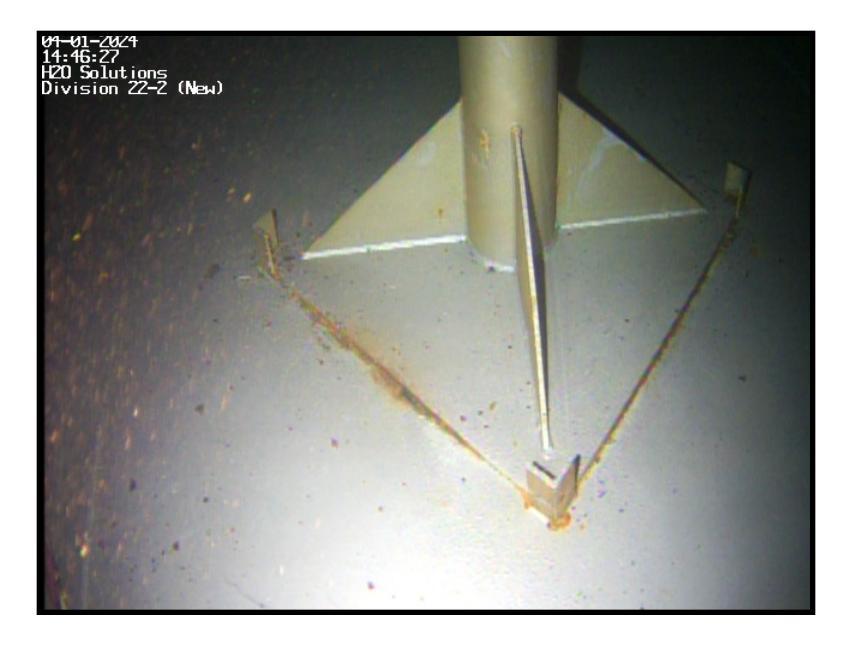
Interior Column Base

Appeared to be structurally sound and in good condition with corrosion present.

Appeared to be in good condition with rust staining present.

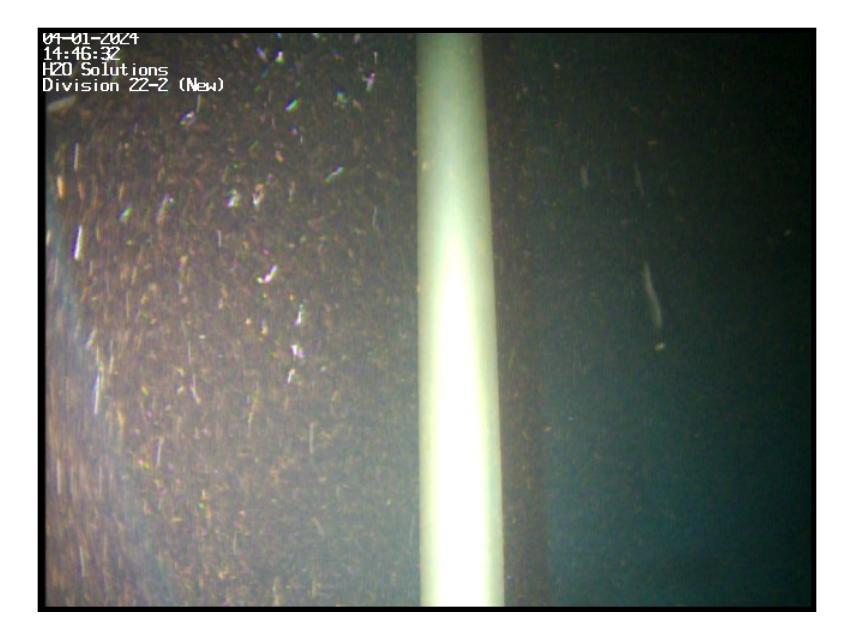
Interior Ceiling

Appeared to be in poor condition with heavy corrosion present.

Appeared to be in poor condition with heavy rust staining and delamination present.

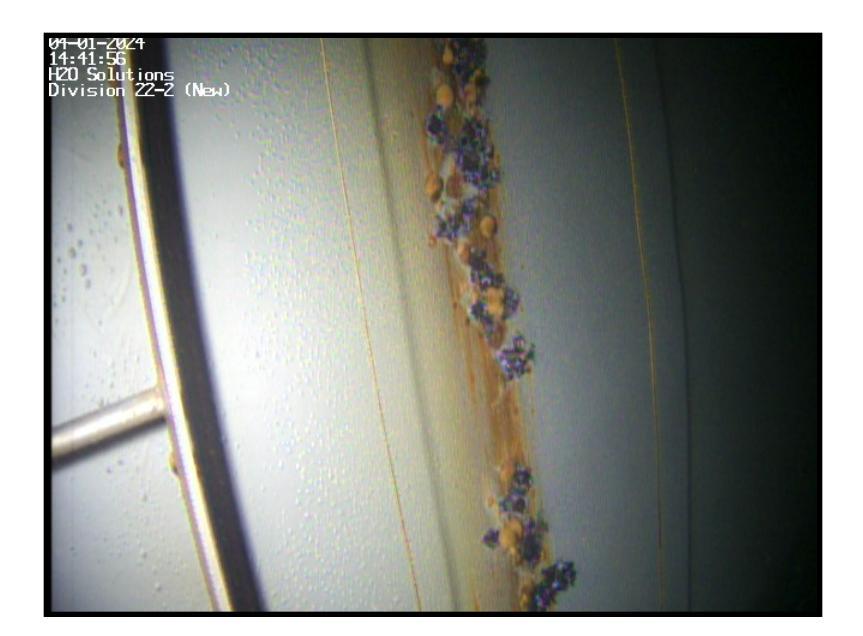
Appeared to be in good condition with areas of corrosion present.

Appeared to be in good condition with areas of rust staining and delamination present.

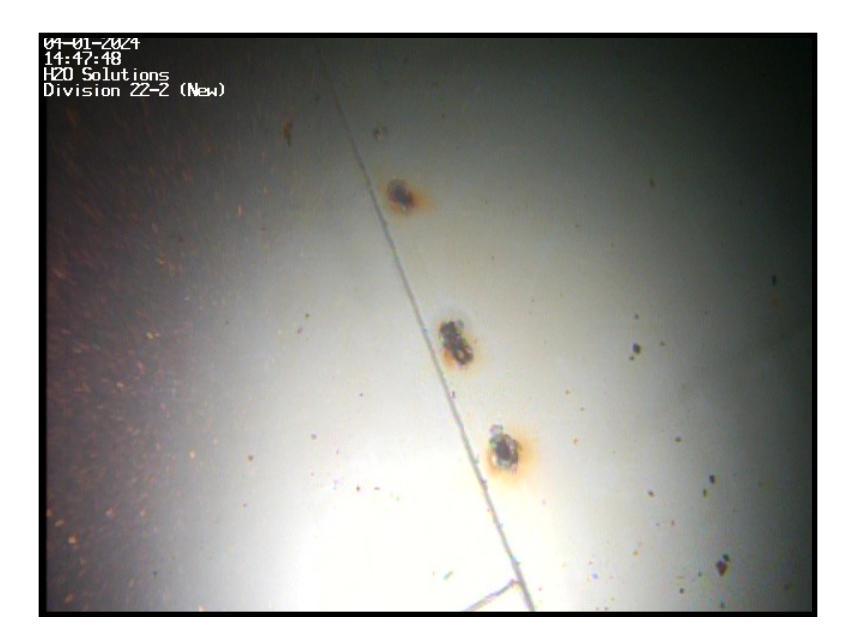
Interior Floor

Appeared to be in good condition with areas of corrosion present.

Appeared to be in good condition with areas of rust staining and delamination present.

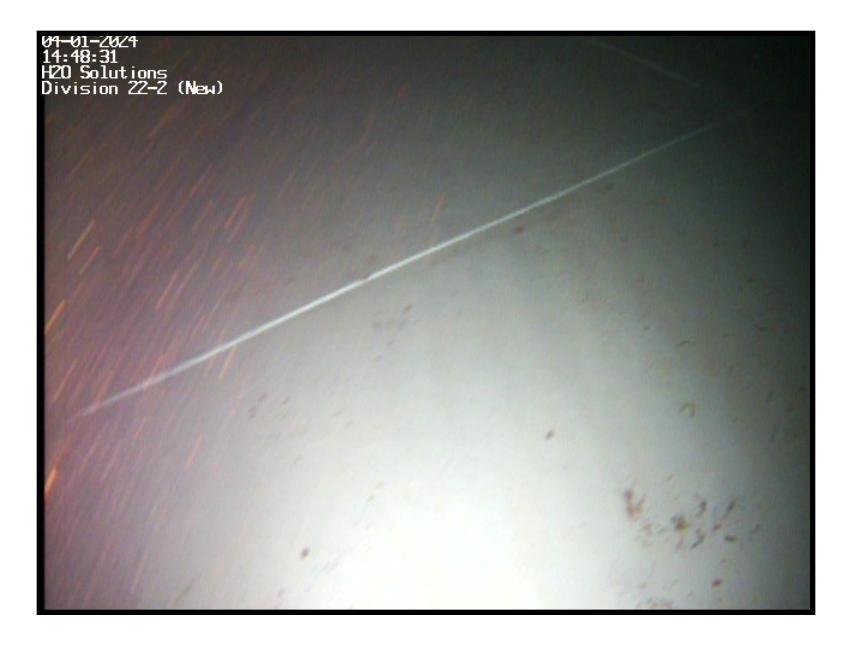
Interior Floor

Appeared to be in good condition with areas of corrosion present.

Appeared to be in good condition with areas of rust staining and delamination present.

None at this time.

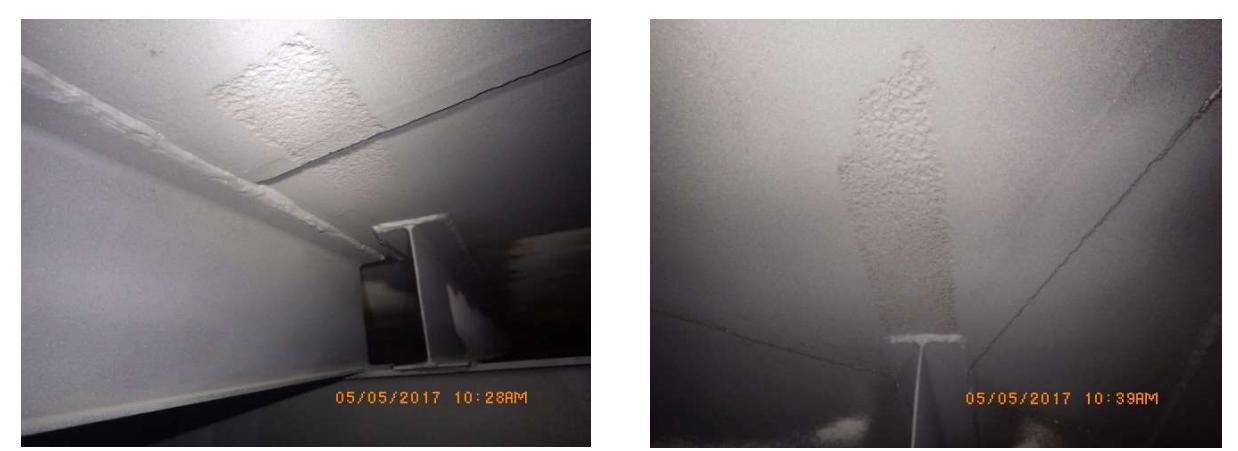
Seal welding is discussed relative to each reservoir and is highly recommended. Seal welding results in a tighter interior reservoir roof and eliminates locations that cannot be blast cleaned and coated. These areas include underneath the roof lap joints and between the rafters and roof plates. The coating system on a seal welded roof will last longer than one on a non-seal welded roof given an equally applied coating system. Examples of the damage to the roof plates from the inaccessible area between rafter and roof plate are included below where excess portions of the rafters were removed during the seal welding process. The steel loss in the deeper pits is more than half of the plate thickness of 1/4-inch. Additionally, there was steel loss on the rafter flange.

Two examples of the corrosion damage to the roof plates above the rafters of a 38-year-old reservoir.

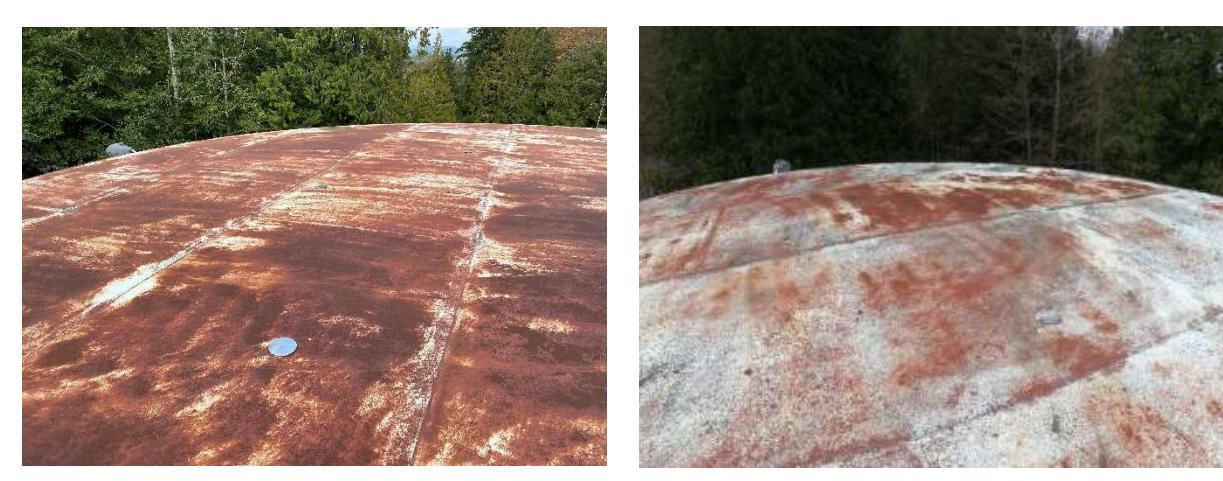
The exterior coating system is in poor condition at this time. The coatings on the roof are largely gone and no longer protecting the steel substrate. The coatings on the shell wall are still intact and protecting the substrate. The openness of the site is helping to keep the reservoir in better condition but corrosion on the roof will continue unabated during the rainy months. Comparison to the H2O Solutions report show that corrosion on the roof has progressed significantly since 2018 with the area actively rusting increasing perhaps 300- to 400-percent.

Roof condition in 2022.

Roof condition in 2018.

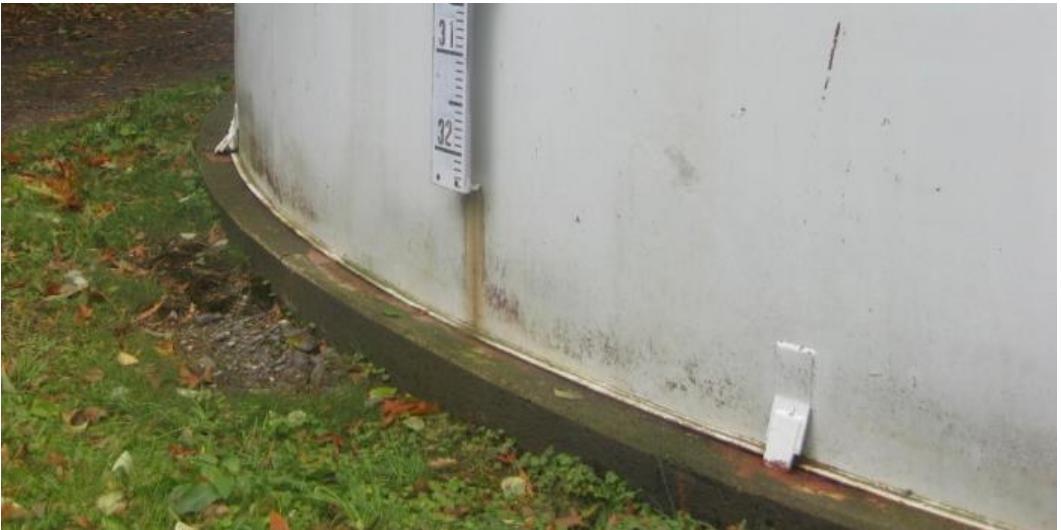
Anchored tanks are required by AWWA D100 to have a grout layer between the floor plate and the ringwall at the shell; however, no grout was observed.

Figure 5 Geneva Reservoir at Shell to Foundation Interface

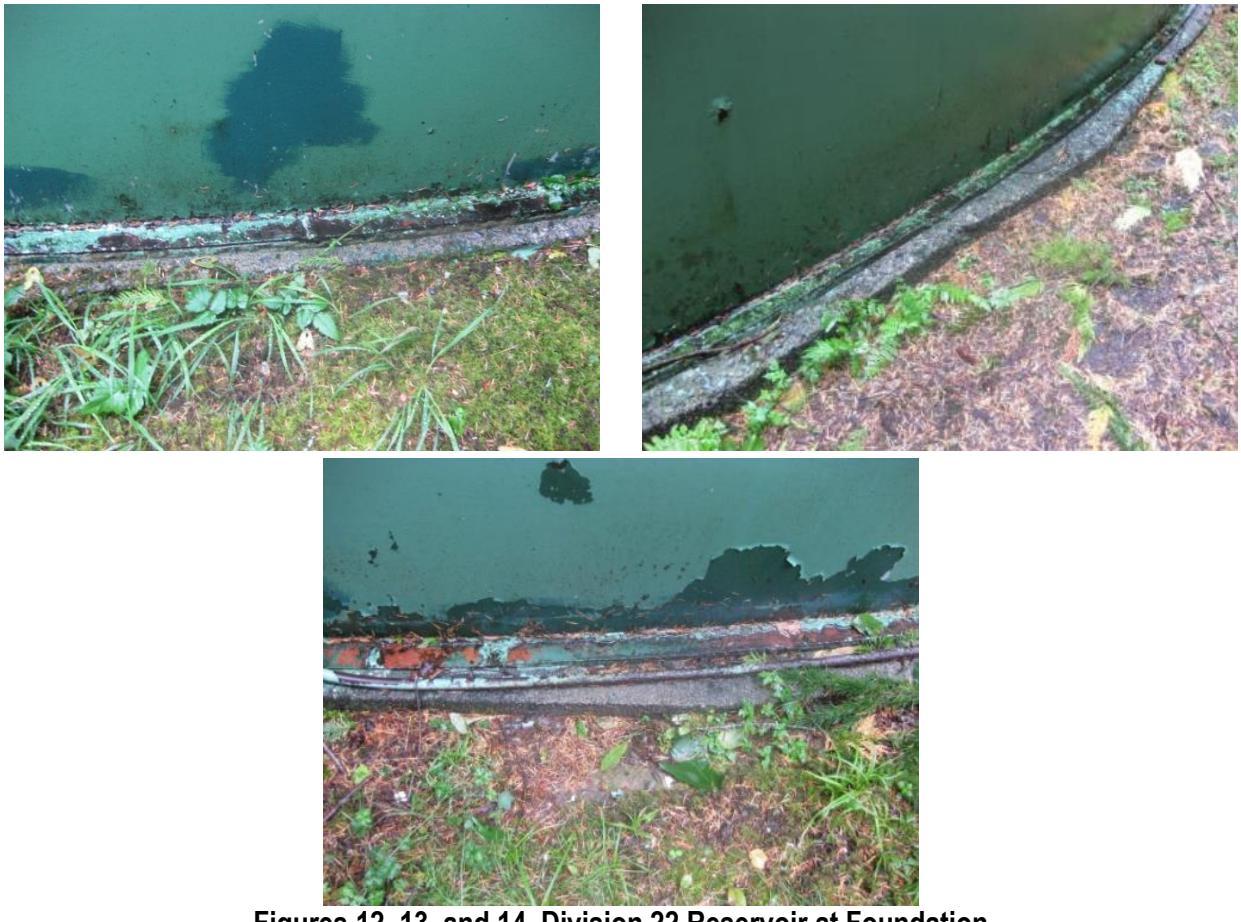
The tank has a grout layer between the floor plate and the ringwall at the shell. The grout layer is in poor condition, with gaps several feet long where the grout has fallen out. The thickness of the grout layer varies from about 1 inch to virtually nothing. The ringwall circumference is irregular and the tank floor plate barely sits on the ringwall in some locations. Photos from the site visit are shown in Figures 12 through 15.

Figures 12, 13, and 14 Division 22 Reservoir at Foundation Note minimal or missing grout and irregular ringwall.

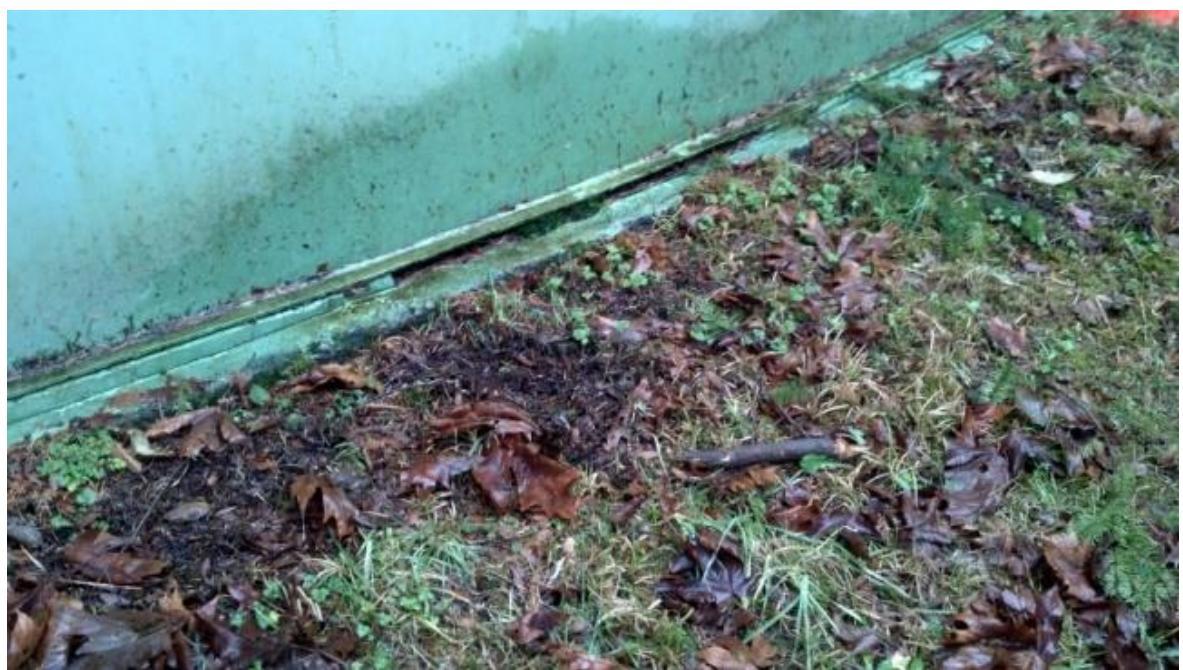
The tank has a grout layer between the floor plate and the ringwall at the shell which is in very poor condition, with gaps several feet long where the grout has fallen out. The thickness of the grout layer varies from about 2 inches to virtually nothing. Photos from the site visit are shown in Figures 19 through 21.

Figure 19 Division 7 Reservoir at Foundation Note missing grout.

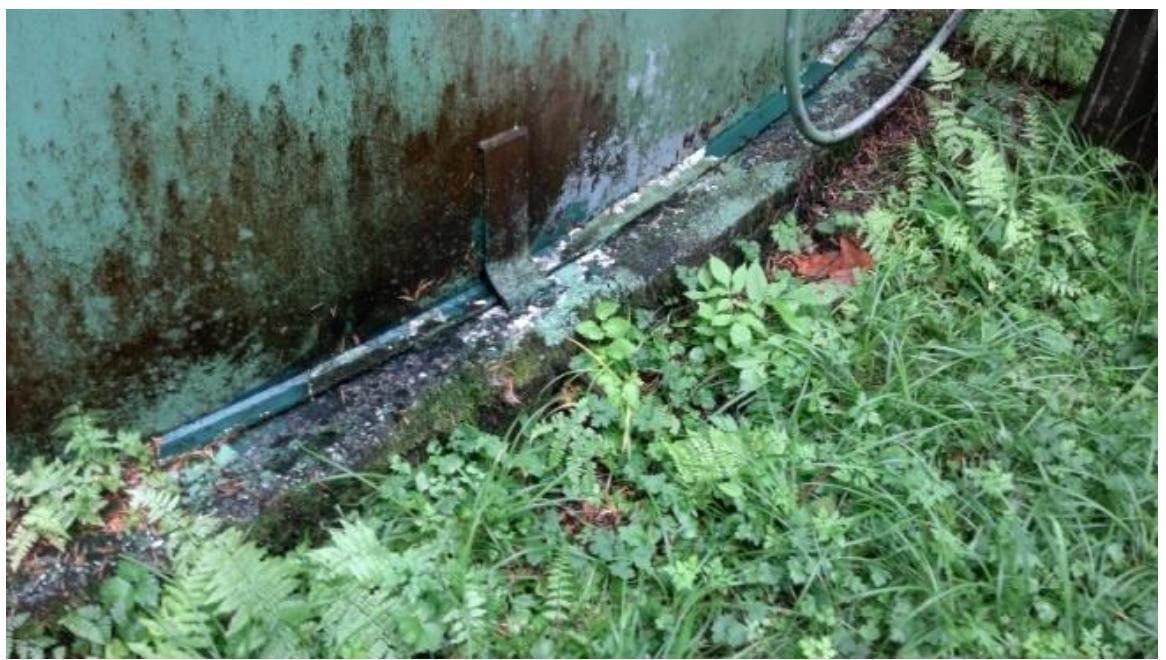
The tank has no grout layer between the floor plate and the ringwall at the shell. The current AWWA D100 standard requires that all anchored tanks be grouted at the base of the shell. Photos from the site visit are shown in Figures 25 through 28.

Figure 25 Division 30 Reservoir at Foundation Note typical strap anchor and no grout under the shell.
