# Lake Whatcom Water and Sewer District

Sudden Valley WTP Assessment Project

June 24, 2020

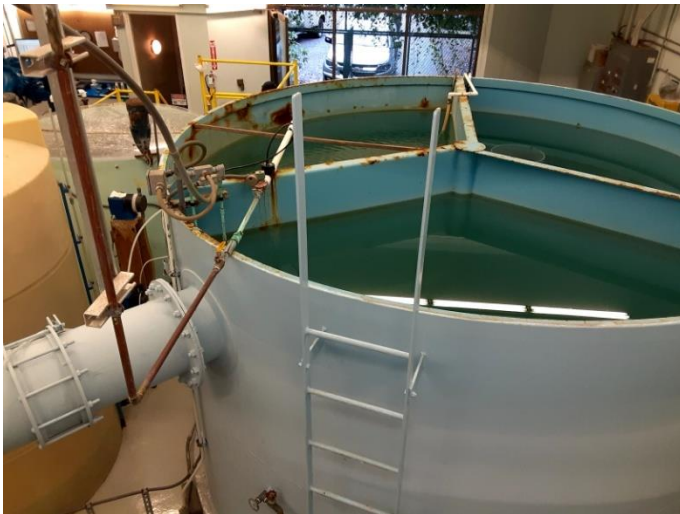
**Tight Space**– Large tanks restricts use and/or potential reorganization of equipment. No space for new or larger equipment. Area includes low-hanging pipes and multiple floor obstructions.

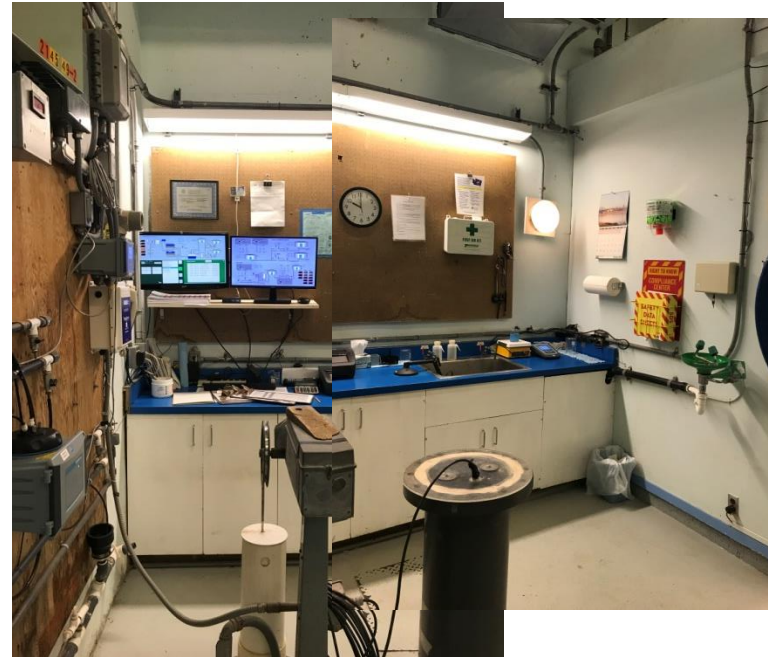
**Tight Work Station** – Space is limited and lab counter is directly above computer equipment. Floor obstructions are nearby.

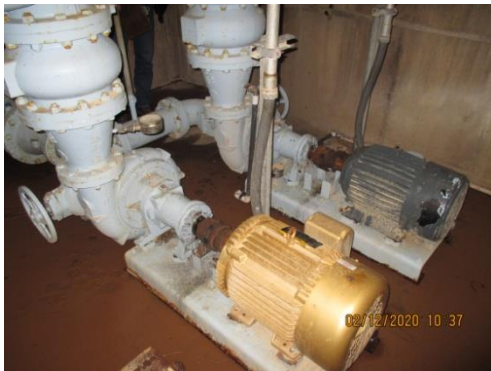
**Raw Water Pumps** – Raw Water Pump 2 is original (1970) and near the end of its recommended useful life.

- Process / Operational
  - Alternatives Analysis
    - Disinfection System
    - CT System / Projected Demands
    - Backwash system
  - Pump performance testing
    - Prepare / budget for pump replacement
  - Chemical dosing system modifications

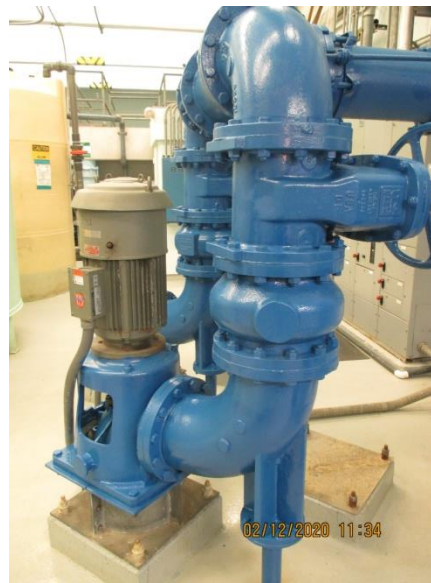
**Transfer Pumps** – Pumps are original (1990) and near the end of their recommended useful life.

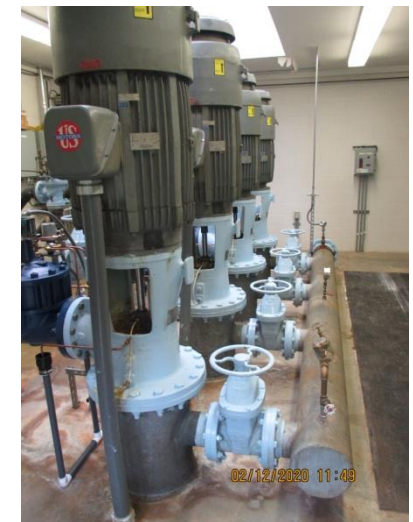
**Distribution Pumps** – Pumps are original (1990) and near the end of their recommended useful life.

**\*\* Testing** – Pumps have not been recently performance tested. Some spare motors are available at WTP.

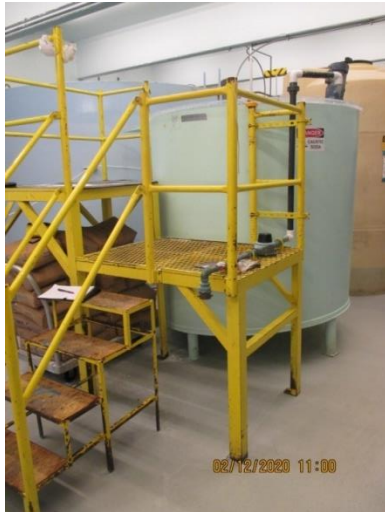
**Tank Access** – Staff must climb platform with heavy chemicals and add manually. Large platform restricts space.

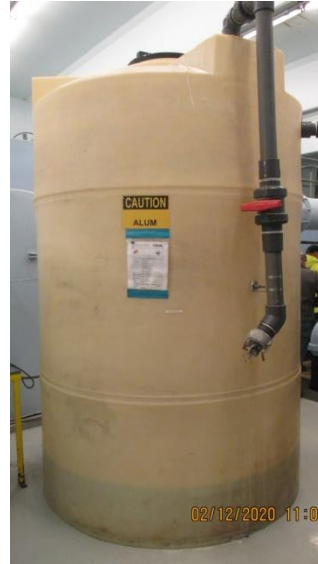
**Old Equipment** – Existing alum tank is at end of useful life and should be replaced.

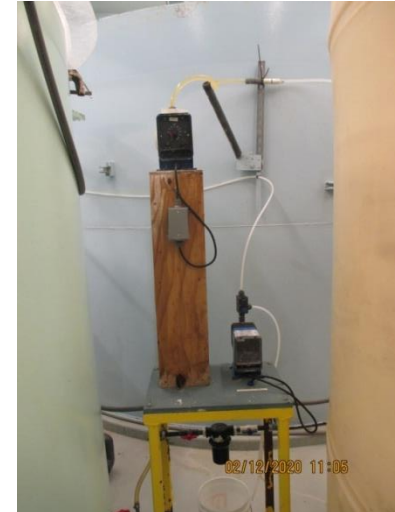
**Chemical Metering** – Dosing is tested manually on a daily basis by removing injection fittings. Common skid is desired.

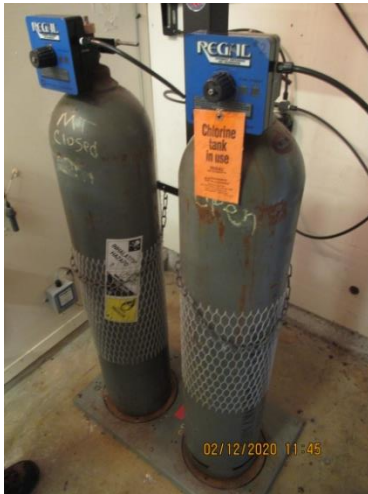
**Disinfection** – WTP utilizes gas chlorine, which works, but has inherent safety risks. ANY modifications to this system would require bringing system into compliance with **current** codes and regulations.
