Lake Whatcom Water and Sewer District

Sudden Valley WTP Assessment Project

August 11, 2021

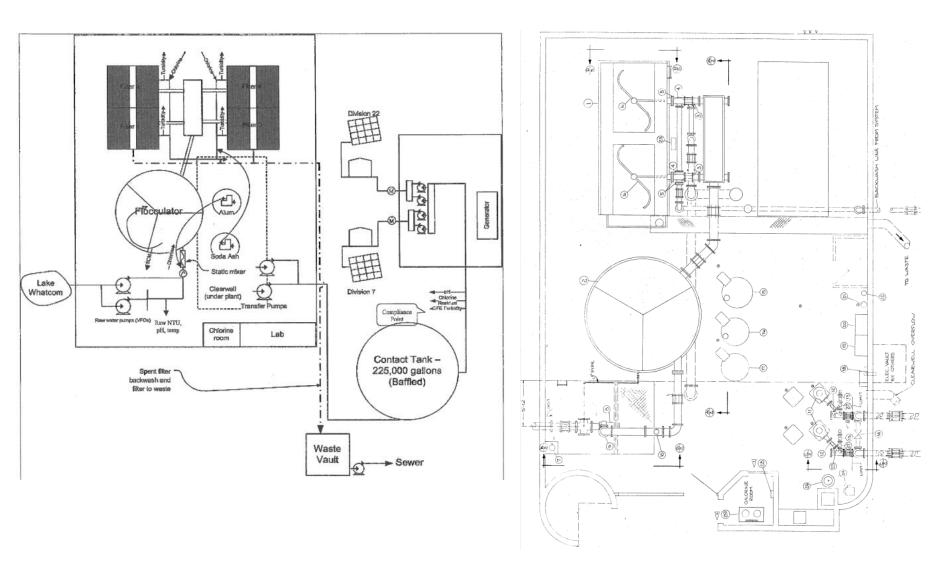
$Schematic\ view\ of\ SV\ WTP\ Main\ Building.$

Mechanical plan of SV WTP Main Building.

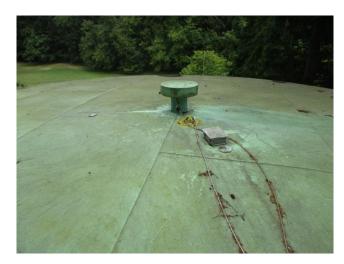
Corrosion – Tank has several corrosion spots, some of which have been repaired.

Algae – Roof exhibits lichen and algae growth, both of which may have damaged the coatings.

- Chlorine Contact Basin Coatings TM2
 - Interior and Exterior Coating Assessment
 - Exterior sidewall coating in fair condition
 - Recommend replacement within 5-10 years
 - Exterior roof coating in moderate/poor condition
 - Recommend replacement within 5 years
 - Interior coating in fair condition
 - Recommend replacement within 5-10 years
 - Recommendations
 - Seal welding, additional roof hatch, exterior ladder security, additional access security measures
 - New exterior and interior coating systems (<7 years)

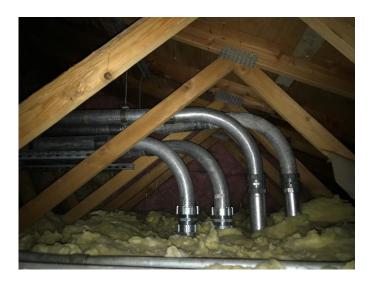
Seismic Support – Conduit within the FWP Building with insufficient seismic bracing.

- Seismic Analysis TM3
 - Complete Tier 2/Tier 3 Seismic analysis
 - Main Building
 - · No structural deficiencies identified
 - Non-structural deficiencies include additional bracing
 - Finished Water Pump Building
 - Shear wall and diaphragm shear structural deficiencies
 - Non-structural deficiencies include additional bracing and securing existing gas piping
 - Chlorine Contact Basin (CCB)
 - Foundation ring wall deficiencies identified (BHC, 2016)
 - Nonstructural deficiencies include flexible piping connections

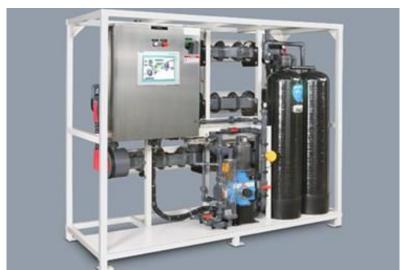
- Disinfection System TM6
 - Gas Chlorine injection and Chlorine Contact Time

- Filter Systems TM5
 - Media filter modifications
 - Recommendations: Continue use of rapid rate mixed media filtration, rehabilitate existing Filters 1/2.
- Disinfection TM6
 - Chlorine disinfection and chlorine contact time
 - Recommendations: Utilize gas chlorine or OSHG in new building, construct replacement CCB and rehabilitate existing CCB.

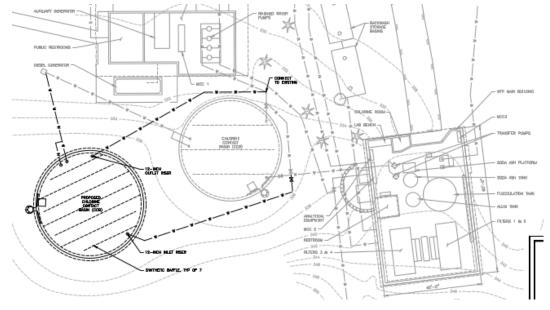
* Proposed CCB modifications.

- Disinfection System TM6
 - Gas Chlorine injection and Chlorine Contact Time
 - Disinfection
 - Gas chlorine, bulk hypochlorite, and onsite hypochlorite generation alternatives
 - Most alternatives require new building
 - Chlorine Contact
 - CCB size and BE limit flow through the WTP
 - Alternatives include reuse of existing, new larger replacement CCB, and new supplemental CCB
 - High priority item and construction sequencing must be considered to ensure distribution system supply

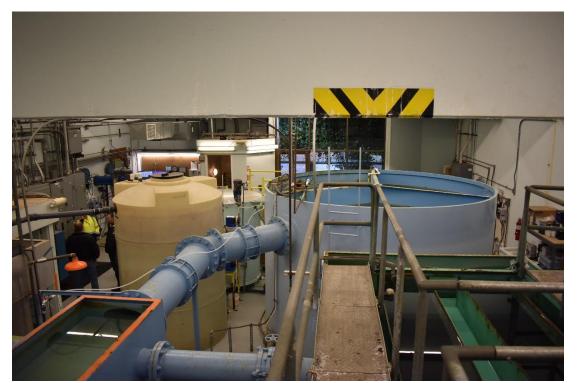
- Structural & Architectural Components TM8
 - WTP Main Building and FWP Building
