## TECHNICAL MEMORANDUM 20434-1

SUBJECT: SUDDEN VALLEY WTP PUMP  
PERFORMANCE TESTING  
LAKE WHATCOM WATER & SEWER  
DISTRICT, WHATCOM COUNTY,  
WASHINGTON  
G&O #20434.00

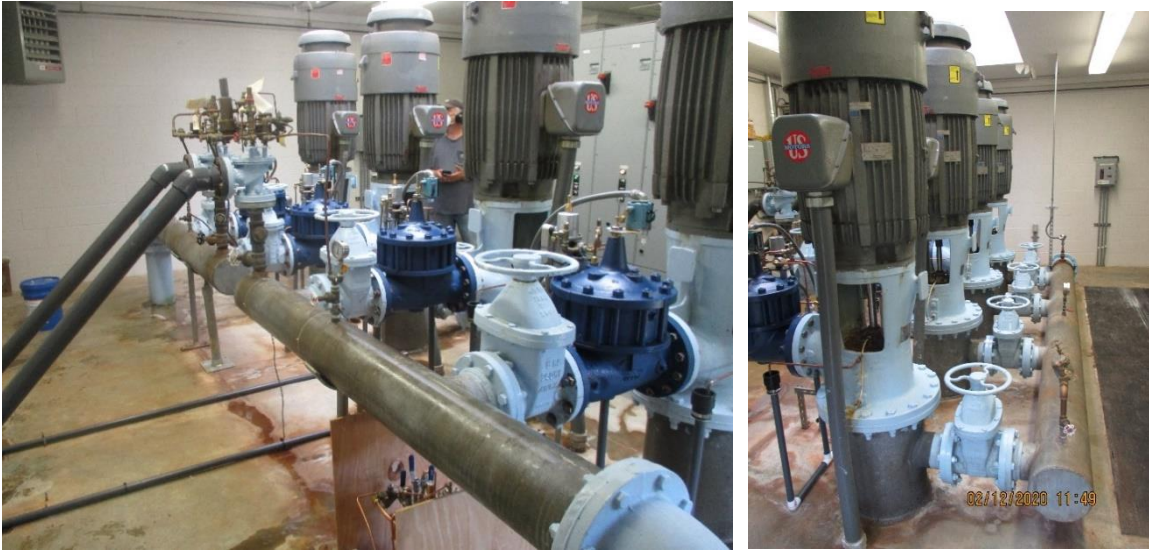
**FIGURE A-1**

The Assessment Report noted that all four pumps were originally installed in 1992, but are in good condition. The Assessment Report also noted that all of these pumps may be nearing the end of their reliable useful life and recommended that the District conduct a performance test for these pumps, and depending on the results of that testing, repair, rehabilitate, or replace the finished water pumps. The Assessment Report also noted that MCC1 was in good condition, but given its age is no longer supported by the equipment manufacturer. As such, acquiring spare parts has become increasingly difficult and expensive. The Assessment Report recommended that the District replace MCC1 as part of any modifications to the finished water pumps and that they consider the location of other electrical equipment before selecting a final installation location for these components. Lastly, the District has expressed interest in controlling these pumps using VFD motor starters, which will provide additional operational flexibility for the treatment process, equipment, and staff.

The finished water pumps and MCC1 are shown as Figures A-1, A-2, and A-3 (Exhibit A). Each pump is equipped with manual isolation valves, hydraulic control valves, and inlet/discharge pressure gauges. The discharge piping from each pump connects to a common header, which exits the building below grade. Isolation valves are 6-inch butterfly valves and typically operate in the fully open position. Control valves for all four pumps are 6-inch Cla-Val Model 60-11BY. Pressure gauges are standard glycerin-filled units suitable for potable water service. The existing pressure gauges are at least 8 years old and have not recently been calibrated. Flow for Division 22 pumps is measured by an 8-inch Endress & Hauser magnetic flow meter located in a buried vault on the north side of the Finished Water Pump Building. This meter was installed in 2019 and the flow value for this meter is displayed on a remote display located on the east wall within the Finished Water Pump Building. Flow for Division 7 pumps is measured by an 8-inch Badger magnetic flow meter located in a buried vault southeast of the chlorine contact basin. This meter was installed in 2006 and the flow value for this meter is displayed on a remote display located on the east wall within the Finished Water Pump Building. Amperage across the motor was measured by an ammeter placed around the load wire within the motor control center cabinet as shown on Figure A-2.

**Existing Finished Water Pumps  
(Division 22 Pumps Are in the Foreground While Division 7 Pumps Are in the  
Background)**

Even though pump testing described herein suggests that the finished water pumps are performing very near their original design conditions, we recommend that the District replace the pumps, motors, and motor starters. The MCCs should be replaced and sized to accommodate the desired VFD motor starters and the pumping equipment, including the motor, should be replaced so that it is compatible with the desired VFD controllers. The location of the proposed MCCs should be coordinated with any other modifications to the WTP with regard to exposure to chemicals, water, or other planned improvements. We also recommend that the District replace the discharge pressure gauge assemblies for each pump and procure one spare pressure gauge for each type so that failures can be addressed quickly.

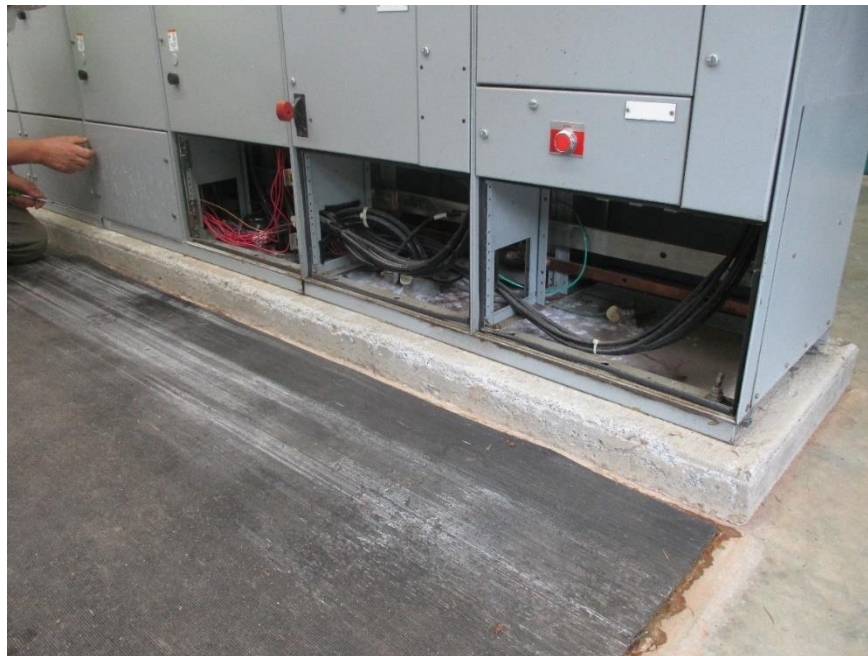
**FIGURE A-2**

**Location Where Motor Amperage Was Measured  
(An Ammeter Was Placed Around the Motor Load Conductor and the Value Was  
Read from the Digital Display)**

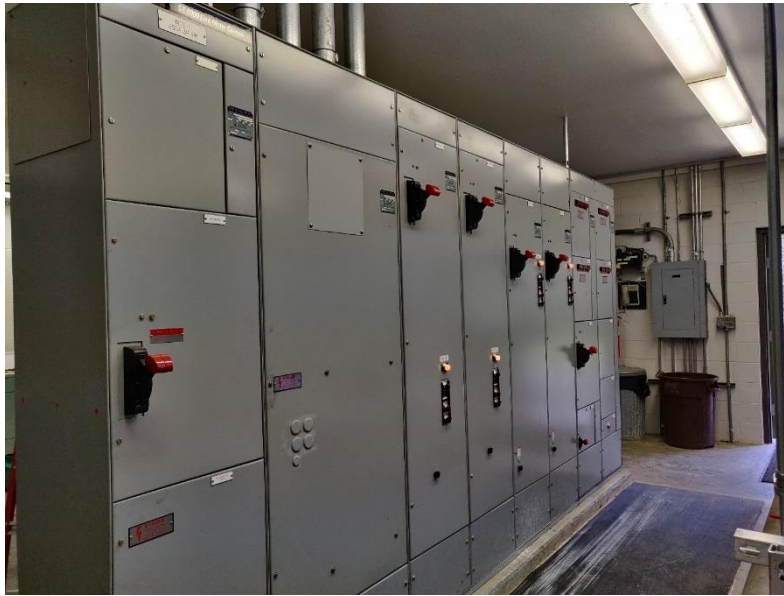
**FIGURE A-3**

**MCC1**

**(Shown Is Old and No Longer Supported by the Manufacturer)**

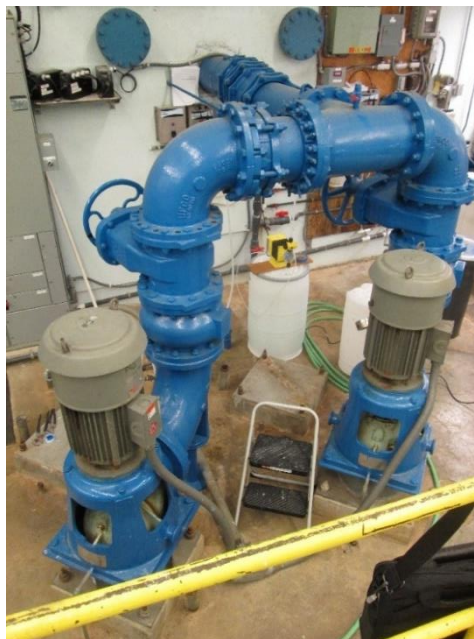
**FIGURE A-4**

The clearwell transfer pumps and MCC2 are shown as Figures A-4 and A-5 (Exhibit A). Each pump is equipped with a check valve, isolation valve, and pressure gauge assembly. The discharge from each pump connects to a common header, which then proceeds to the chlorine contact basin. Prior to the pipe exiting the building, various filtered water samples are extracted through small fitting connections. Check valves, isolation valves, and piping within the WTP Main Building are 10-inch diameter ductile iron materials. There is no flow meter on the transfer pump discharge line.

Secondly, the pressure gauge assemblies on the discharge elbow for each pump were not operational. The isolation valves for these valve assemblies were closed and could not be opened without potentially damaging the threaded fittings. We did investigate other installation locations for these pressure gauge assemblies, but all available locations were downstream of the isolation valve and would not provide useful data.

**Clearwell Transfer Pumps**

**(The Pumps Move Water from the Below-Grade Clearwell to the Chlorine Contact Basin)**

Due to these issues, the transfer pumps were not tested as part of this analysis. We recommend that the District replace the existing pressure gauge assemblies with new equipment so that performance testing could be attempted in the future. Additional recommendations are discussed in subsequent sections of this memorandum.

Even though the clearwell transfer pumps appear to be performing adequately, we recommend that the District replace the pumps, motors, and motor starters. The MCCs should be replaced and sized to accommodate the desired VFD motor starters and the pumping equipment, including the motor, should be replaced so that it is compatible with the desired VFD controllers. The location of the proposed MCCs should be coordinated with any other modifications to the WTP with regard to exposure to chemicals, water, or other planned improvements. We also recommend that the District replace the discharge

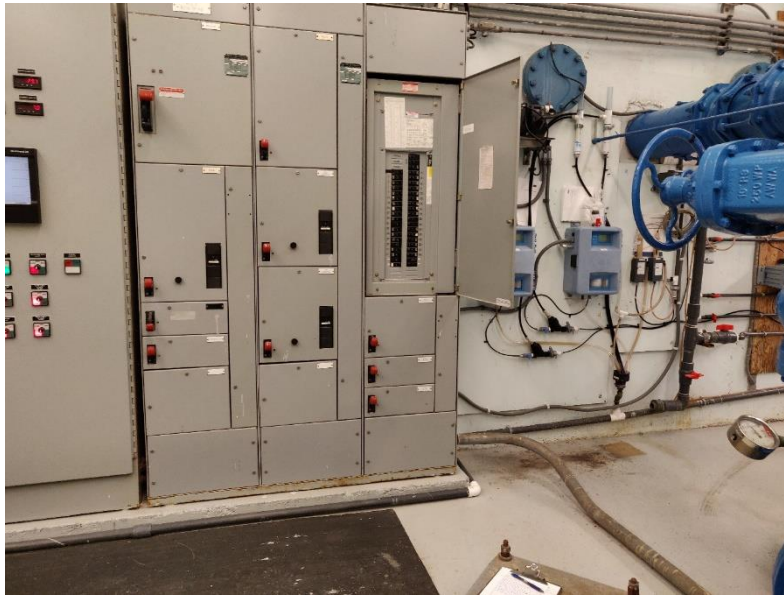
**FIGURE A-5**

condition, but because of its age is no longer supported by the equipment manufacturer. As such, acquiring spare parts has become increasingly difficult and expensive. MCC2 exhibits a moderate level of corrosion and the Assessment Report recommended that the District replace MCC2 as part of any modifications to the clearwell transfer pumps and that they consider chemical storage and exposure to moisture before selecting a final installation location for these components. Lastly, the District has expressed interest in controlling these pumps using VFD motor starters, which will provide additional operational flexibility for the treatment process, equipment, and staff.

**MCC2**

**(Shows Slight Signs of Corrosion from Exposure to Chemicals and Moisture, Is Old, and Is No Longer Supported by the Manufacturer)**

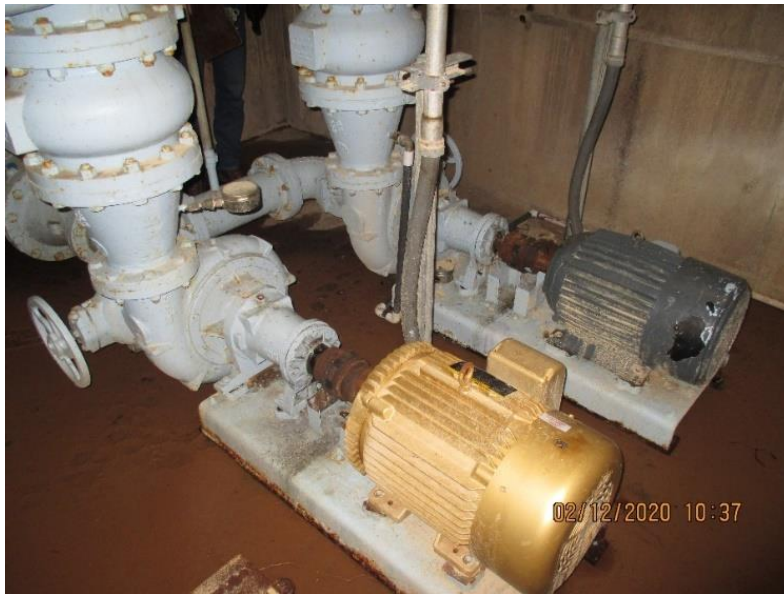
**FIGURE A-6**

The raw water pumps and MCC3 are shown as Figures A-6 and A-7 (Exhibit A). Each pump is equipped with a 4 x 10 reducer, 10-inch check valve, and 10-inch isolation valve. Ductile iron discharge piping from each pump connects to a common header and this header proceeds above grade and to the flocculation basin.

Similar to the transfer pumps, the existing pressure gauge assemblies were locked in the closed position. Even if these gauges were available for use, the equipment was installed in 1992 and is likely no longer accurate. Spare gauges could not be found and as such, the raw water pumps were not tested as part of this analysis. The discharge piping for the raw water pumps does contain a flow meter, so pump performance testing could be completed when new gauge assemblies are installed.

**Raw Water Pumps**

**(The Pumps Move Water from the Lake Whatcom Source to the Flocculation Basin and Are Located Below Grade in the Raw Water Pump Pit)**

Given the age of the pumps, if the District continues to utilize these pumps, we recommend that the District complete pump performance testing every 2 to 4 years to ensure functionality of the equipment and to proactively identify potential points of failure. We also recommend that the District replace the existing pressure gauge assemblies with new calibrated pressure gauges to ensure accurate measurements. Additional recommendations are discussed in subsequent sections of this memorandum.

Even though the raw water pumps appear to be performing adequately, we recommend that the District replace the pumps, motors, and motor starters. The MCCs should be replaced and sized to accommodate the desired VFD motor starters and the pumping equipment, including the motor, should be replaced so that it is compatible with the desired VFD controllers. The location of the proposed MCCs should be coordinated with any other modifications to the WTP with regard to exposure to chemicals, water, or other planned improvements. We also recommend that the District replace the discharge pressure gauge assemblies for each pump and procure one spare pressure gauge for each type so that failures can be addressed quickly.

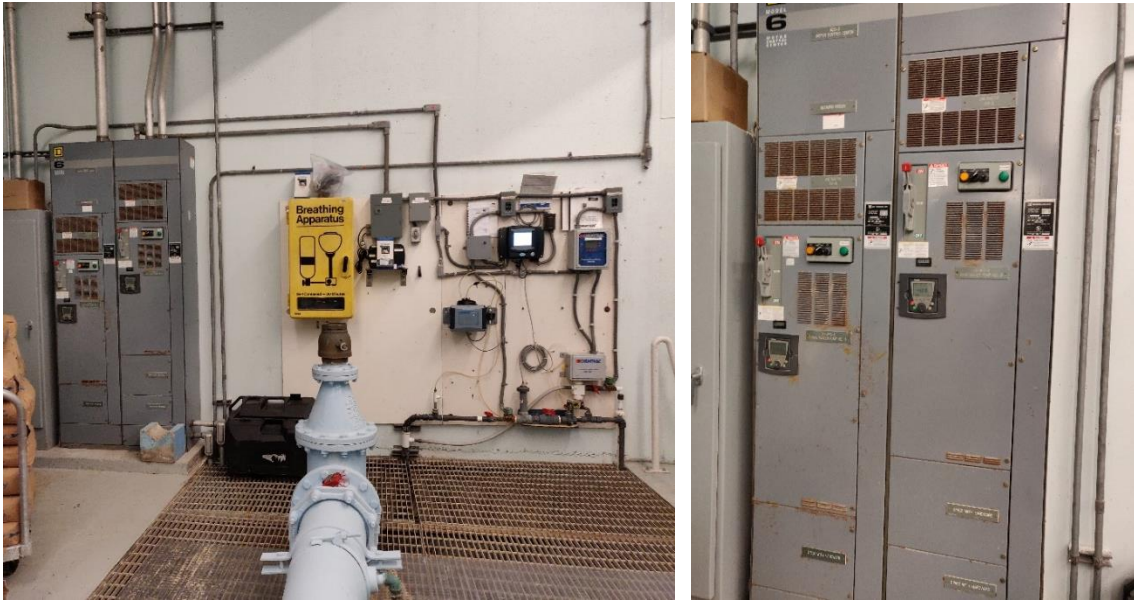
**FIGURE A-7**

**MCC3**

**(Shows Signs of Corrosion – Interior and Exterior – from Exposure to Chemicals and Moisture)**
