## TECHNICAL MEMORANDUM 20434-2

SUBJECT: SUDDEN VALLEY WTP CHLORINE  
CONTACT BASIN COATING ASSESSMENT  
LAKE WHATCOM WATER & SEWER  
DISTRICT, WHATCOM COUNTY,  
WASHINGTON  
G&O #20434.00

Technical Memorandum 20434-2 – Sudden Valley WTP  
Chlorine Contact Basin Coating Assessment  
September 10, 2021

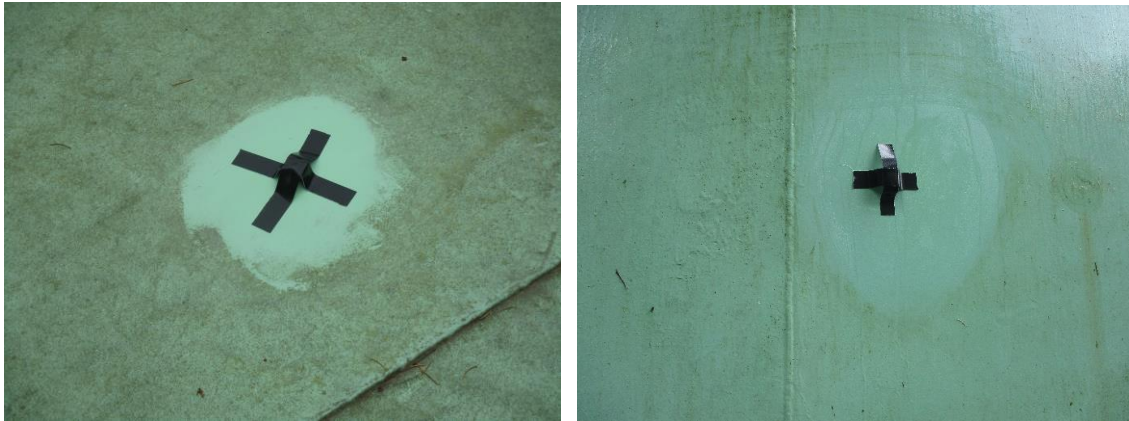
**FIGURE 3**

On August 18, representatives from Gray & Osborne traveled to the WTP and affixed six coating adhesion test dollies to the tank surface. Two dollies were placed on the roof of the tank, and four dollies were affixed to the sidewall. Figure 3 shows some of the testing dollies in place.

**Coating Adhesion Testing Dollies**

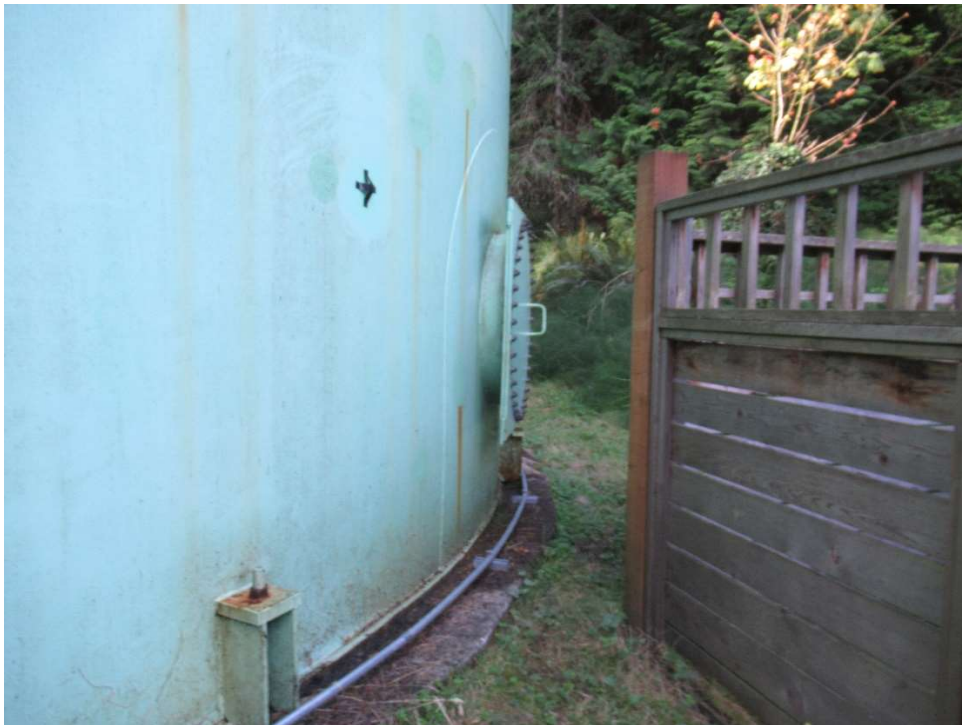
Photo 2: North side of tank with Dolly #4 in the photo.

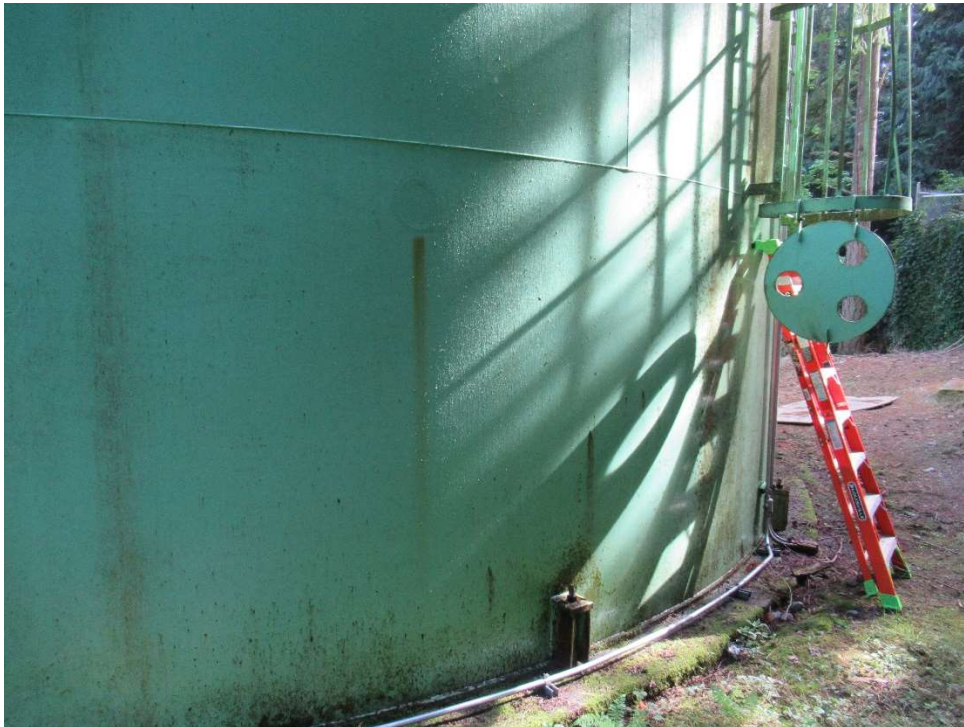
Photo 4: South side of tank with vertical swinging ladder guard.

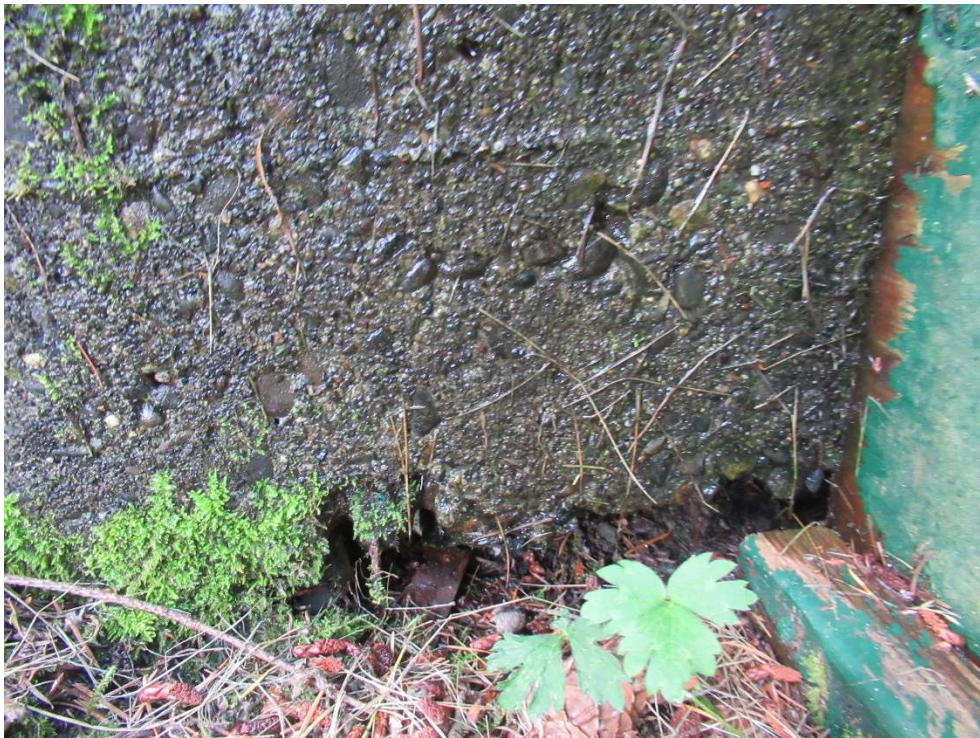
Photo 8: Exposed ring wall on east side by sample lines.

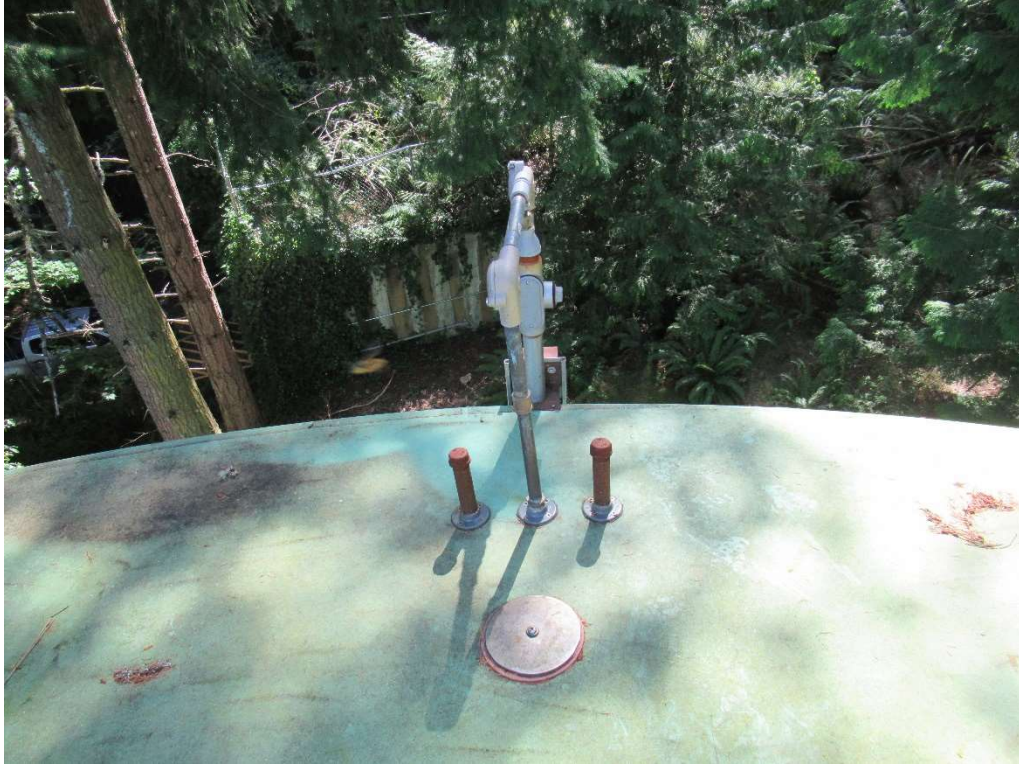
No evidence of vandalism or security issues were noted onsite. If security is a concern, the interior of this tank could be accessed very easily. Although the ladder is approximately eight feet off of the ground, the ladder guard would likely be ineffective in deterring an intruder. The outside of the cage could be ascended to the roof of the tank (Photo 7). Once on the rooftop, the camera is in an obvious and easily accessible area and could be bagged or dismantled (Photo 16), the padlock on the access hatch is easily accessible to be cut and removed (Photo 23), and the handhole covers could be removed to insert a contaminant into the tank (Photo 17).

Photo 17: Level gauge.

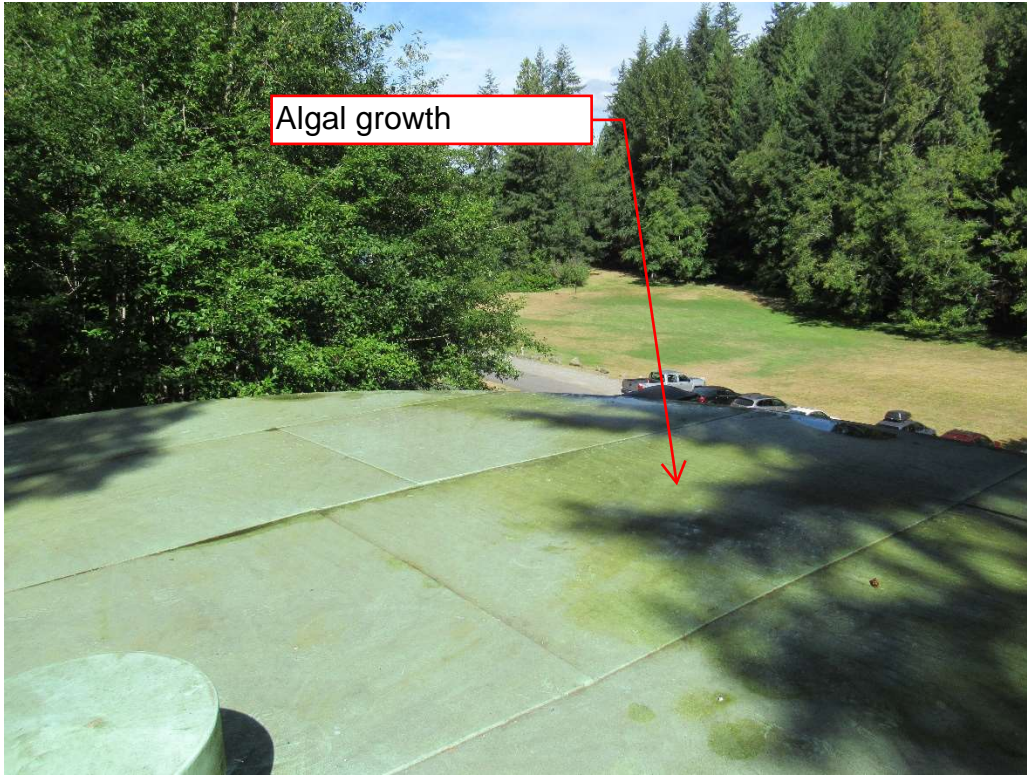
The coatings on the roof of the tank appear to be in moderate condition. The roof had a layer of algae on it which made it very slippery (Photos 21 and 25). While most of the coatings are intact, the top coat could be seen delaminating from the intermediate coat in some areas (Photos 27 and 28). The roof is also suffering from corrosion in areas around the roof hatch and vent. Overall, the roof area around the ladder appears to be an SSPC-VIS 2 Rust Grade 3-S while the rest of the roof is a 10-S.

Photo 21: Looking north. Note the algae in the right side of the photo.

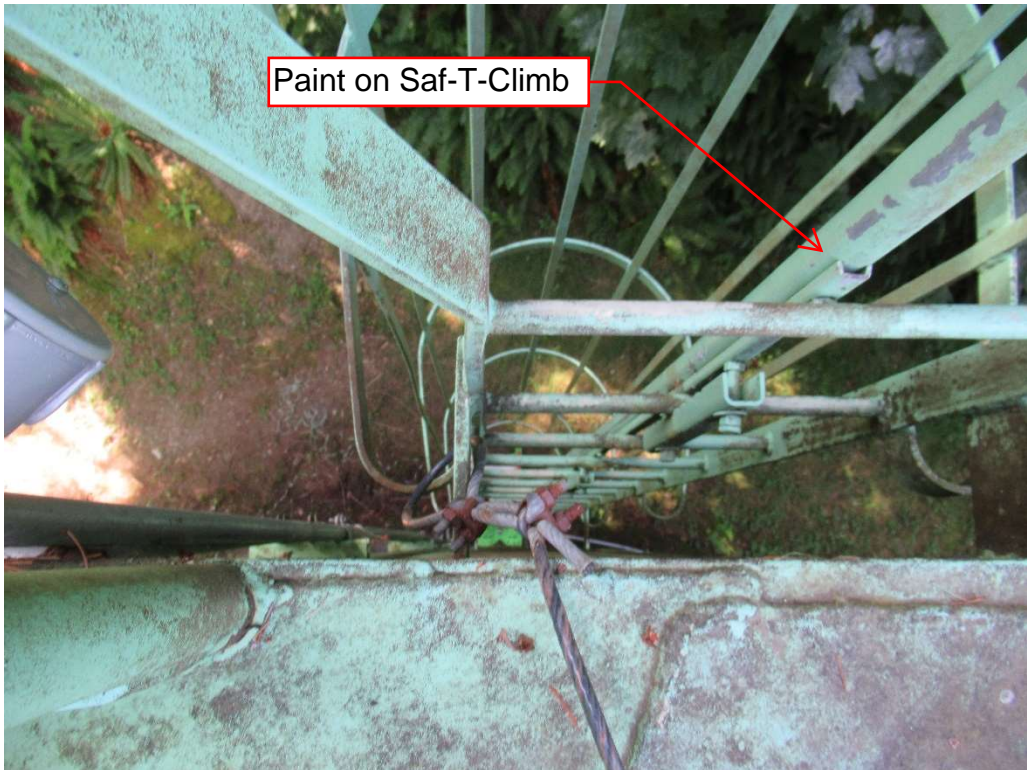
The roof of the tank is accessed via a ladder system that starts 8 feet from the ground and has a ladder cage and Saf-T-Climb for fall protection. The Saf-T-Climb rail has been painted which may interfere with operation of the device (Photo 22). The ladder cage has a cage guard that swings down vertically. These can be problematic as they can swing down quickly when a lock is removed and hit a worker utilizing a ladder to access the guard. These can be replaced with a horizontal swinging guard. A run of three 1-inch conduit run up the right side of the ladder cage.

Photo 22: Safety line tied to ladder standoff. Note the Saf-T-Climb is painted.

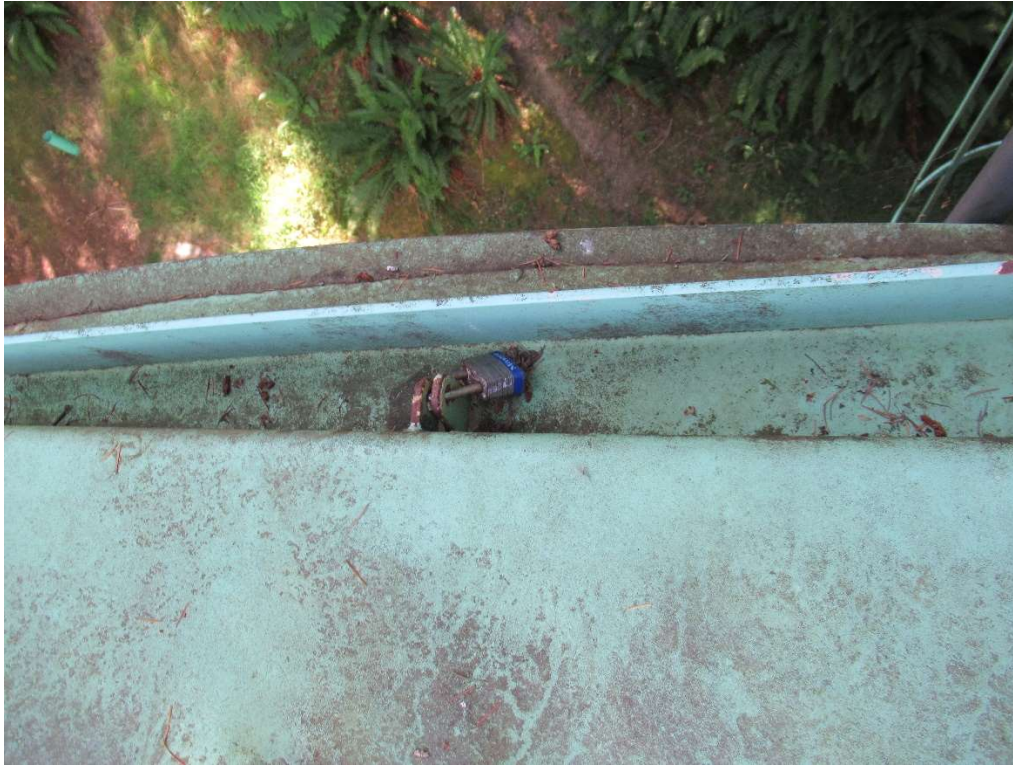
Photo 23: Access hatch lock.

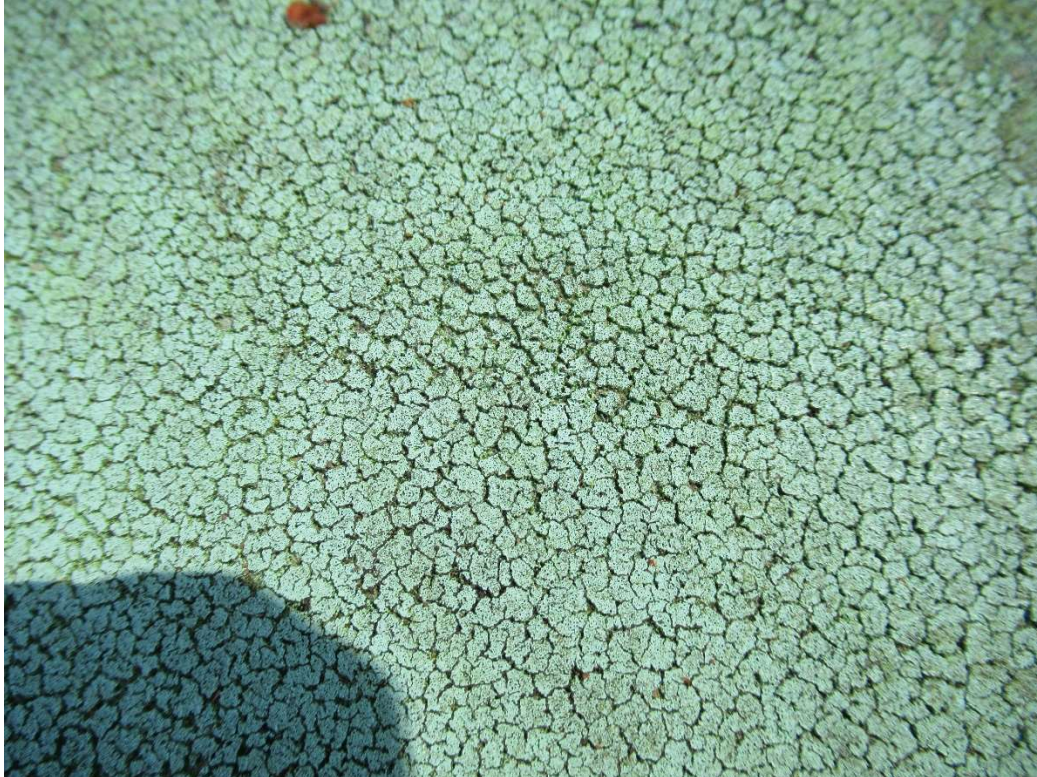
While the adhesion results are good, one concerning issue is the delamination of the top coat from the intermediate coat on the roof (Photos 27 and 28). From the dolly pull, it may be delaminating cohesively from within itself. It could also be due standing water or to biological attack from what appear to be lichens (Photo 26) that are growing on the roof. Mildew, lichens, and moss grow roots into the coatings which can physically break the coatings apart.

Photo 26: Most likely lichens growing on the roof.

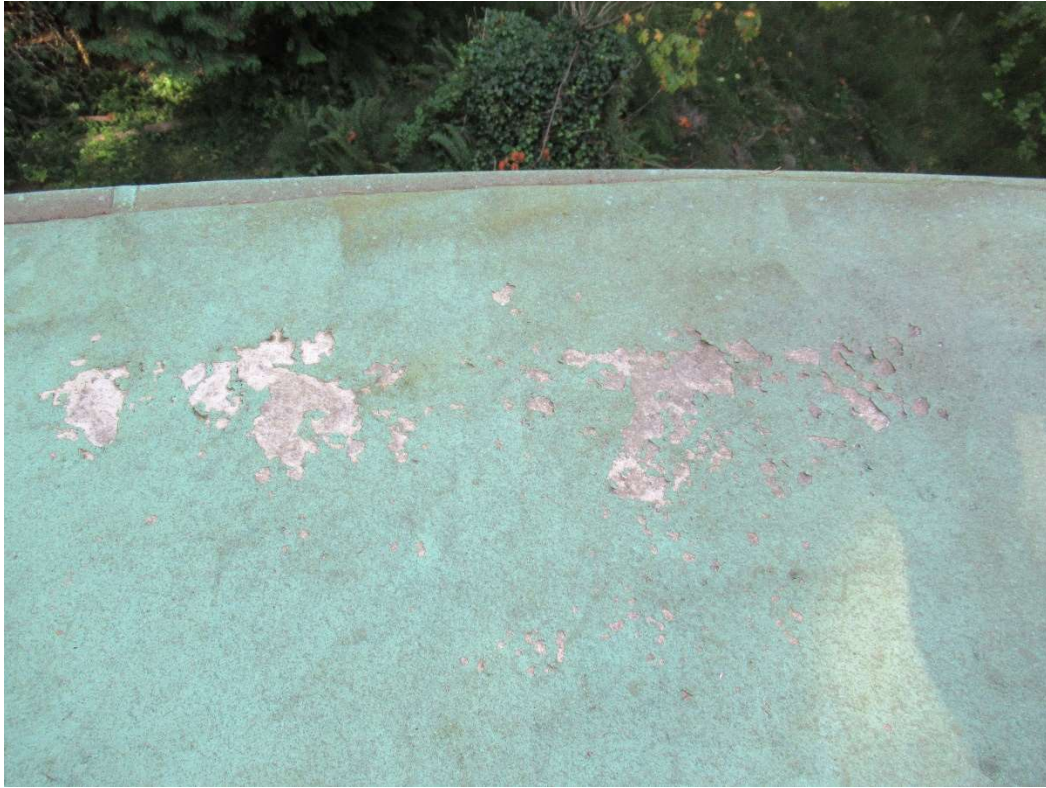
Photo 27: Coating delamination on the roof.

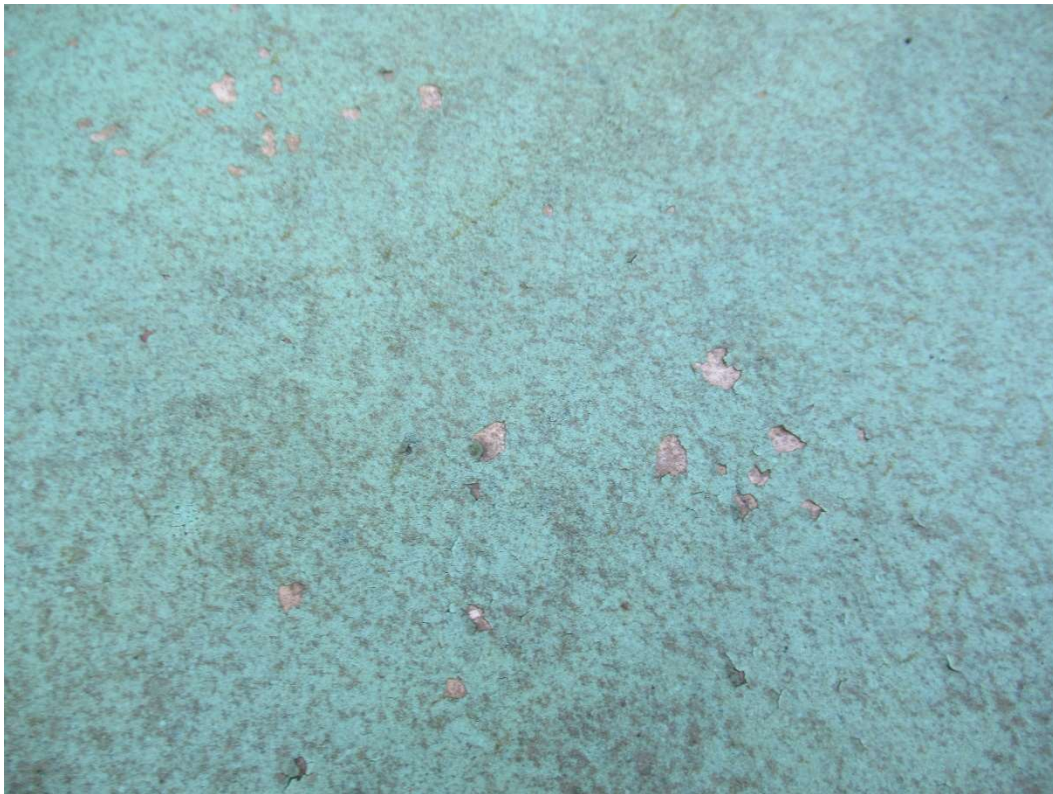
Photo 28: Coating delamination on the roof.

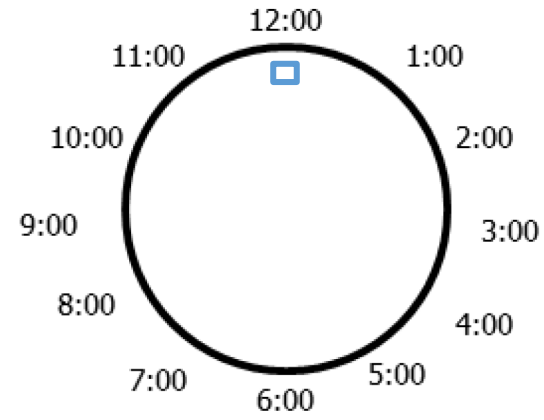
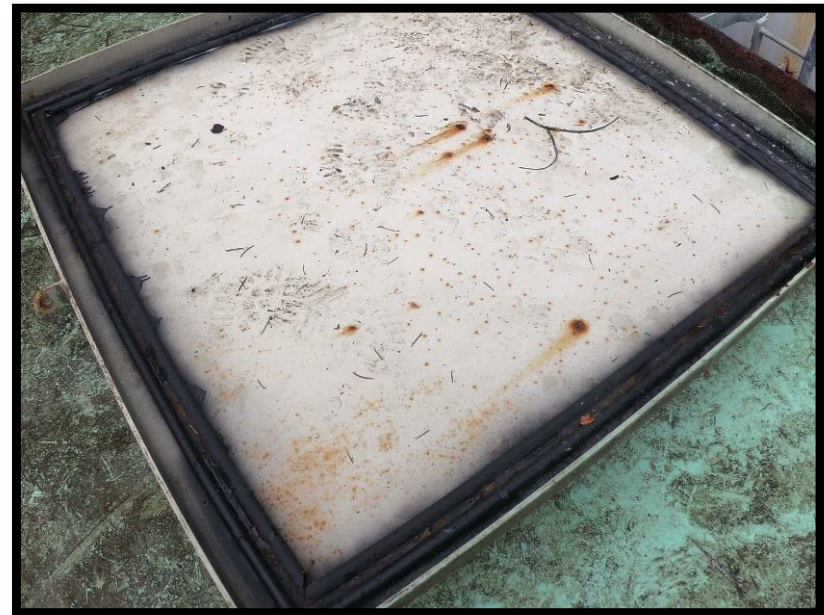
# Exterior Hatch

Appeared to be in good working condition with areas of surface corrosion. Overall 20% corrosion present.

Appeared to be in good condition with chalking, delamination and fading. Overall 25% coating failure.

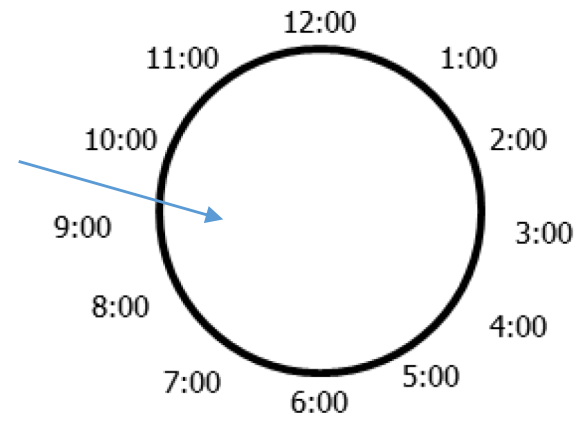
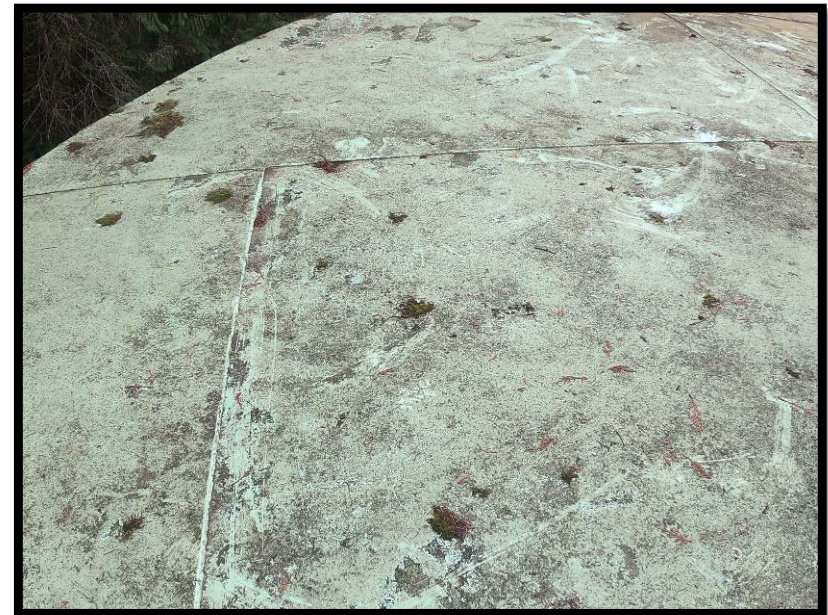
# Exterior Roof

Appeared to be in good condition with a few isolated spots of minor surface corrosion. Overall 5% corrosion present.

Appeared to be in good condition with minor chalking and organic growth build up. Overall 5% coating failure.

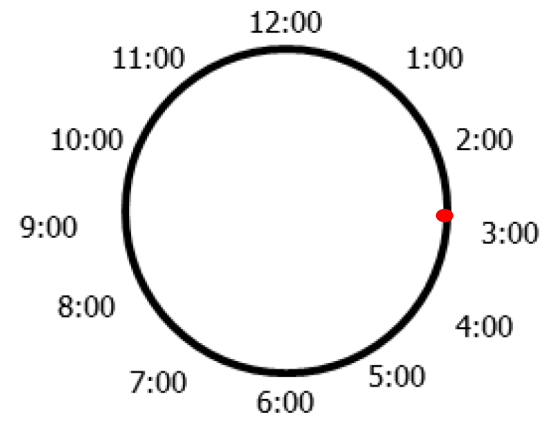
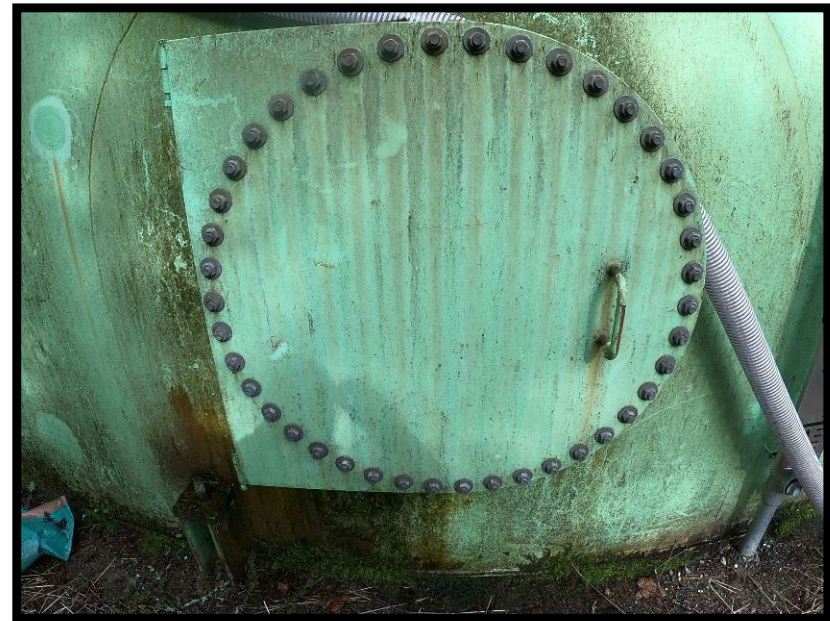
# Exterior Manway

Appeared to be in good condition with a few isolated spots of minor surface corrosion. Overall less than 5% corrosion present.

Appeared to be in good condition with minor chalking and delamination. Overall 5% coating failure.

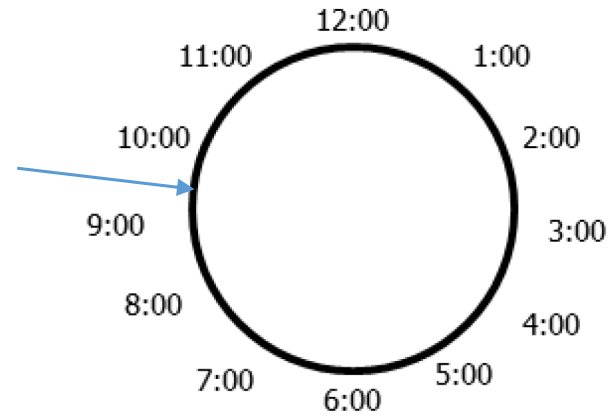
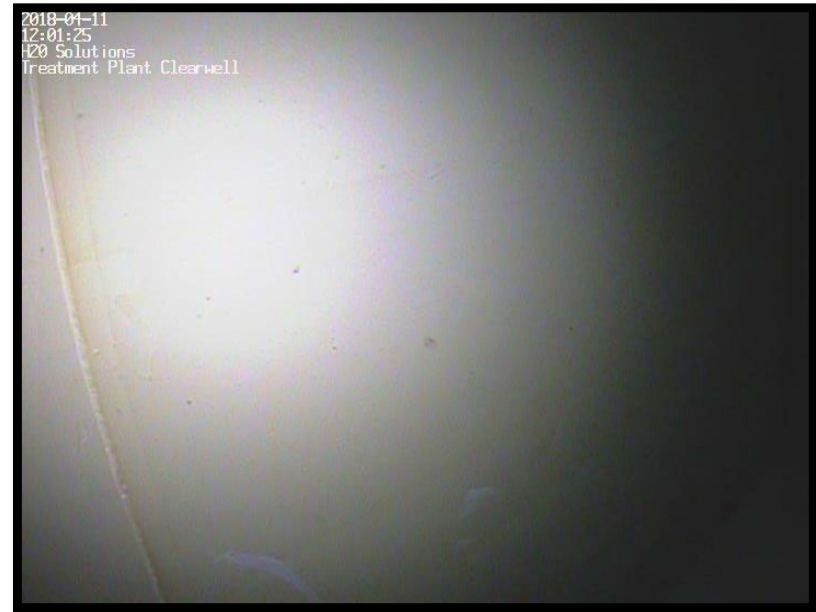
# Interior Wall

Appeared to be in good condition with a few isolated spots of minor surface corrosion. Overall less than 5% corrosion present.

Appeared to be in good condition with chalking, delamination, fading and blistering. Overall 5% coating failure.

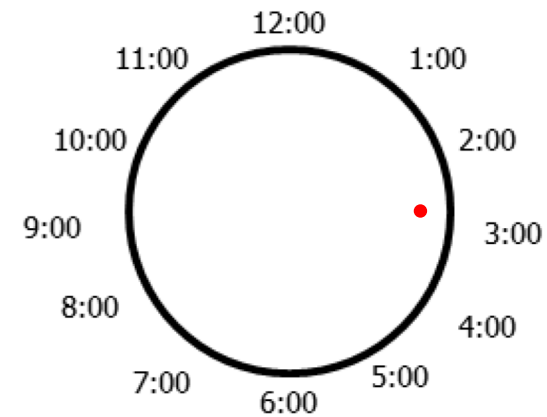
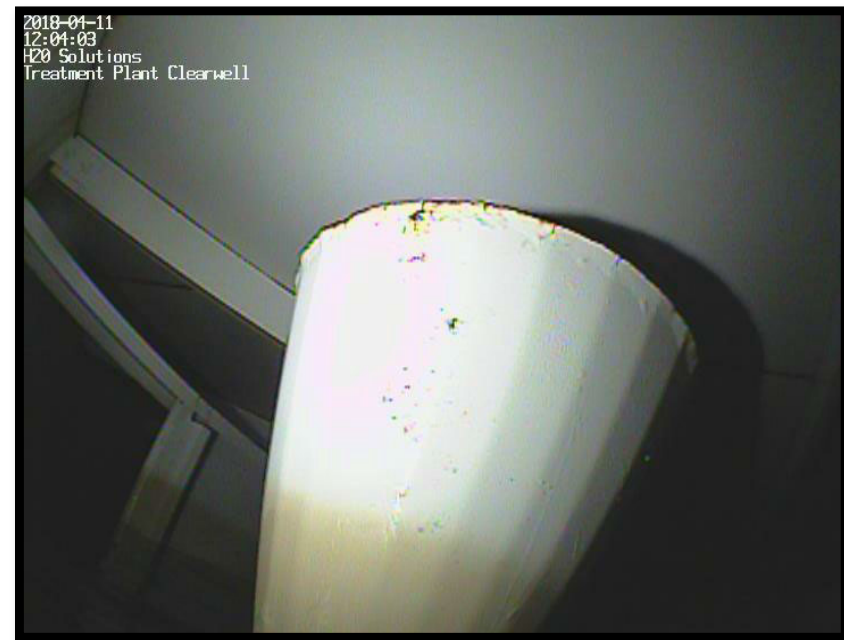
# Interior Overflow Base

Appeared to be in good working condition with a few isolated spots of minor surface corrosion. Overall 5% corrosion present.

Appeared to be in good condition with chalking and blistering. Overall 5% coating failure.

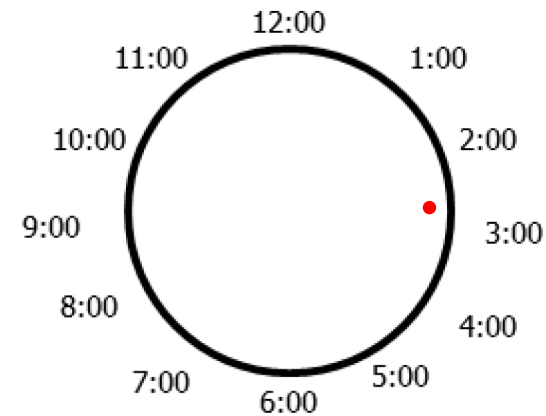
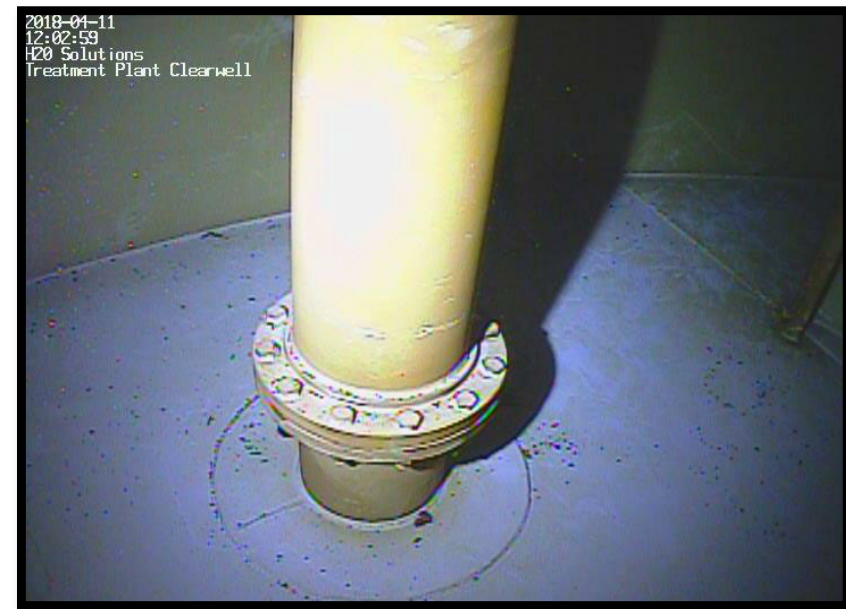
# Interior Inlet Base

Appeared to be in good working condition with areas of moderate surface corrosion. Overall 25% corrosion present.

Appeared to be in fair condition with delamination. Overall 50% coating failure.

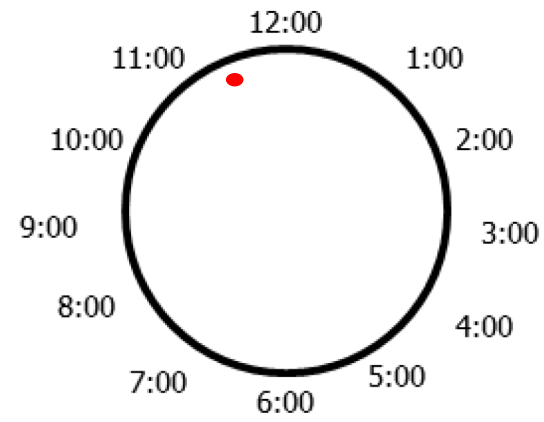
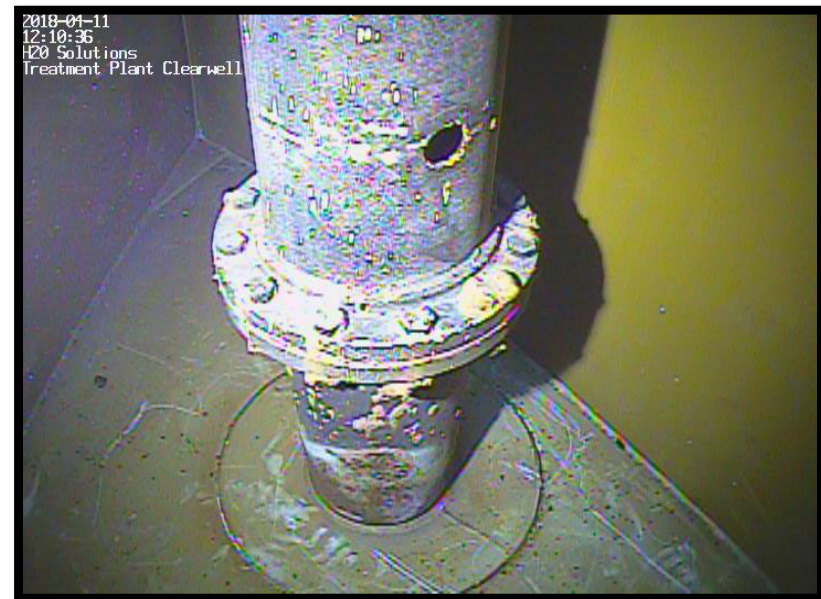
# Interior Inlet

Appeared to be in good working condition with areas of moderate surface corrosion. Overall 25% corrosion present.

Appeared to be in fair condition with delamination. Overall 50% coating failure.

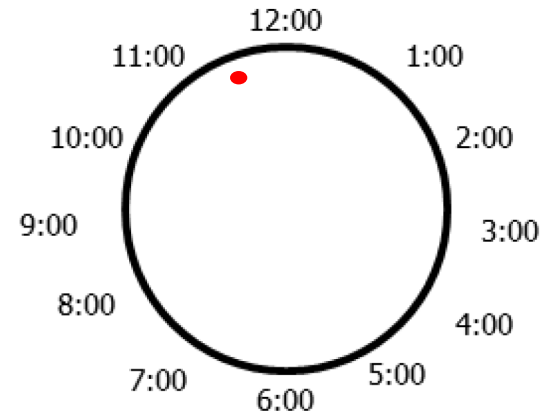
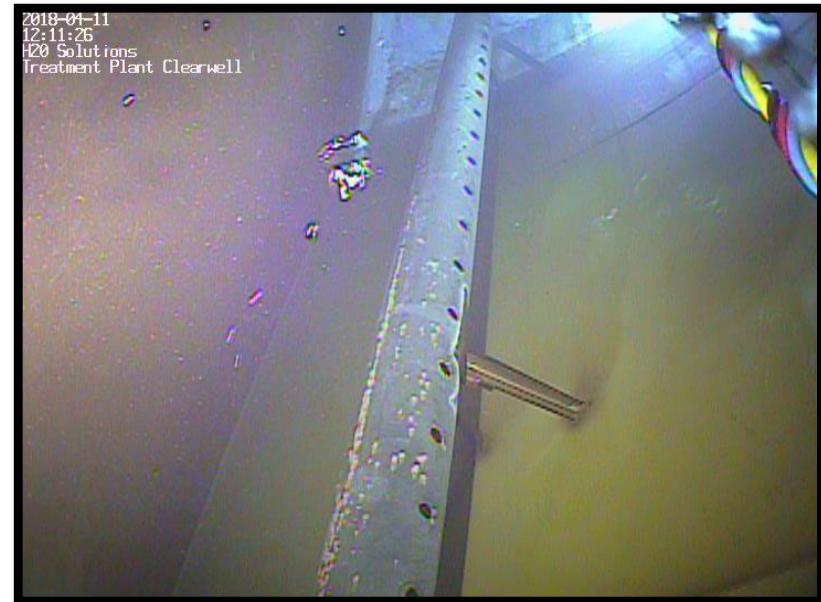
# Interior Outlet

Appeared to be in good working condition with areas of moderate surface corrosion. Overall 25% corrosion present.

Appeared to be in fair condition with delamination. Overall 50% coating failure.

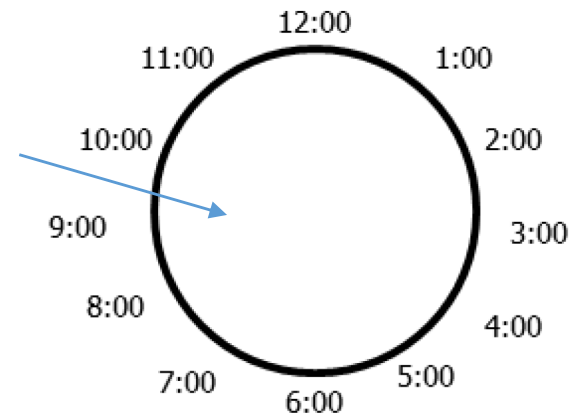
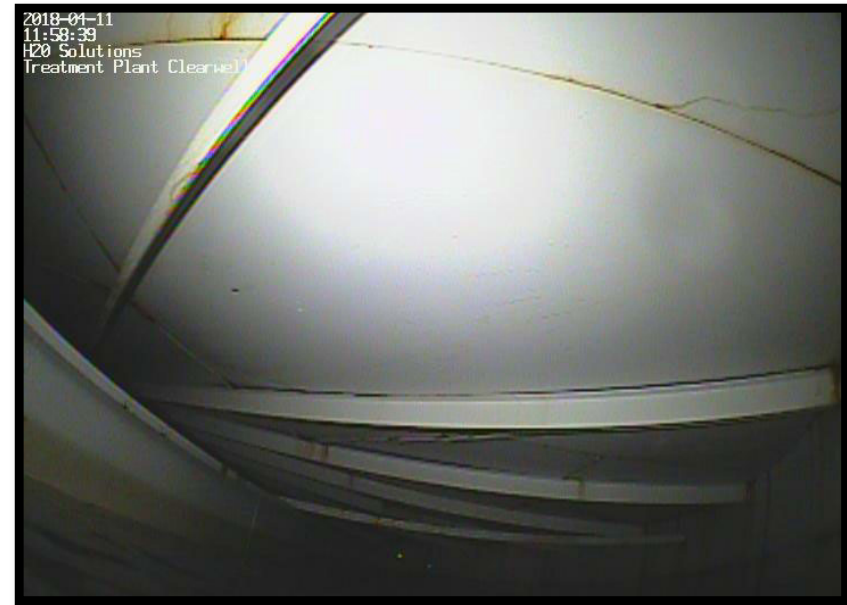
Appeared to be in good condition with a few isolated spots of minor surface corrosion. Overall less than 5% corrosion present.

Appeared to be in good condition with chalking. Overall 5% coating failure.

None at this time

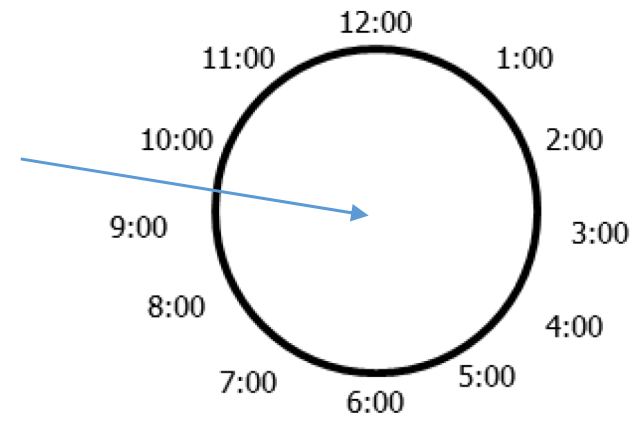
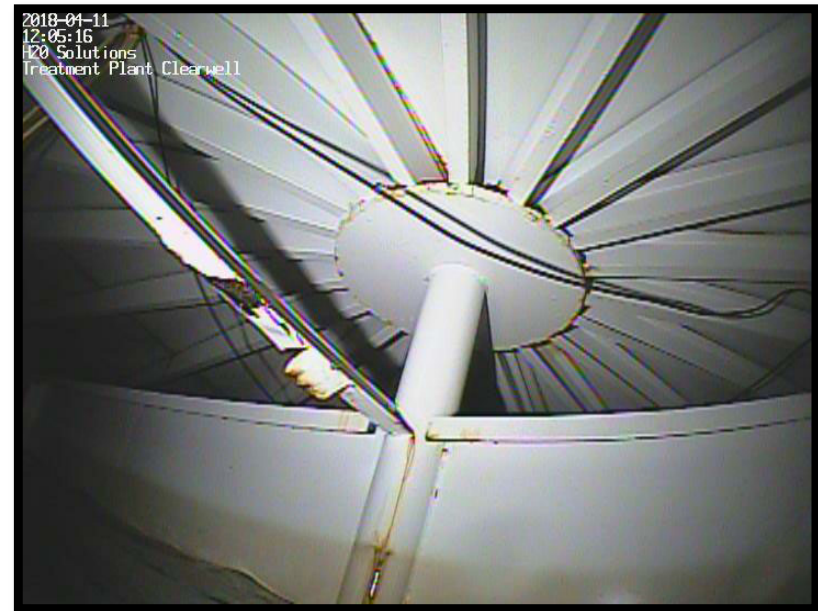
# Interior Ceiling

Appeared to be in good condition with a few isolated spots of minor surface corrosion. Overall less than 5% corrosion present.

Appeared to be in good condition with chalking. Overall 5% coating failure.

None at this time

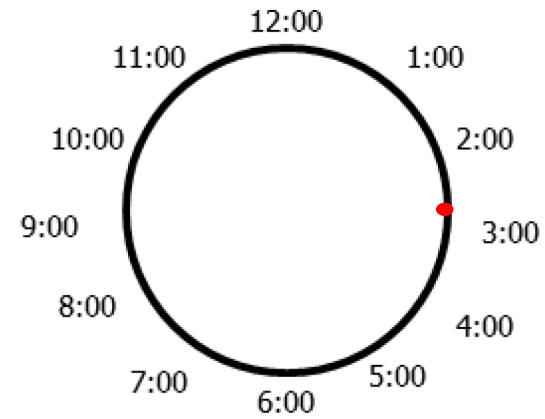
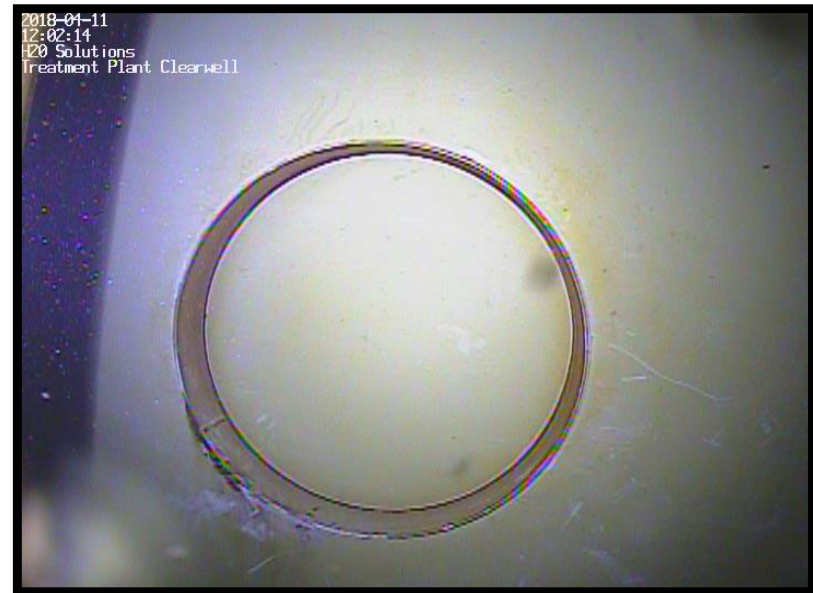
# Interior Manway

Appeared to be in good condition with a few isolated spots of minor surface corrosion. Overall 10% corrosion present. Gasket is in good condition.

Appeared to be in good condition with chalking and blistering. Overall 5% coating failure.

None at this time

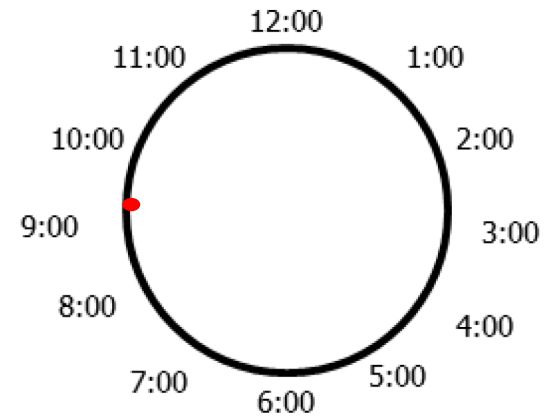
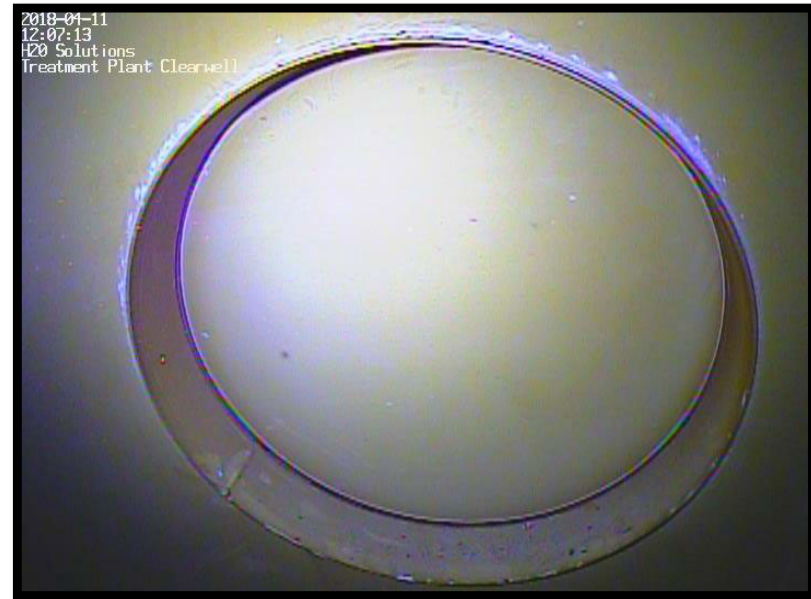
# Interior Manway

Appeared to be in good condition with a few isolated spots of minor surface corrosion. Overall 10% corrosion present. Gasket is in good condition.

Appeared to be in good condition with chalking and blistering. Overall 5% coating failure.

None at this time

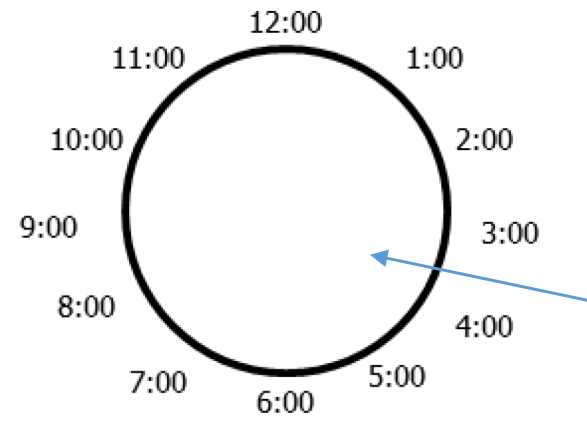
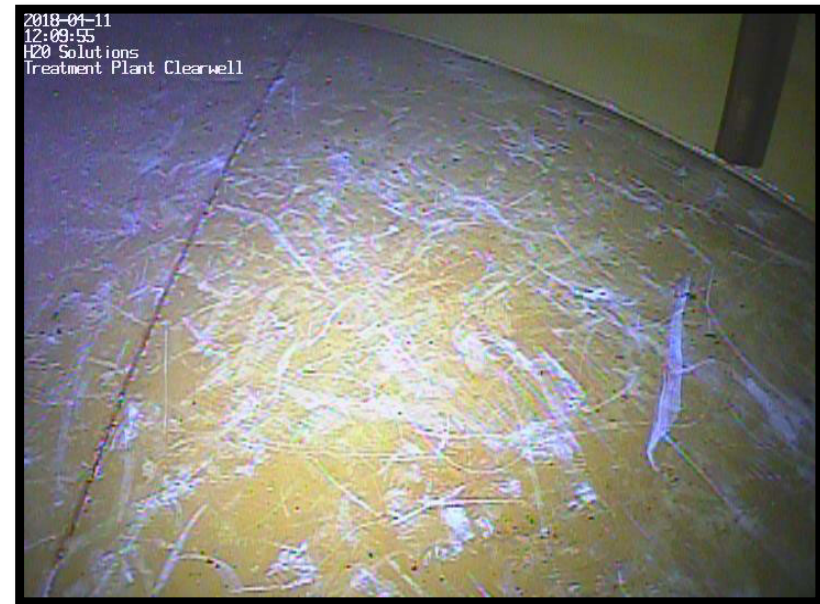
# Interior Floor

Appeared to be in good working condition with a few isolated spots of minor surface corrosion. Overall less than 5% corrosion present.

Appeared to be in good condition with chalking, blistering and staining. Overall 10% coating failure.

None at this time

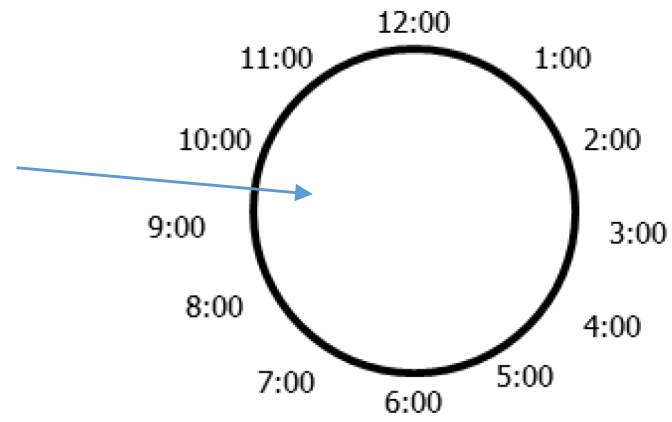
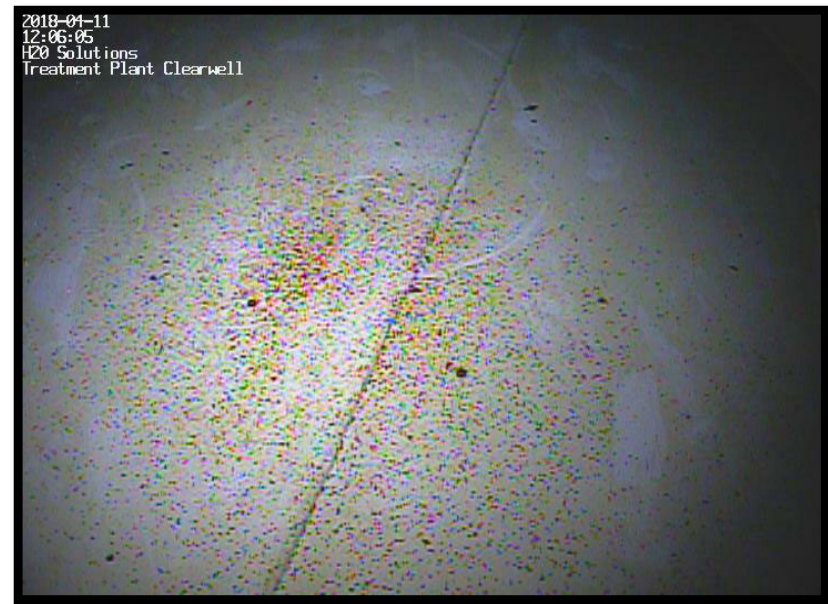
# Interior Floor

Appeared to be in good working condition with a few isolated spots of minor surface corrosion. Overall less than 5% corrosion present.

Appeared to be in good condition with chalking, blistering and staining. Overall 10% coating failure.

None at this time

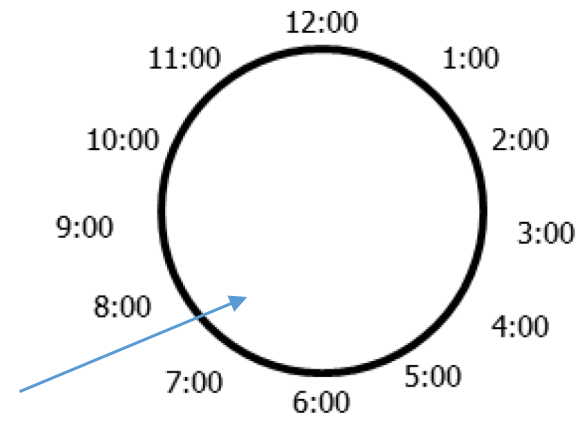
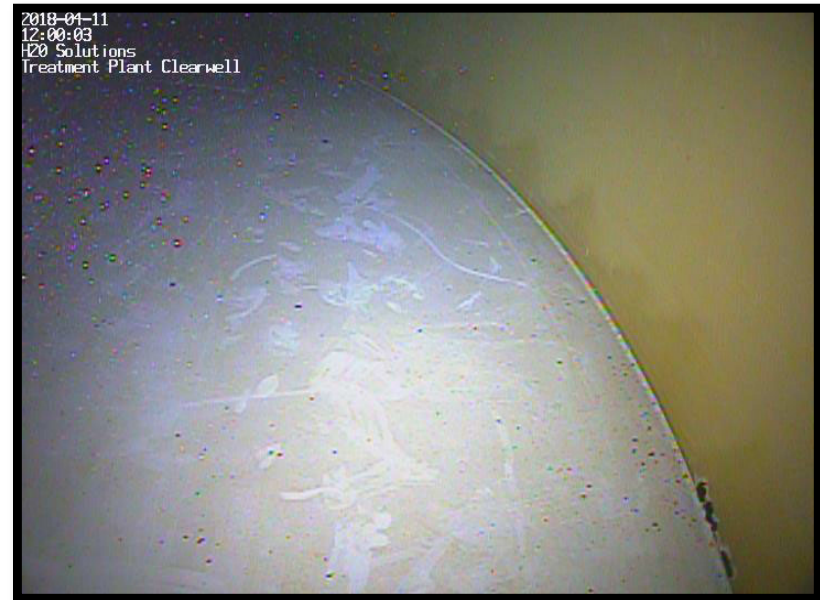
# Interior Floor

Appeared to be in good working condition with a few isolated spots of minor surface corrosion. Overall less than 5% corrosion present.

Appeared to be in good condition with chalking, blistering and staining. Overall 10% coating failure.

None at this time
