Lake Whatcom Water and Sewer District Division 22-1 Reservoir Replacement

ADDENDUM NO. 2 March 25, 2025

Division 22-1 Reservoir Inspection Report April 1, 2024

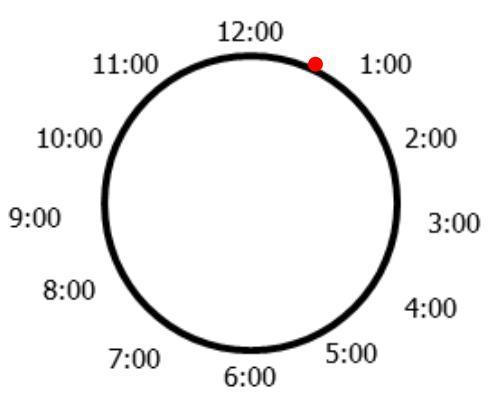
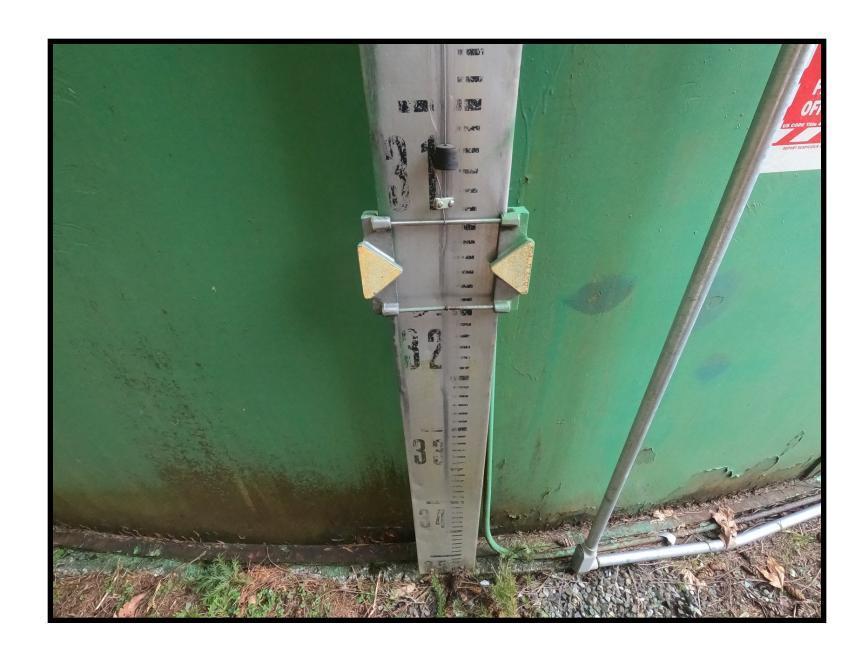
Exterior Manual Level Indicator

Appeared to be in good working condition with no visible discrepancies.

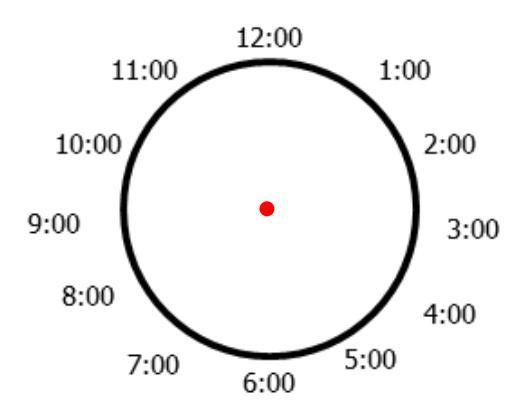
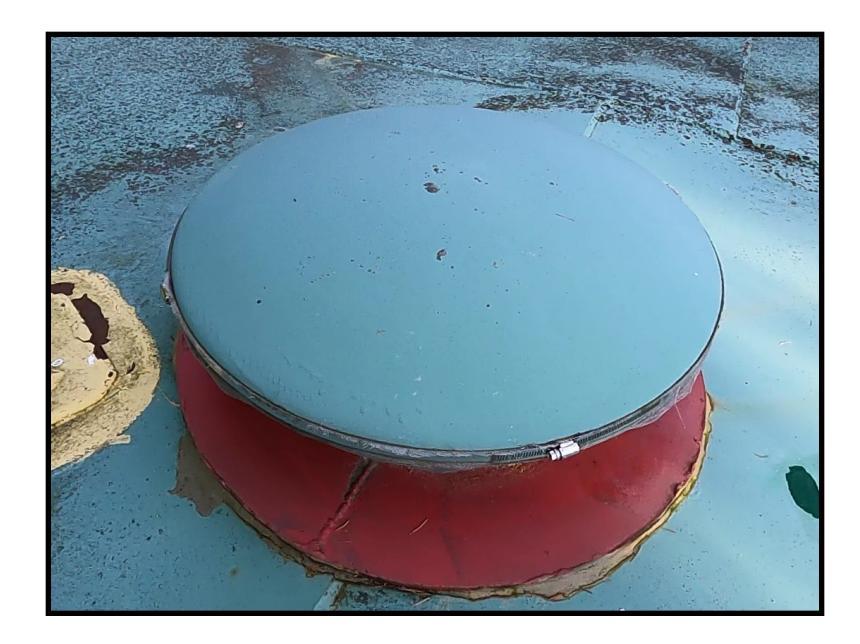
Appeared to be in good working condition with no visible signs of corrosion.

Appeared to be in good condition with light staining present.

< 5%

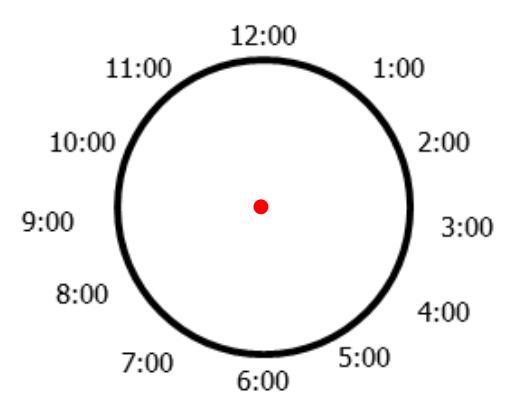
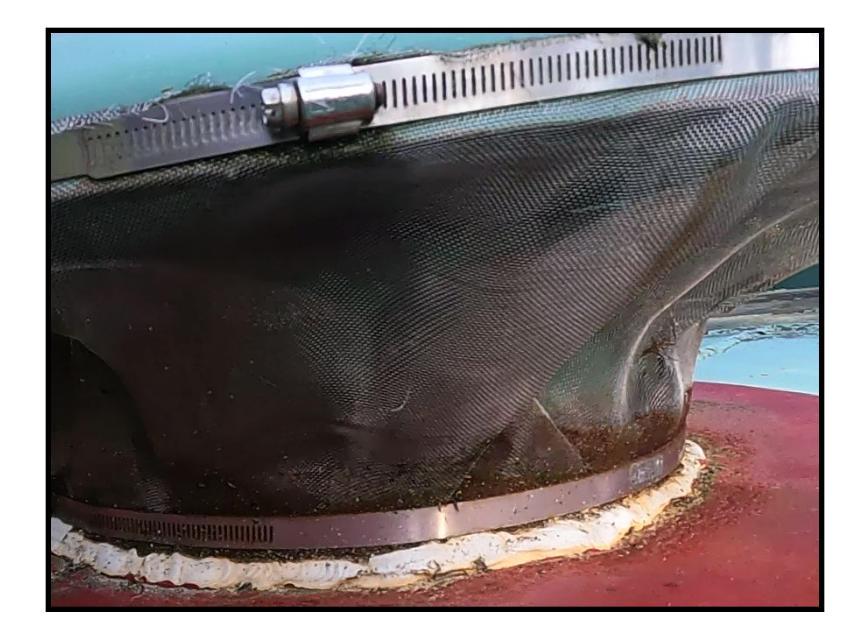
Exterior Vent Screen

Appeared to be fully intact and in good condition with no visible signs of corrosion.

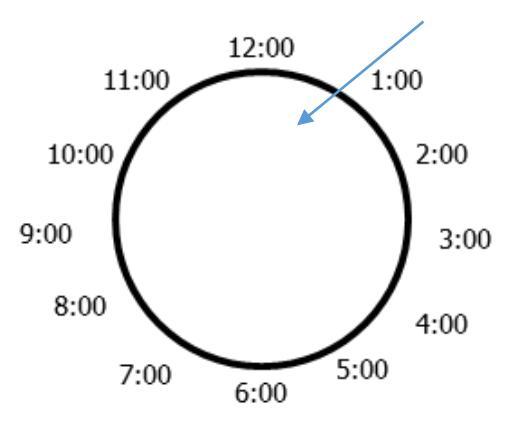
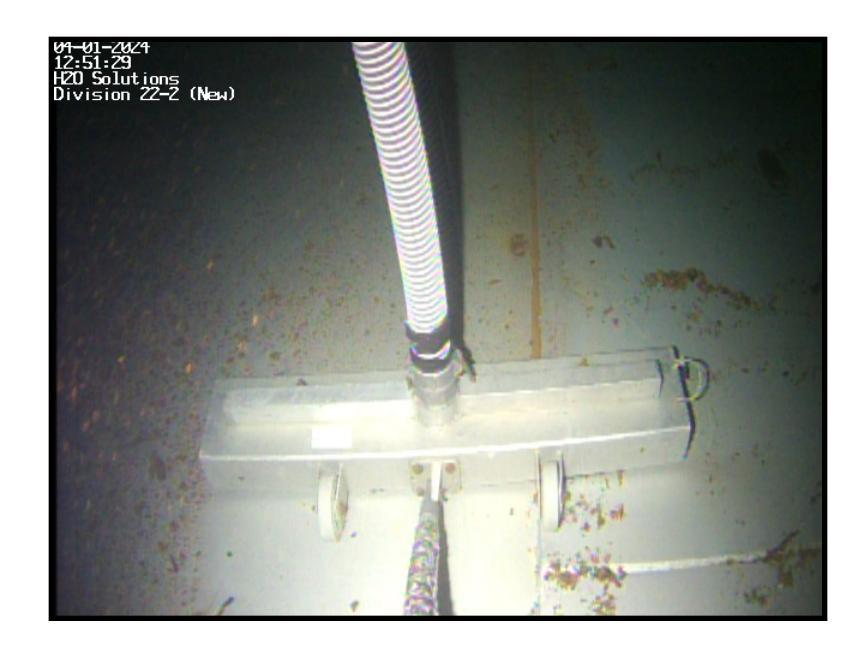
Interior Sediment

¼" of sediment.

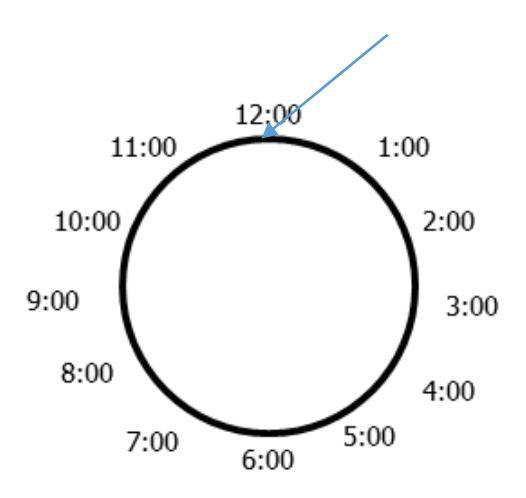
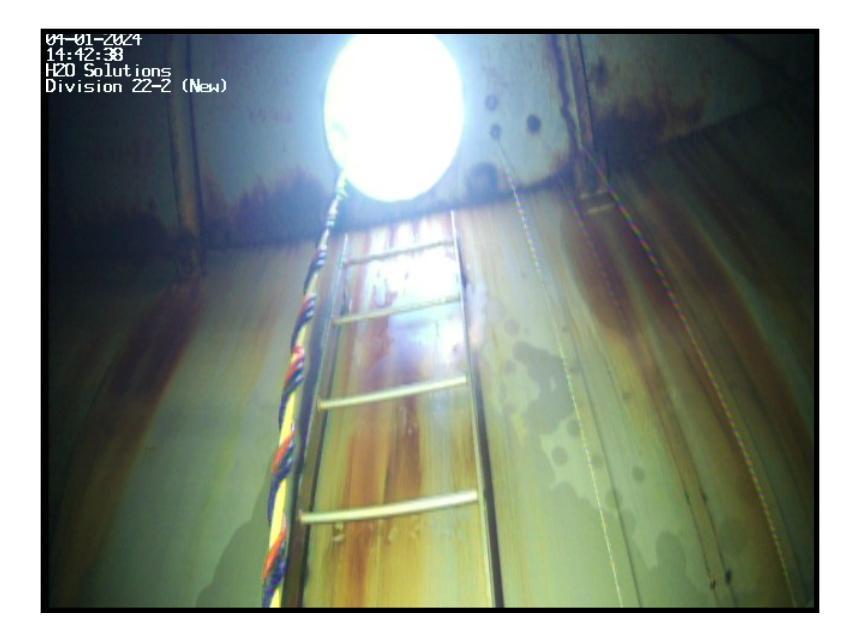
Interior Ladder

Appeared to be structurally sound and in good condition with no visible signs of corrosion.

Appeared to be in good condition with light staining present.

< 5%

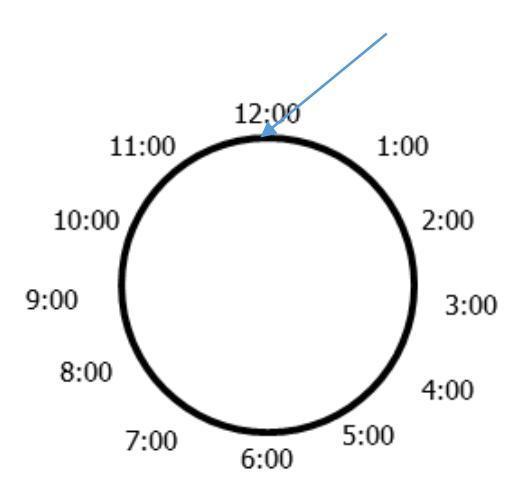
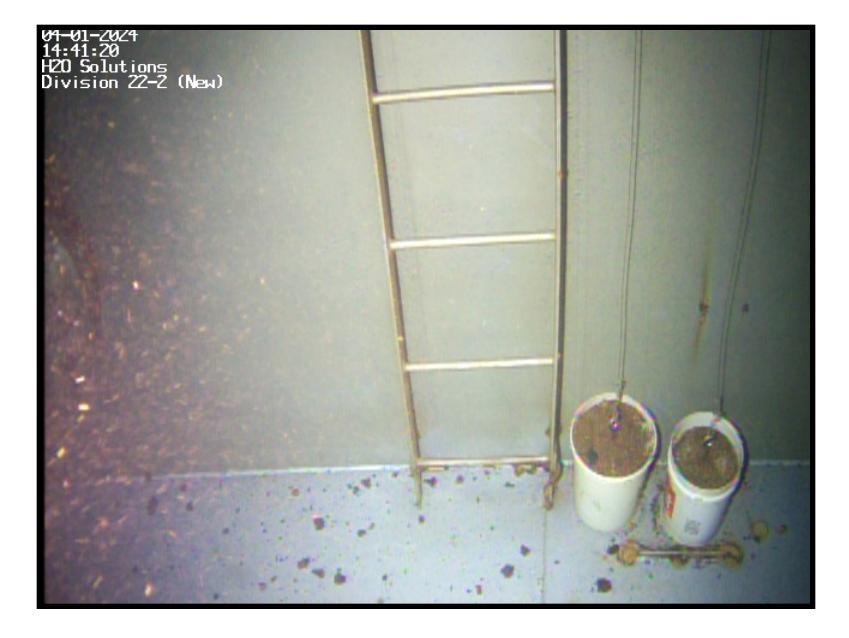
Interior Ladder

Appeared to be structurally sound and in good condition with no visible signs of corrosion.

Appeared to be in good condition with light staining present.

< 5%

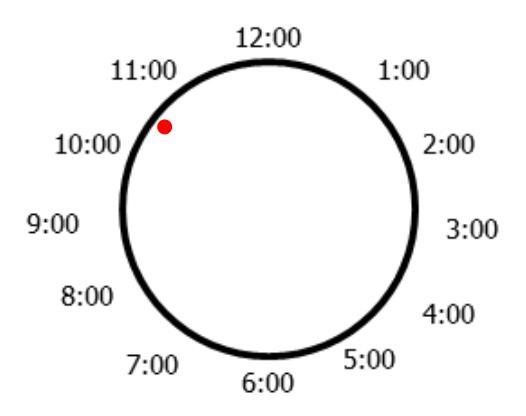
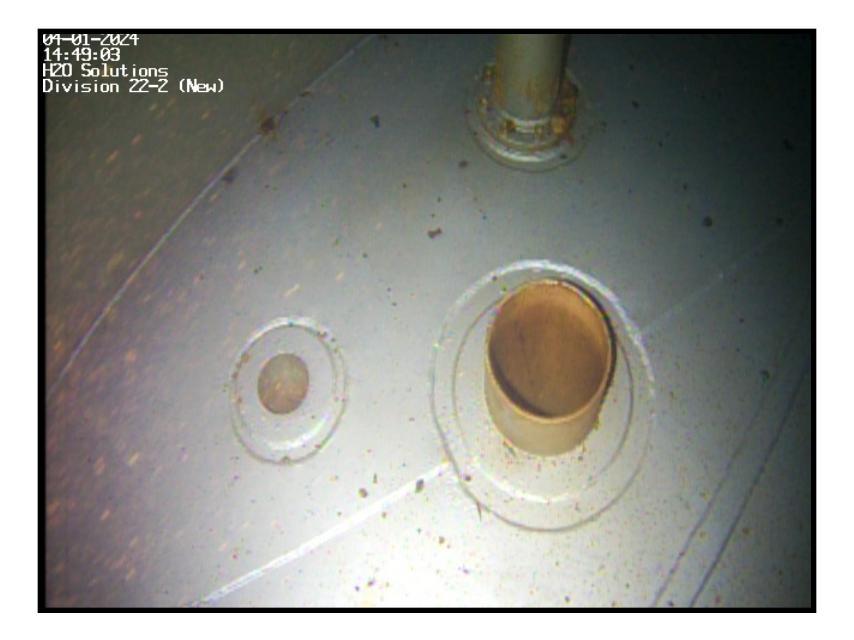
Interior Outlet & Drain

Appeared to be in good working condition with spots of minor corrosion present.

Appeared to be in good condition with light staining present.

< 5%

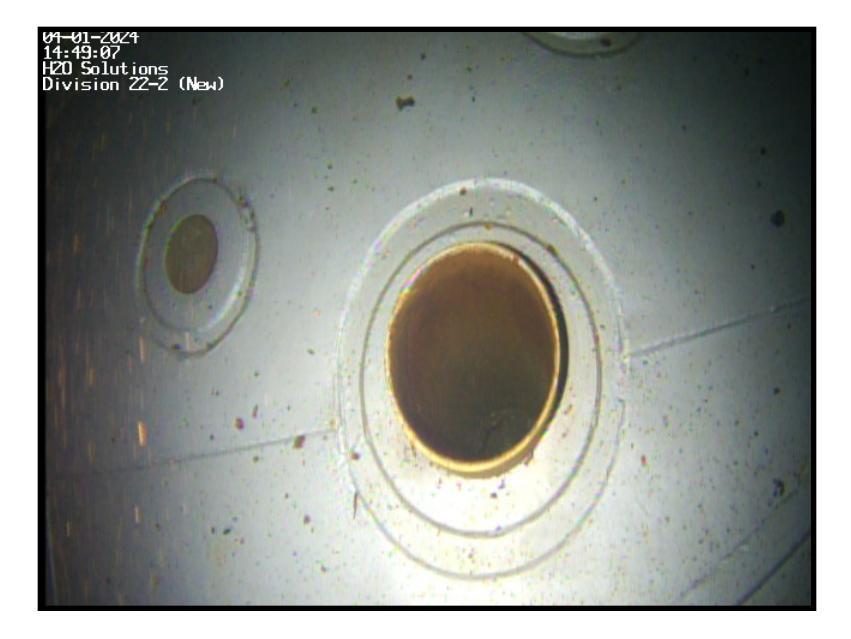
Interior Outlet

Appeared to be in good working condition with spots of minor corrosion present.

Appeared to be in good condition with light staining present.

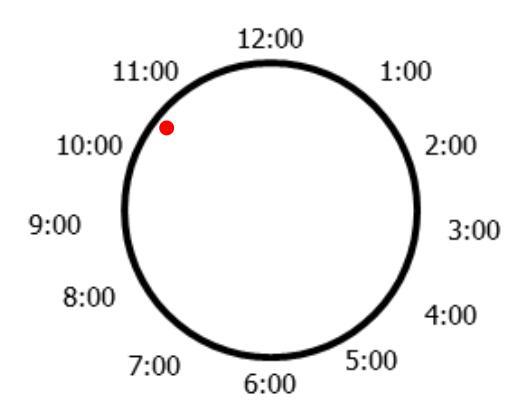
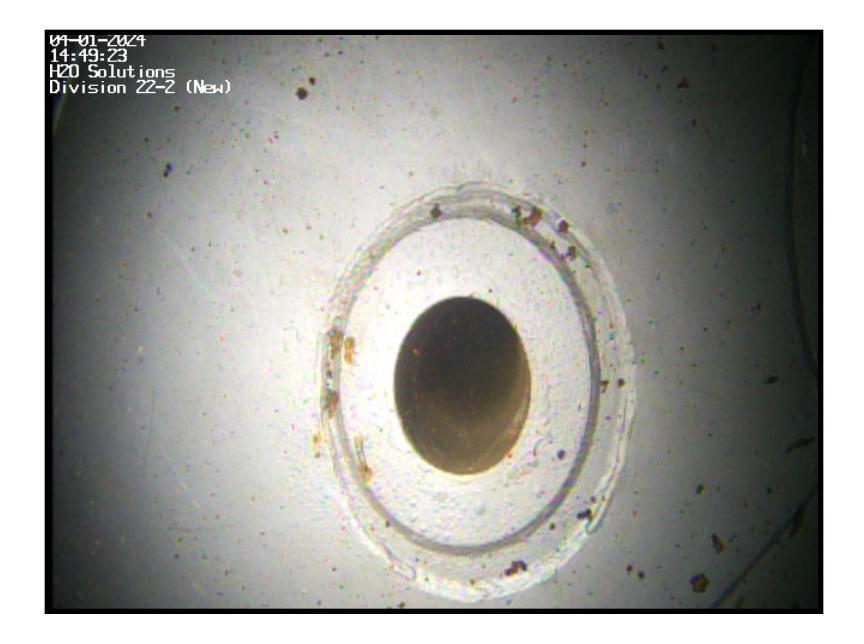
Interior Drain

Appeared to be in good working condition with spots of minor corrosion present.

Appeared to be in good condition with light staining present.

< 5%

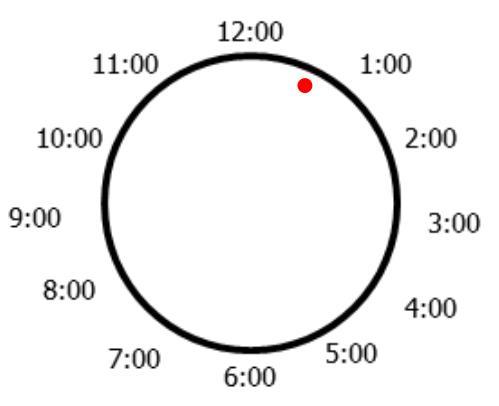
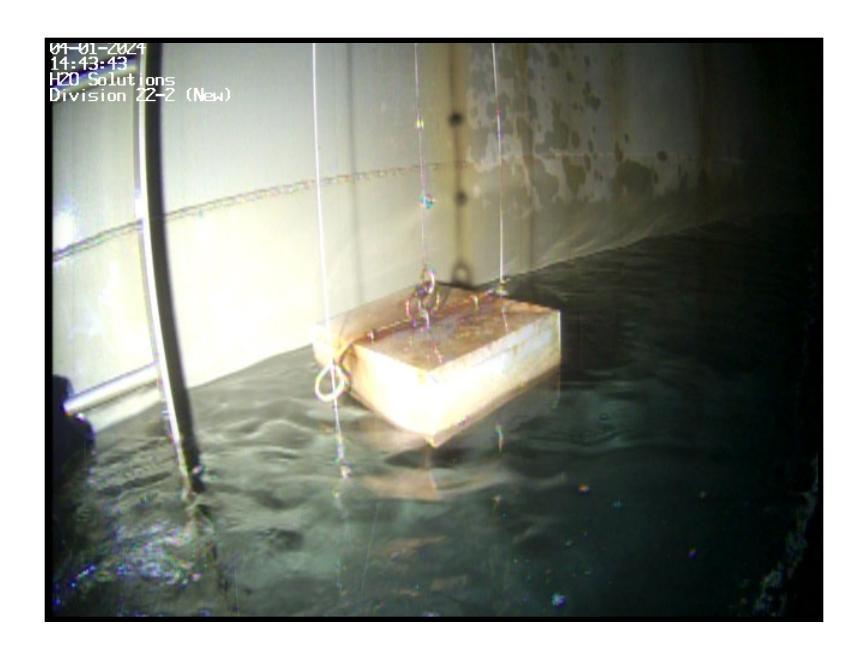
Interior Manual Level Indicator

Appeared to be in good working condition with no visible discrepancies.

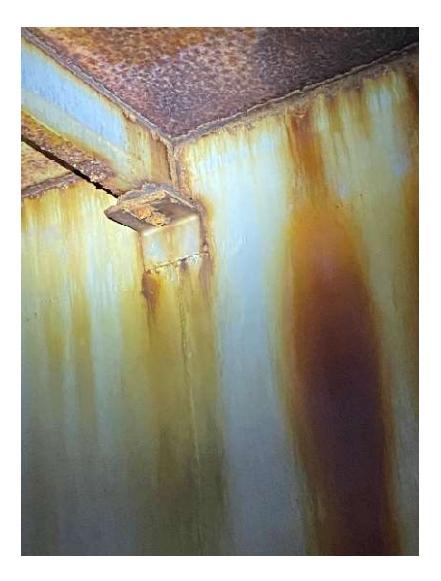
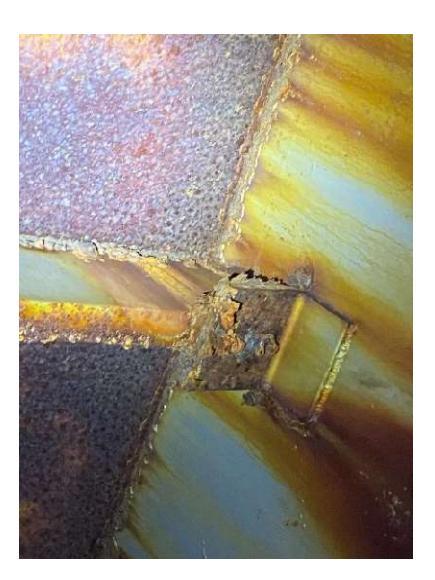
The interior coating system can be broken down into two components above the waterline: The roof structure and the shell wall. The coatings on the roof and rafters have completely failed and aggressive corrosion is occurring. The flanges on the C Channel rafters are severely corroded in places and it can be assumed that the roof plates above the flanges are similarly corroded. The rafters are connected to the shell wall by angle brackets. Most of these brackets and the bolts that connect them to the rafters are moderately to severely corroded. The roof plates have light to moderate corrosion over most of the surface area. The interface between the roof plates and the shell wall at the rim angle also shows significant corrosion.

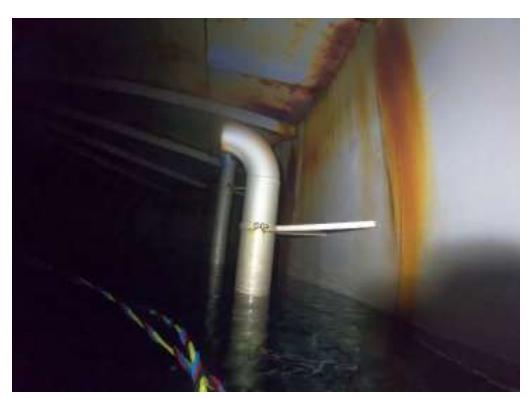
Staining on the wall in 2018.

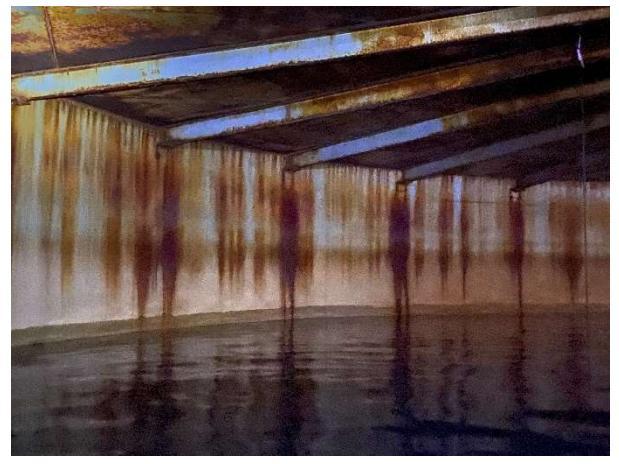
General condition.

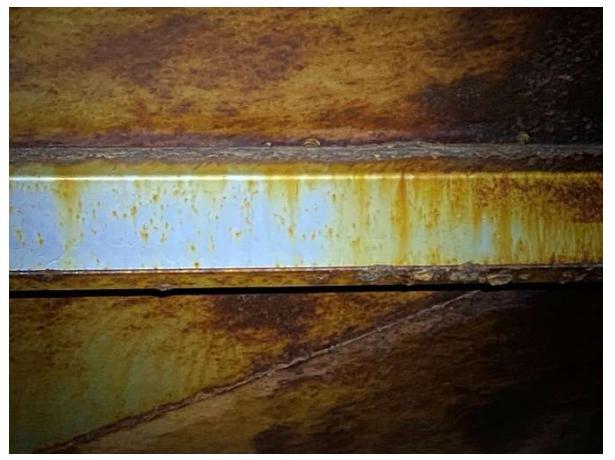
Severe corrosion of the upper flange.

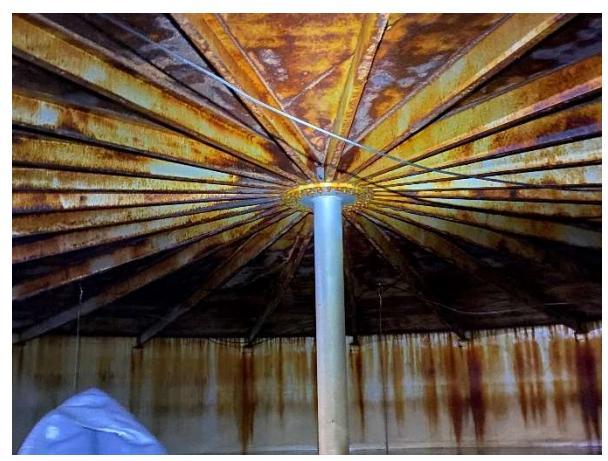
General condition.

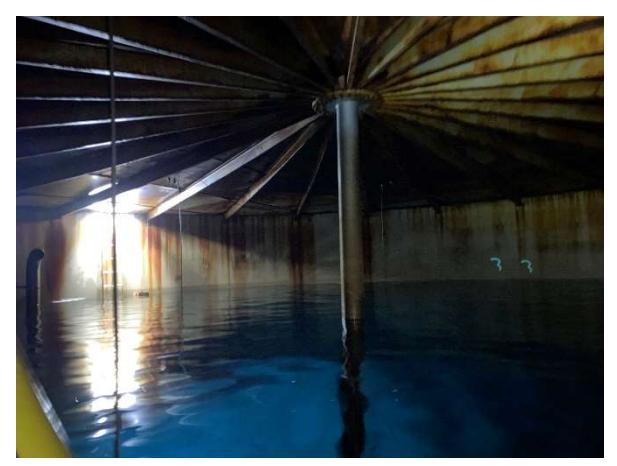
General condition.

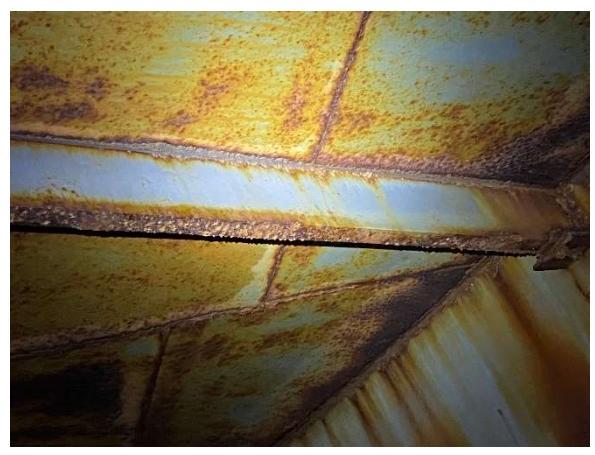
Severe corrosion of the upper and lower flanges.

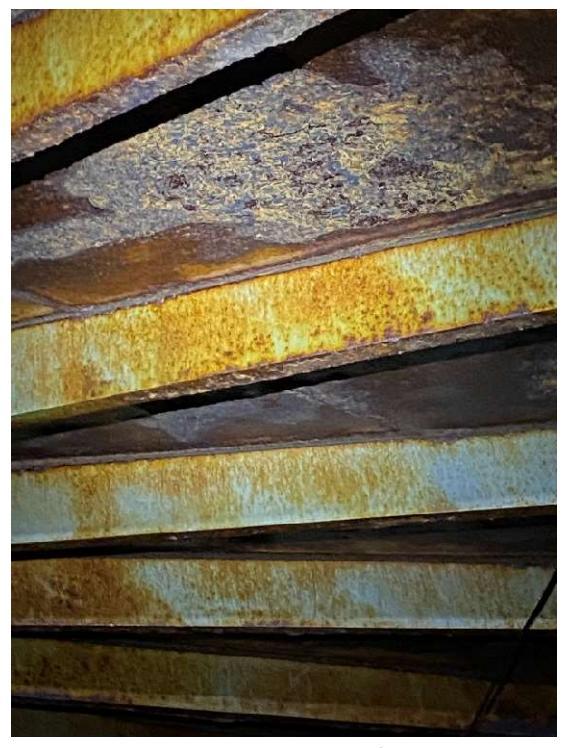
Corrosion on upper and lower flanges.

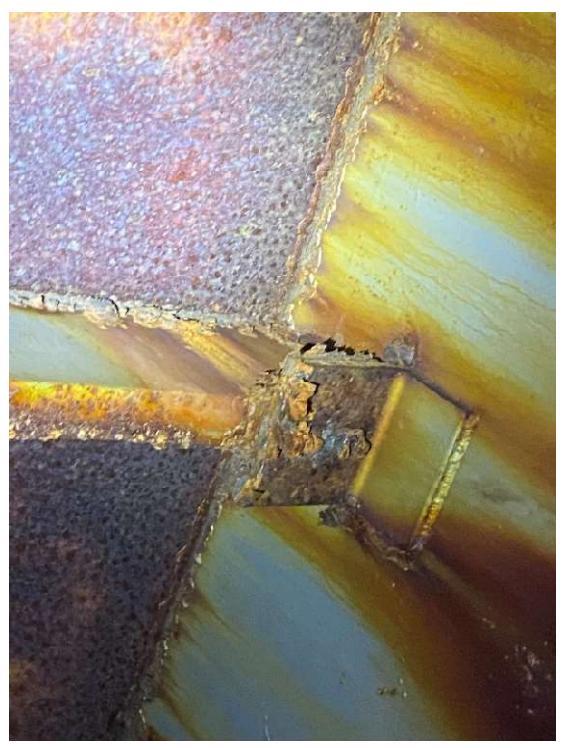
Corroded angle bracket, rim angle, and rafter.

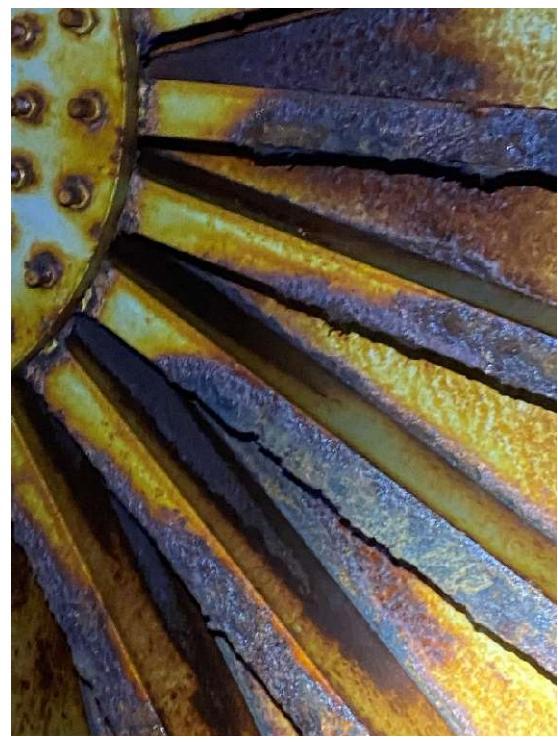
Severe corrosion on upper and lower flanges.

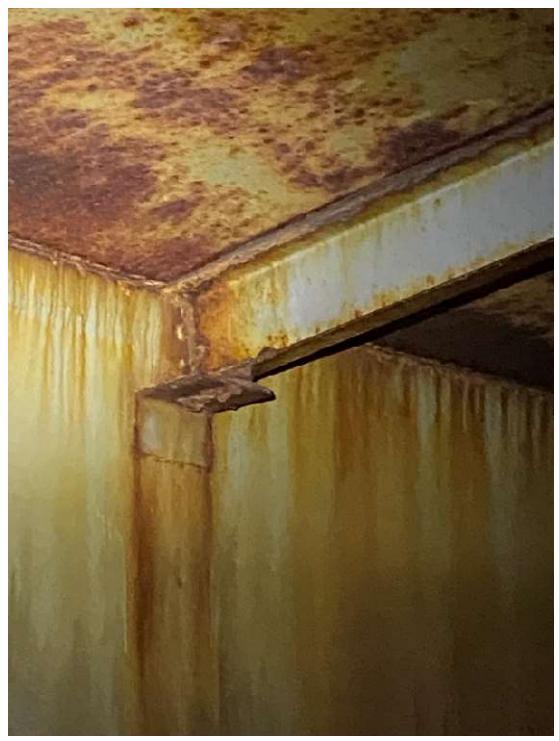
Bolts to the angle bracket have corroded away.

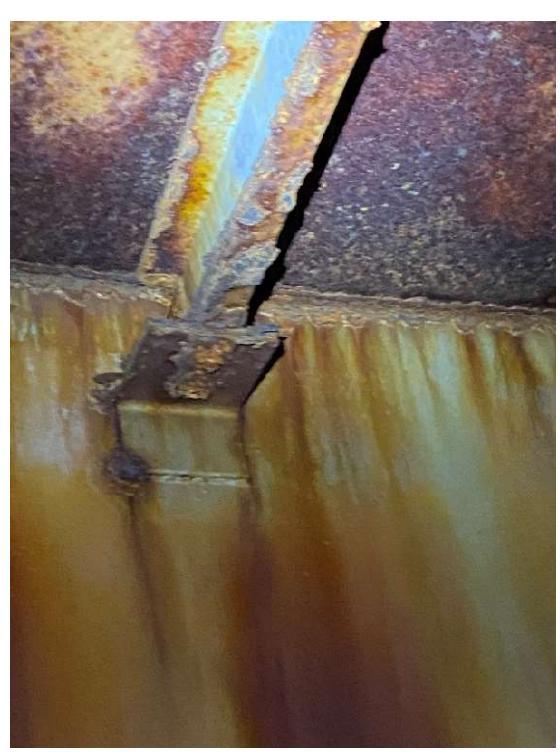
Corroded angle bracket, rim angle, and rafter.

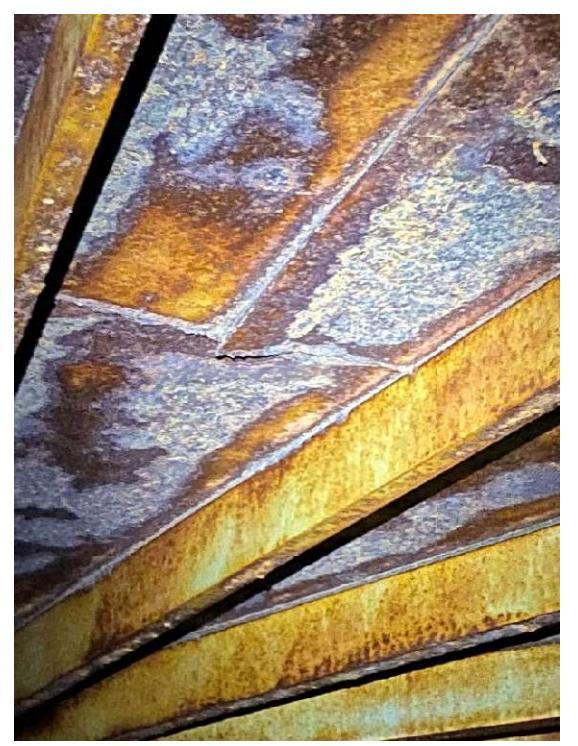
Severe corrosion of the roof plates and rafters.

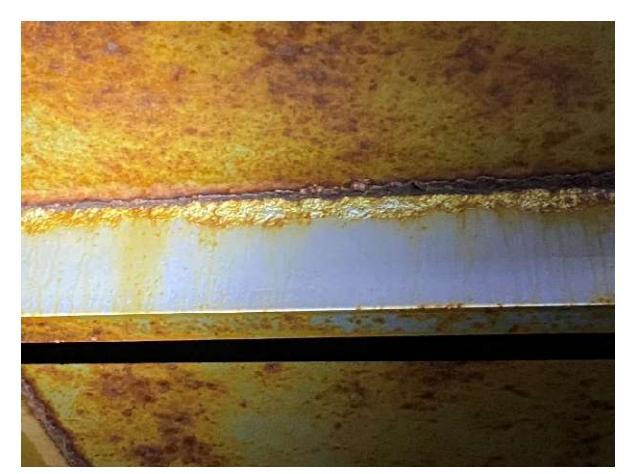
Rafter corrosion.

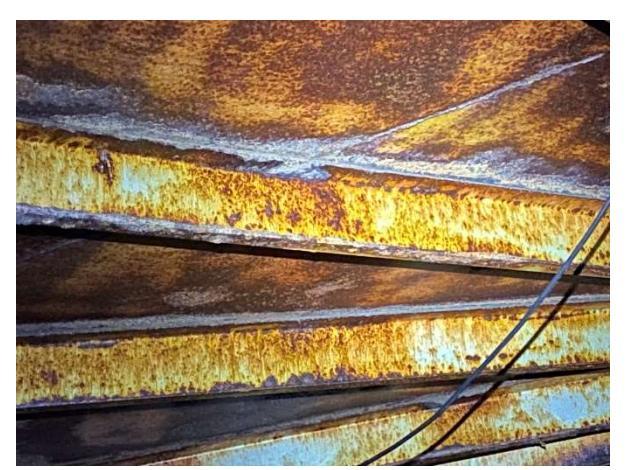
Rafter and roof plate corrosion.

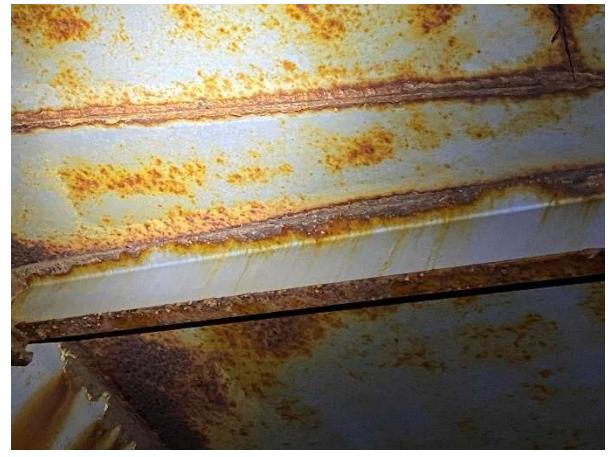
Rafter and roof plate corrosion.

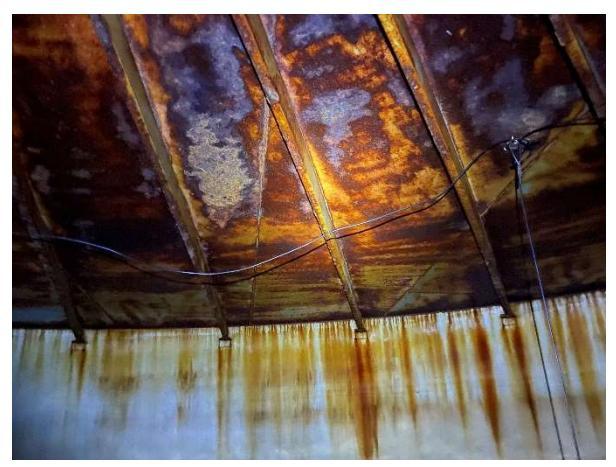
Rafter and roof plate corrosion.

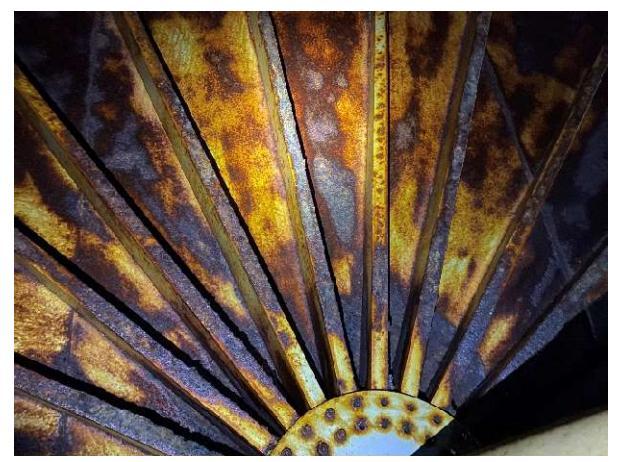
Rafter corrosion at the dollar plate.

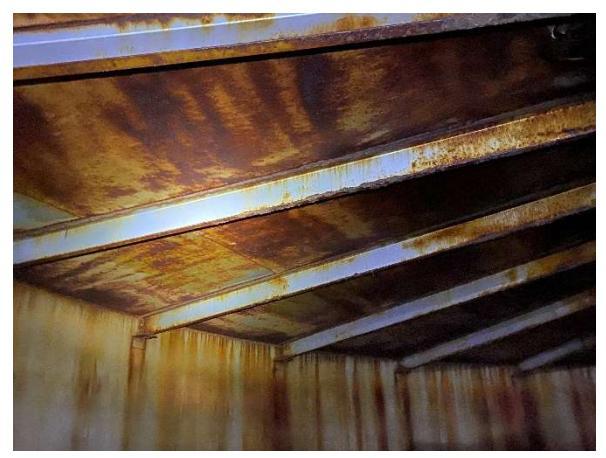
Rafter and roof plate corrosion.

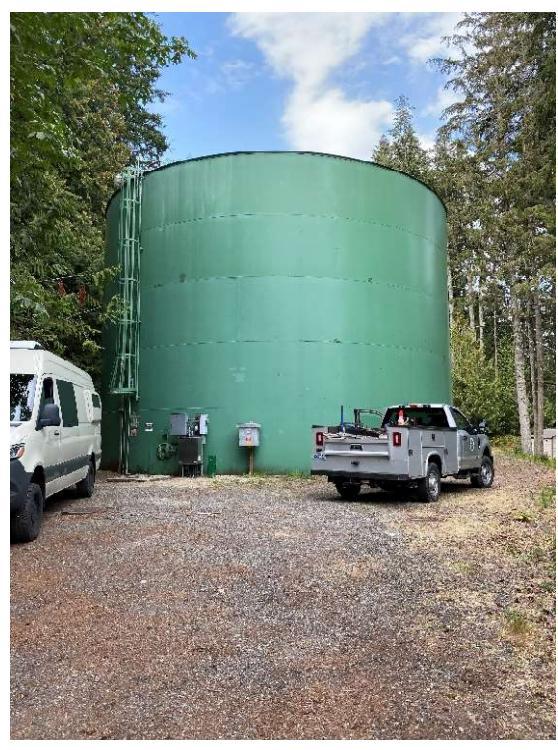
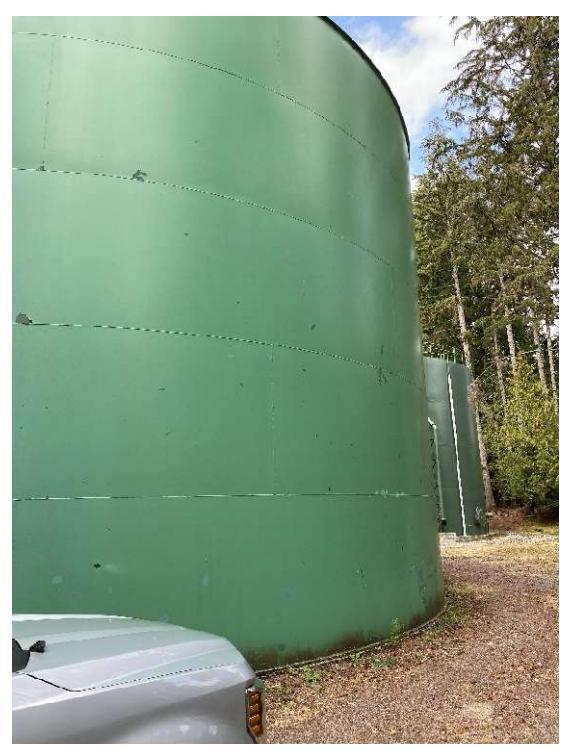
General exterior.

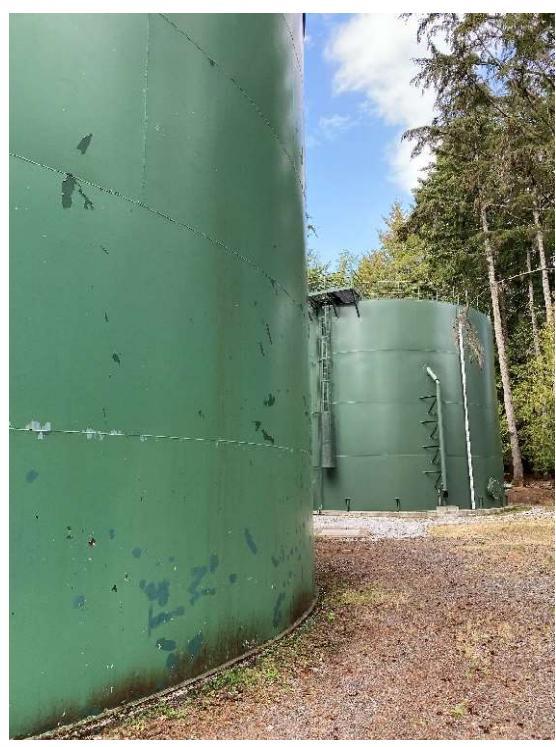
Delamination and repair areas.

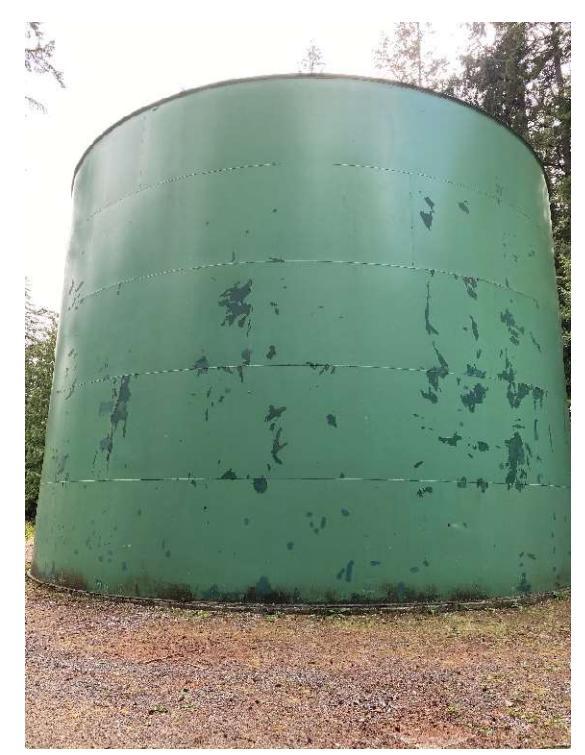
Delamination and repair areas.

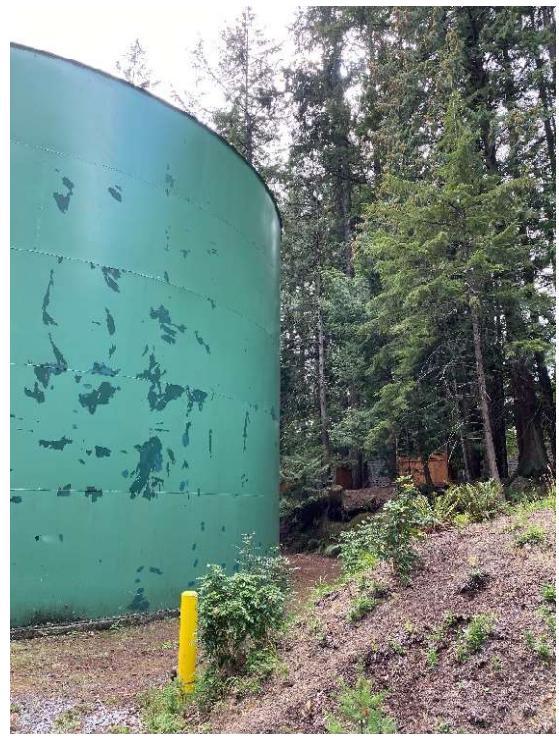
Delamination and repair areas.

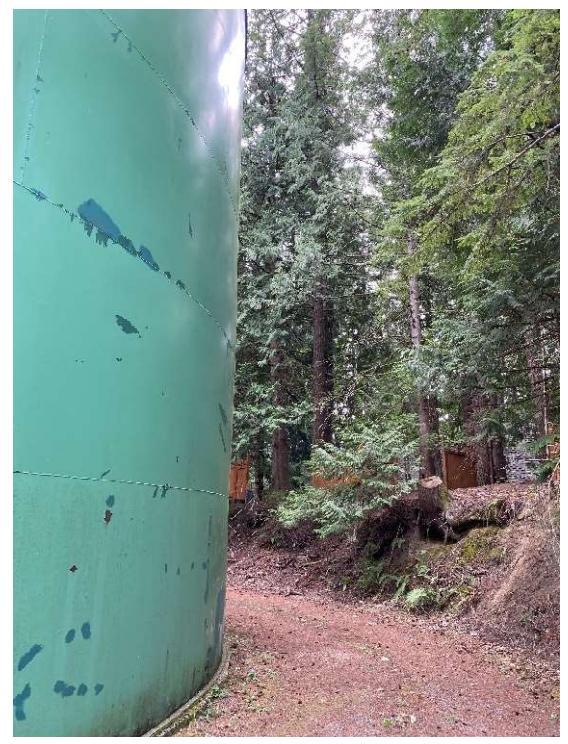
Delamination and repair areas.

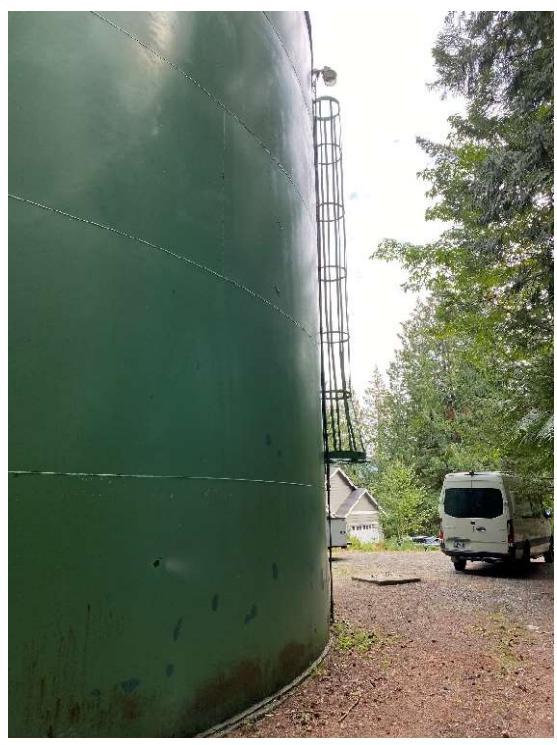
General exterior.

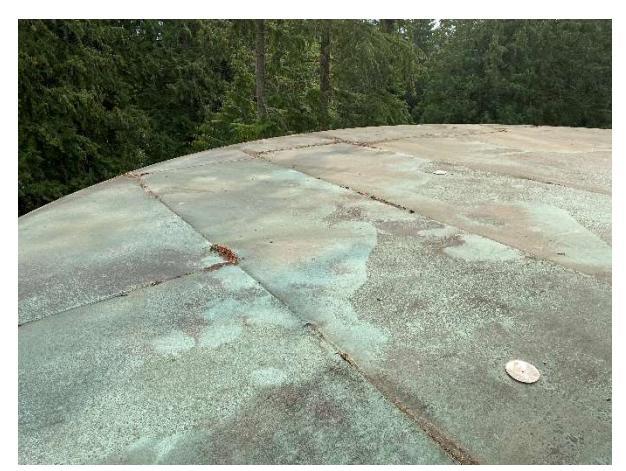
General roof condition.

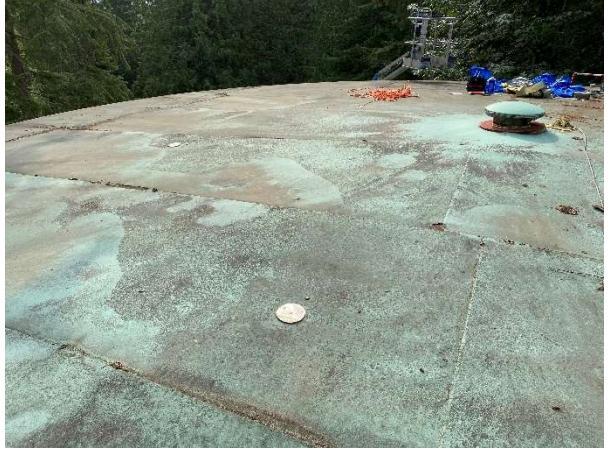
General roof condition.

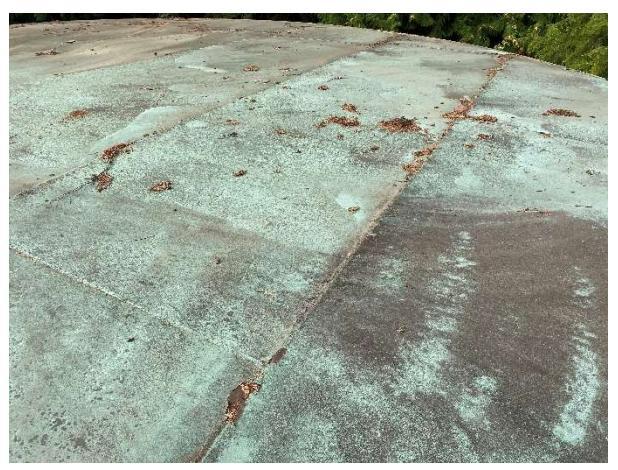
General roof condition.

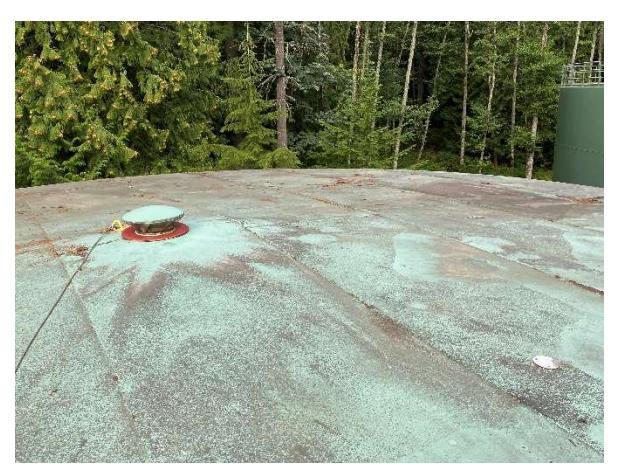
General roof condition.

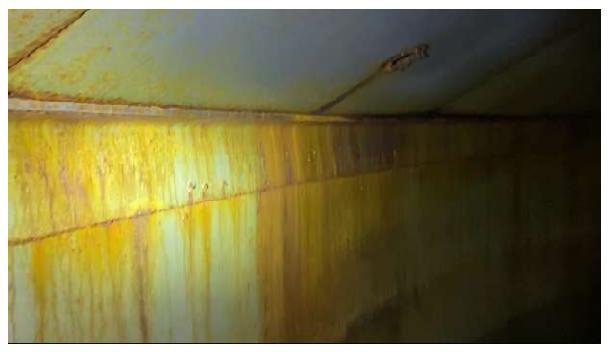
Mild corrosion and rust staining on the shell wall.

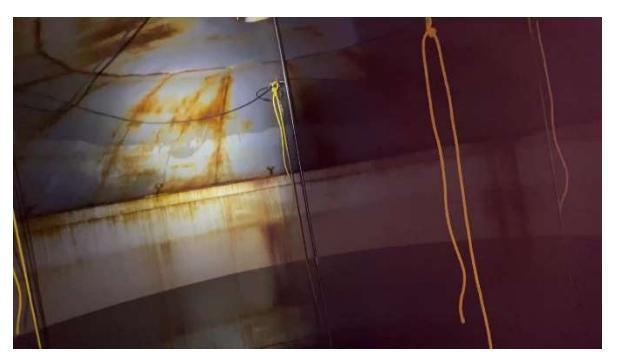
General rusting of the roof plates.

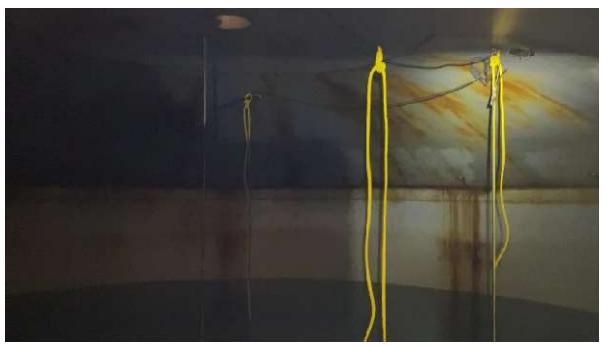
General rusting of the roof plates.

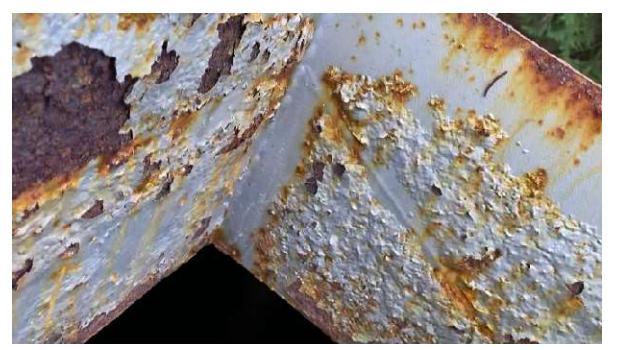
Moderate corrosion on the access hatch riser.

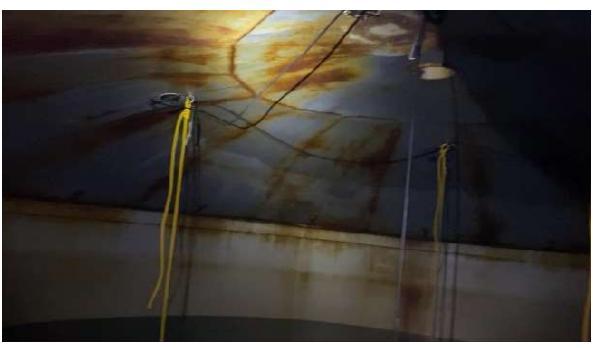
General rusting of the roof plates.

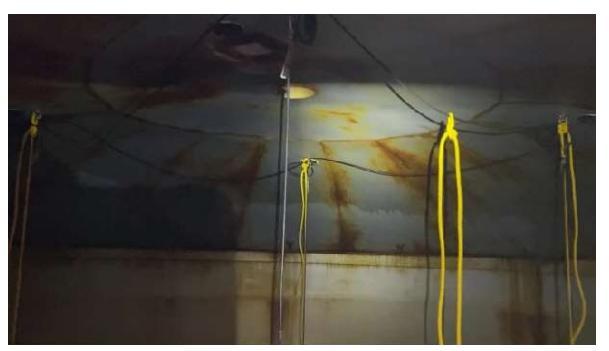
General rusting of the roof plates.

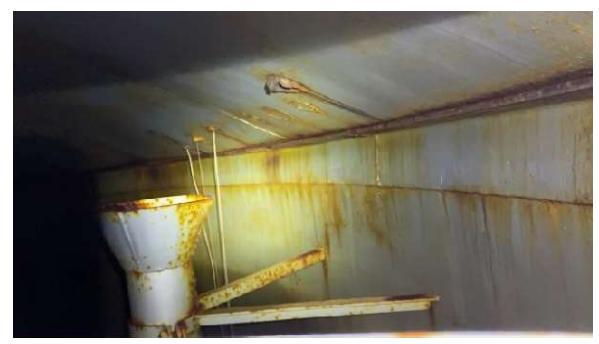
Overflow.

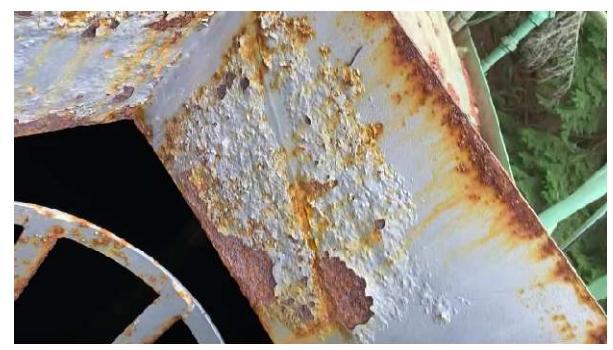
Moderate corrosion on the access hatch riser.

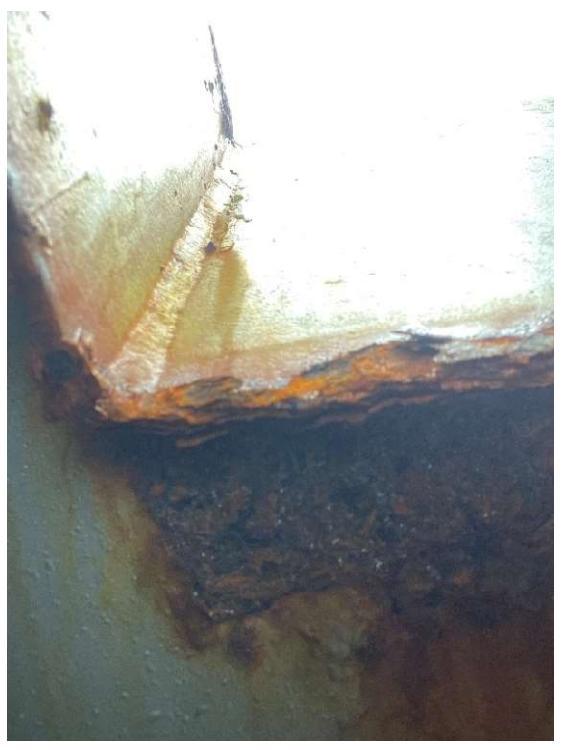
Moderate corrosion under the hatch riser.

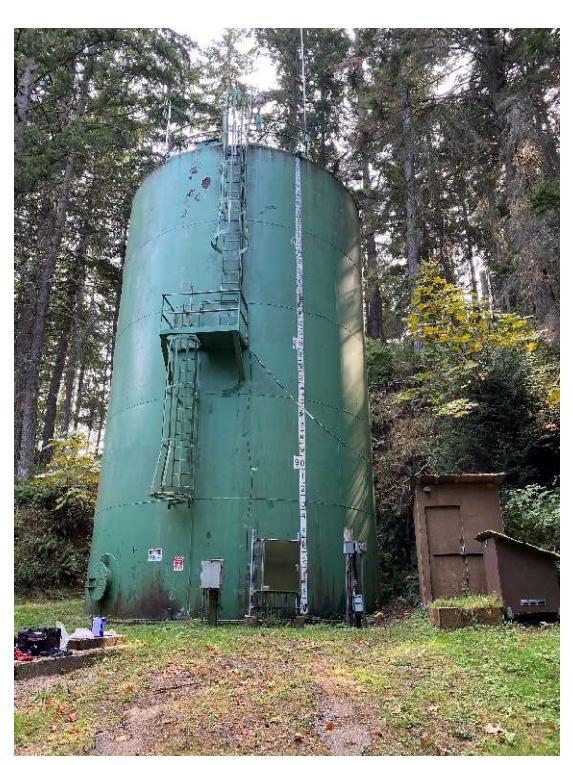
General exterior.

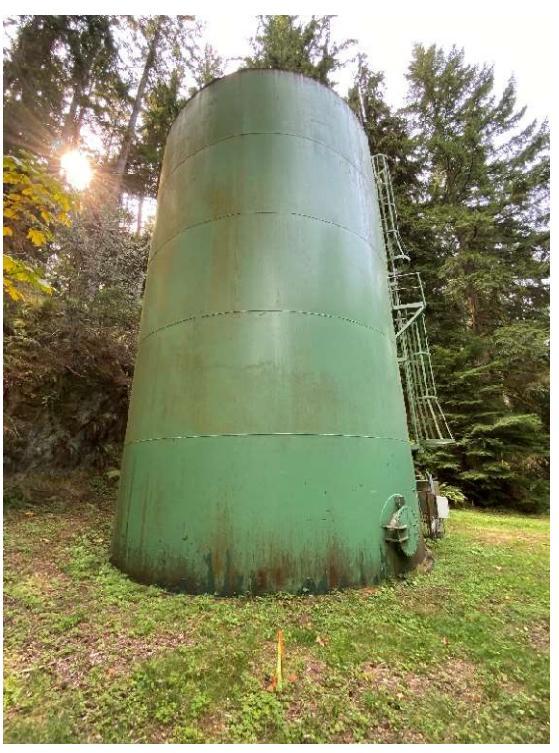
General exterior.

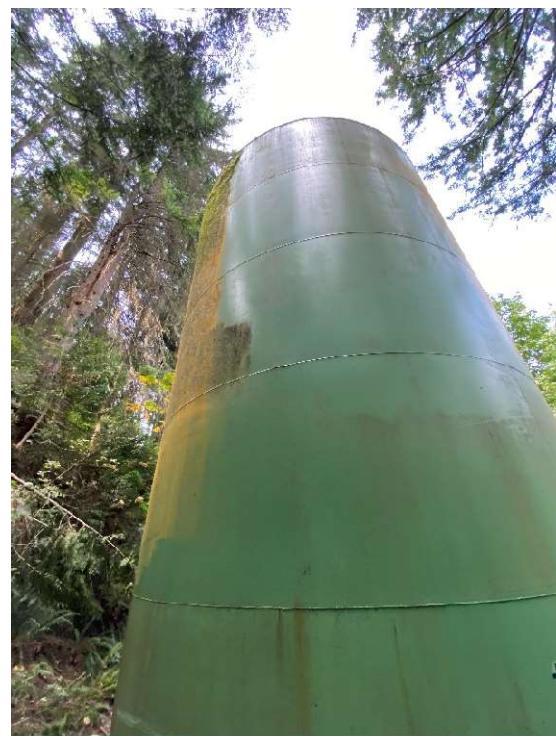
General exterior.

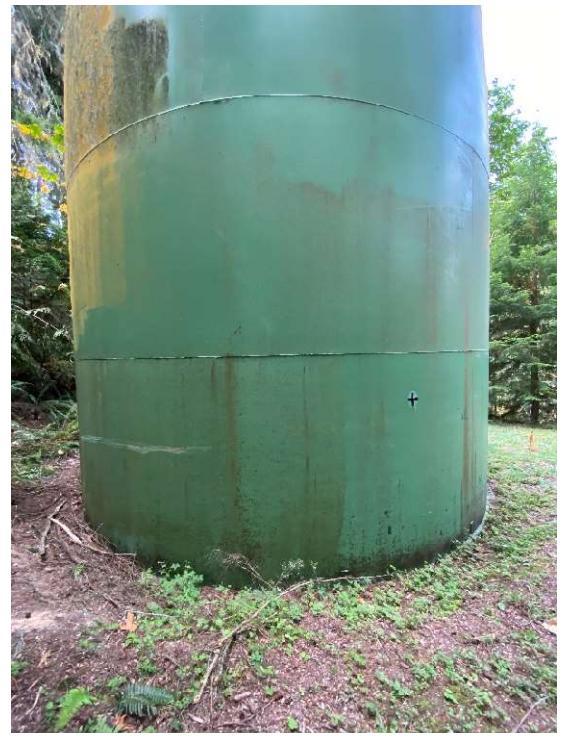
Ringwall below grade.

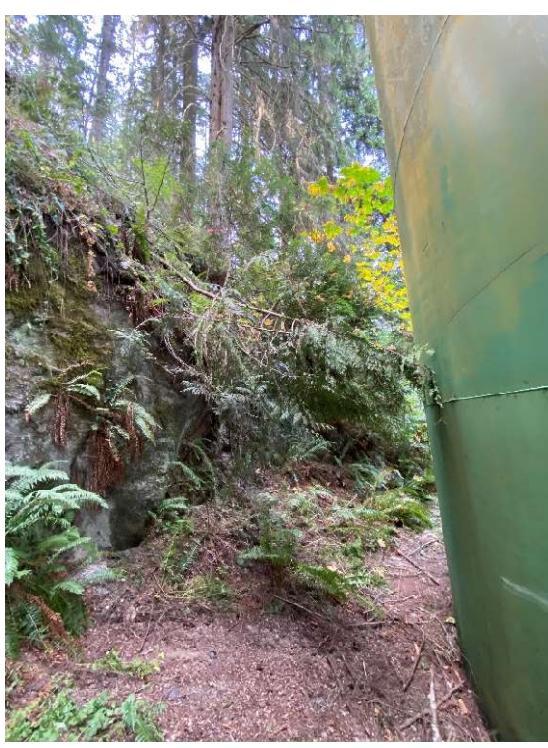
Ringwall below grade.
