Lake Whatcom Water and Sewer District Division 22-1 Reservoir Replacement

ADDENDUM NO. 2 March 25, 2025

Division 22-1 Reservoir Inspection Report April 1, 2024

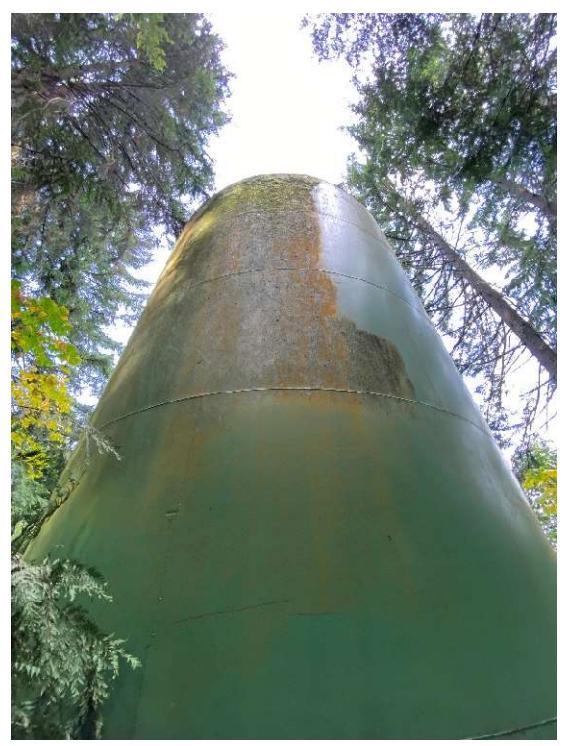
Moss growth on the shell wall.

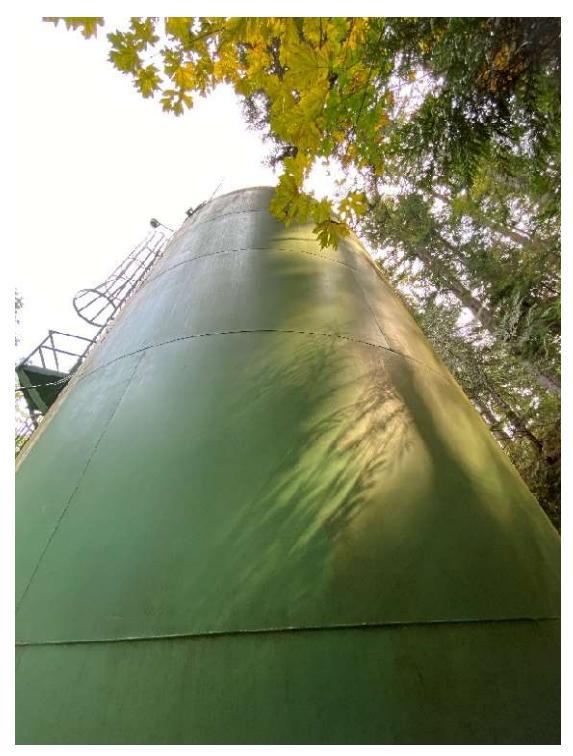
General exterior.

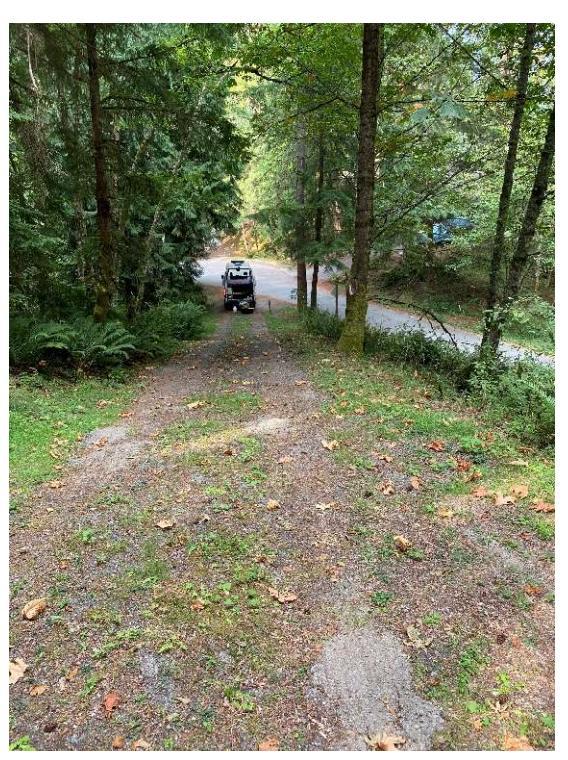
Driveway.

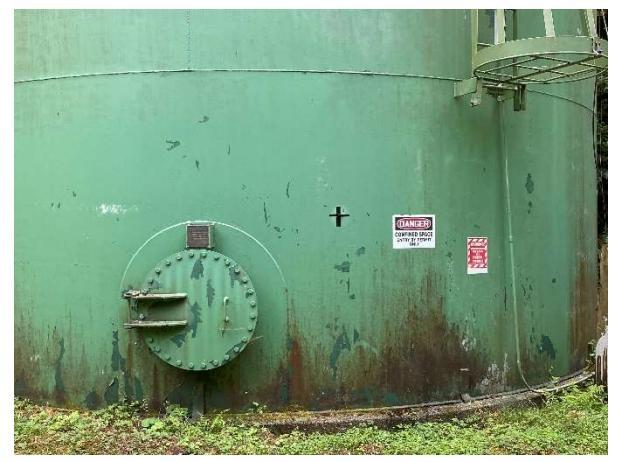
Access hatch and delamination areas.

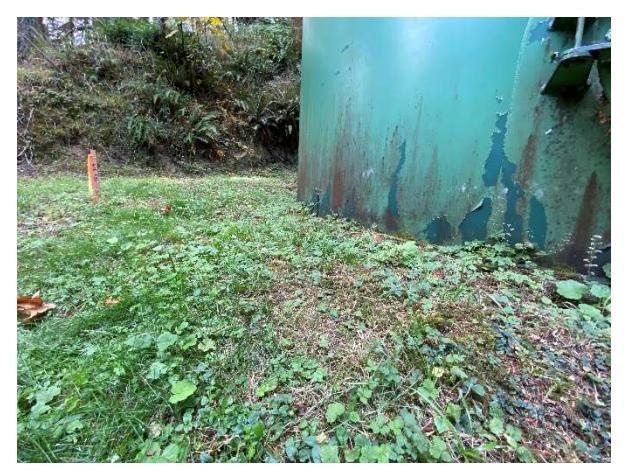
Shell wall delamination.

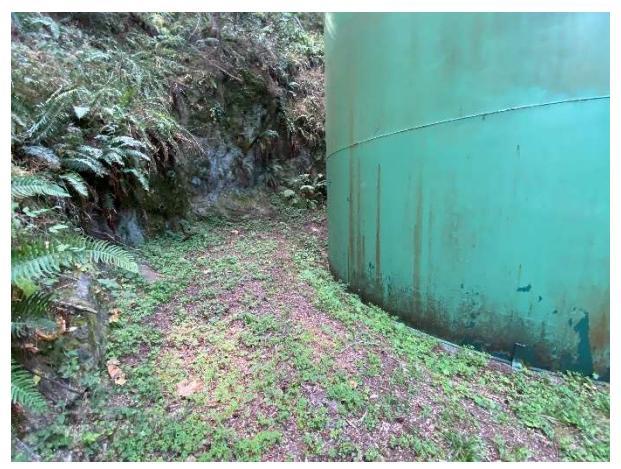
Mildew growth and ringwall below grade.

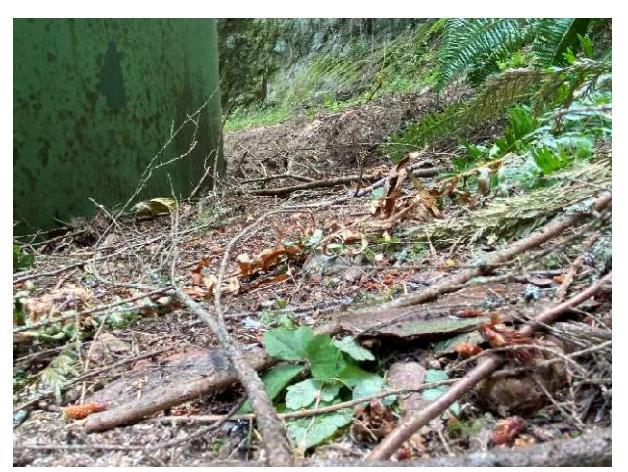
Grade behind reservoir.

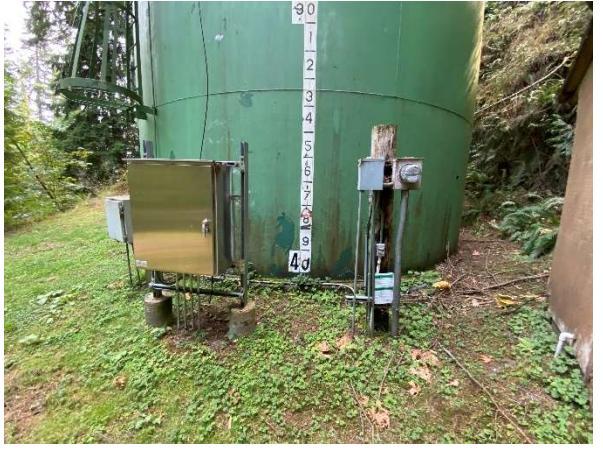
General exterior.

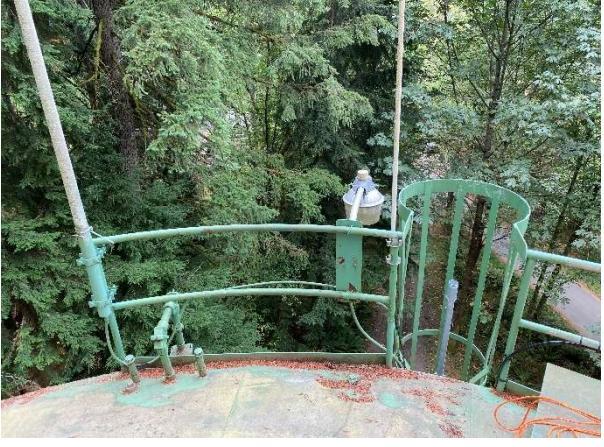
Ladder transition area.

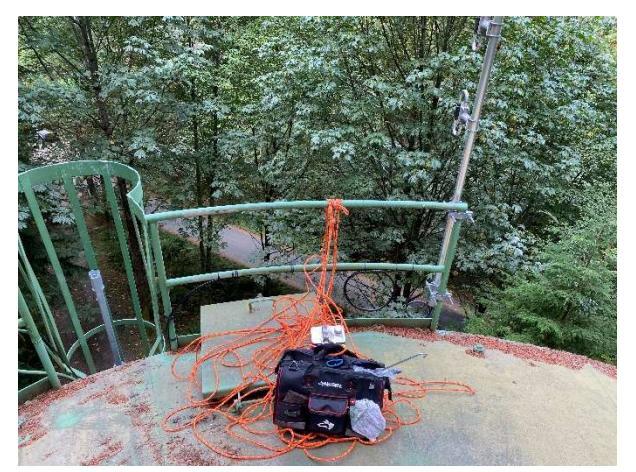
Access hatch.

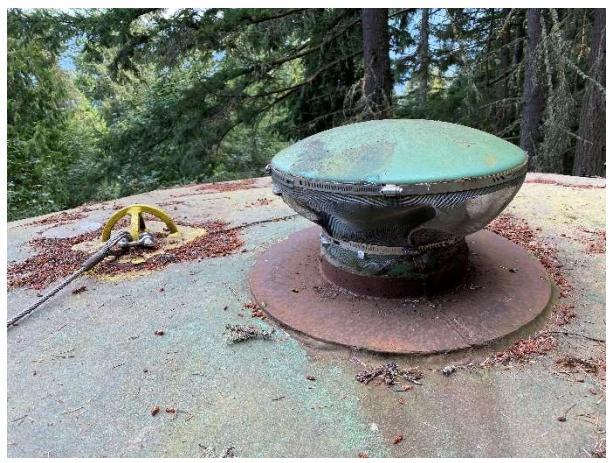
Roof vent and anchor.

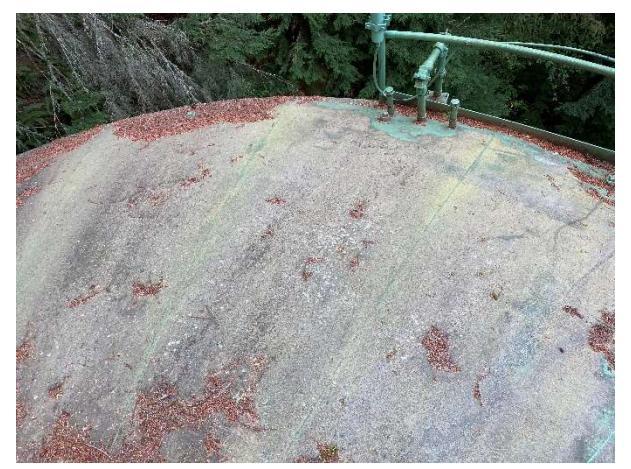
General roof condition.

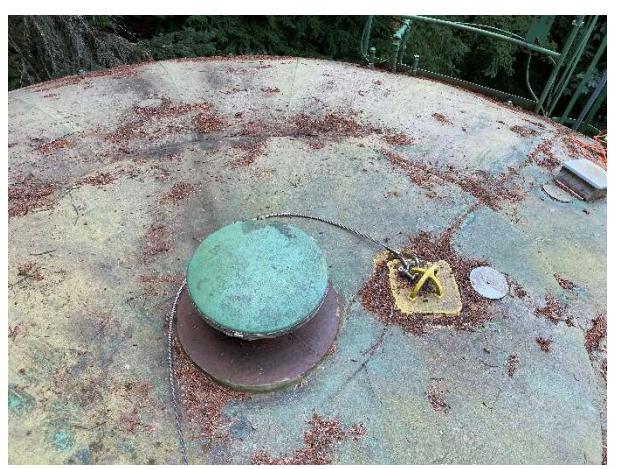
General roof condition.

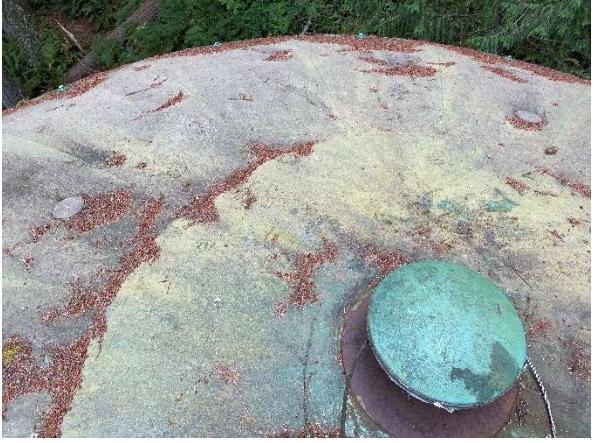
General roof condition.

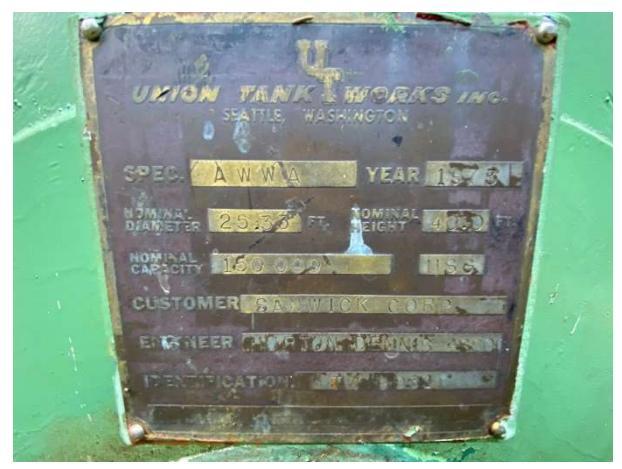
Nameplate.

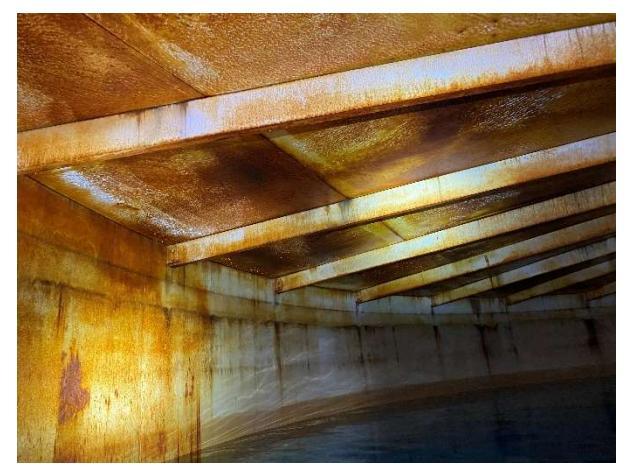
General condition.

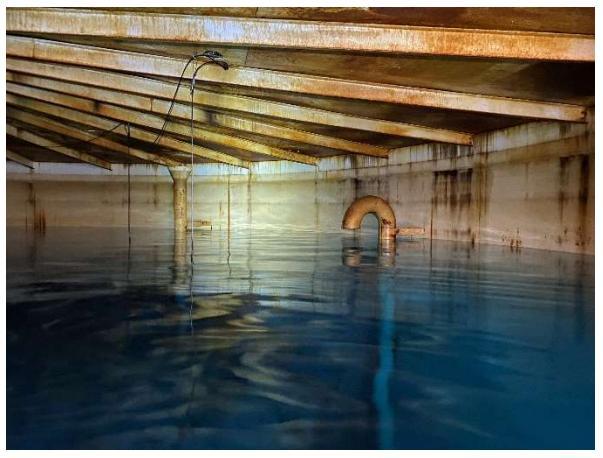
Inlet and Overflow

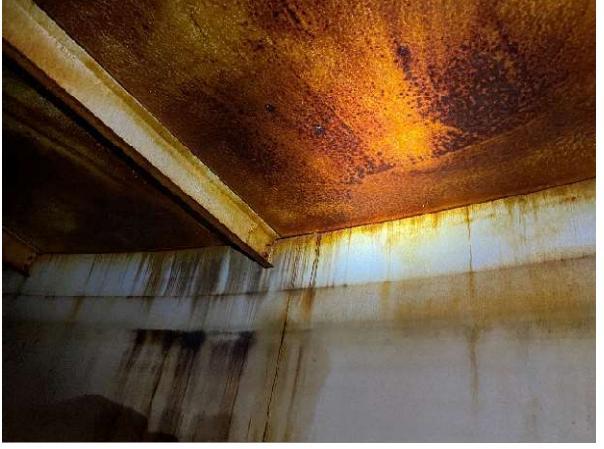
Mild to moderate general corrosion of the roof plates.

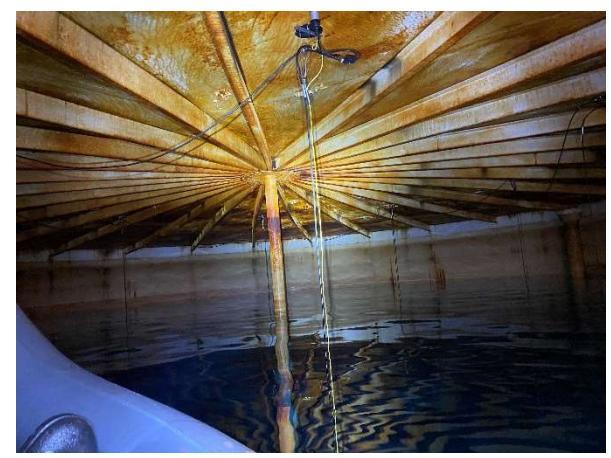
General condition.

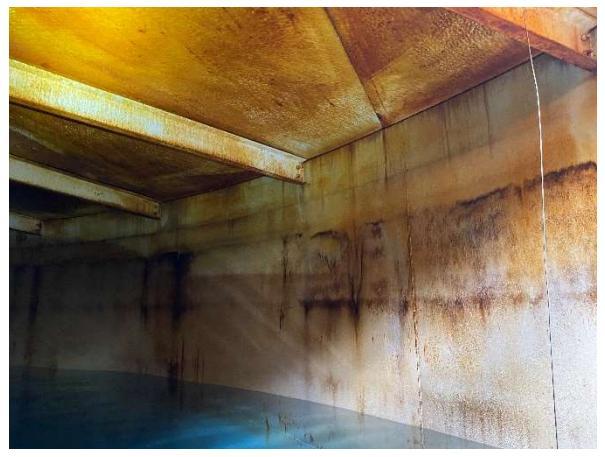
General condition.

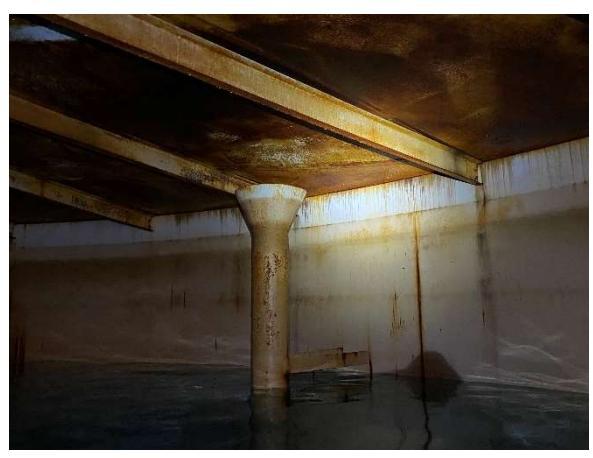
Overflow.

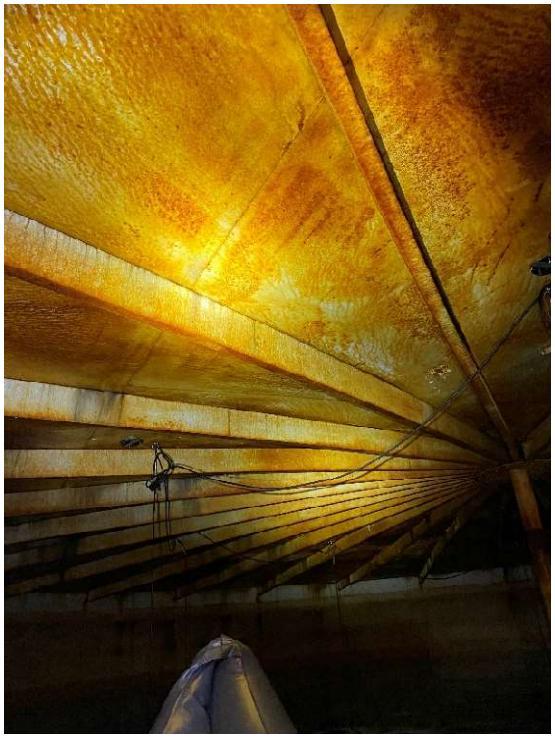
Mild corrosion of the roof plates and rafters.

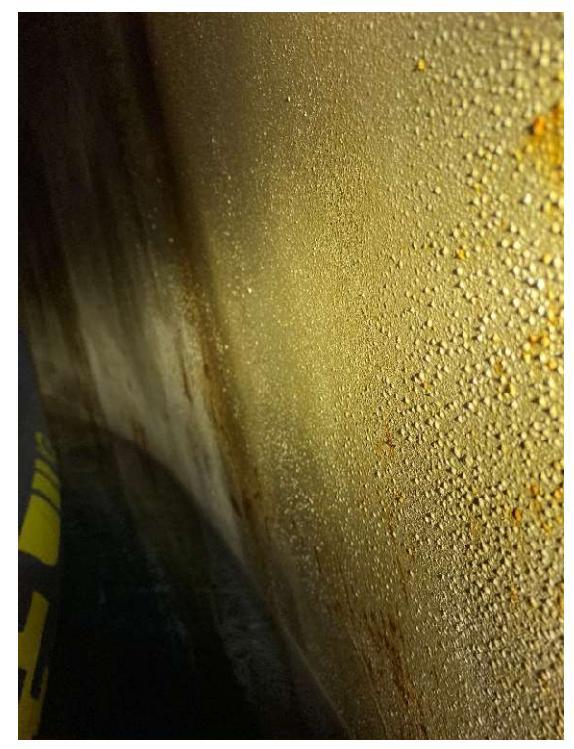
Coatings on the shell wall heavily blistered.

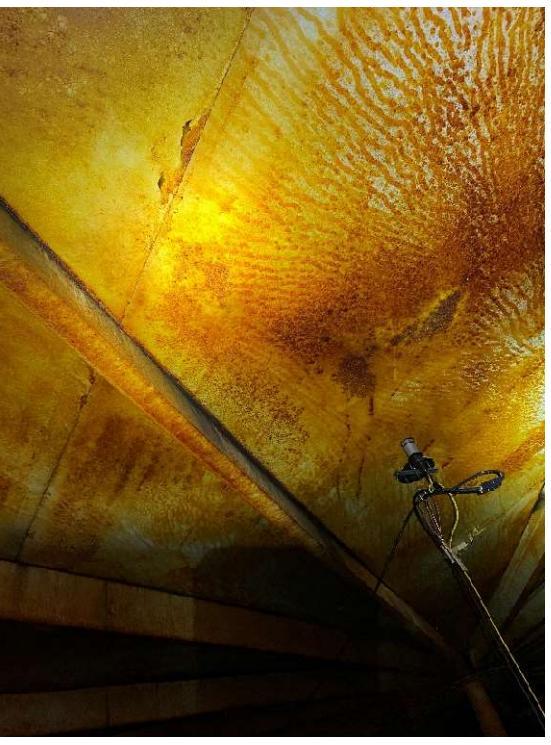
Mild corrosion of the roof plates and rafters.

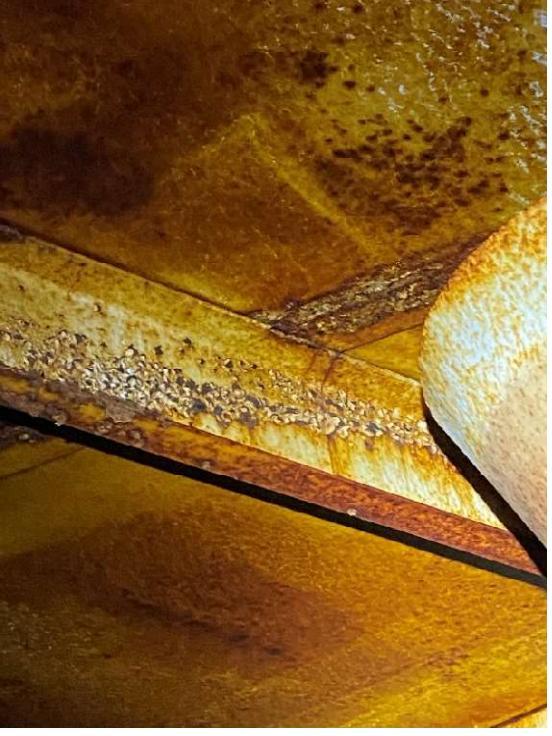
Moderate corrosion on the rafter and roof plate.

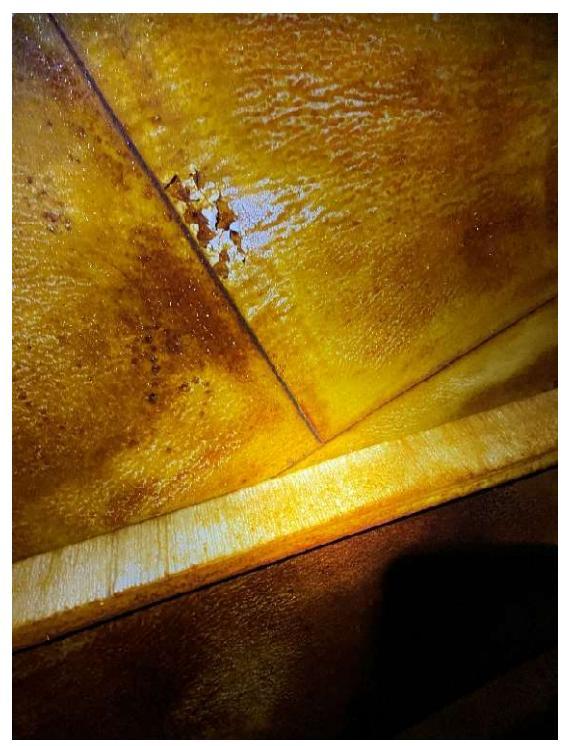
Roofplate and rafters.

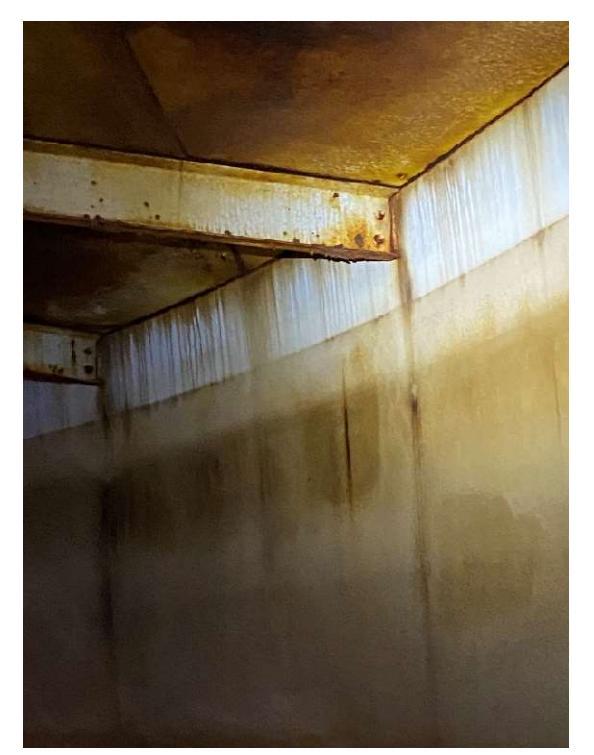
Rafter and rafter tab.

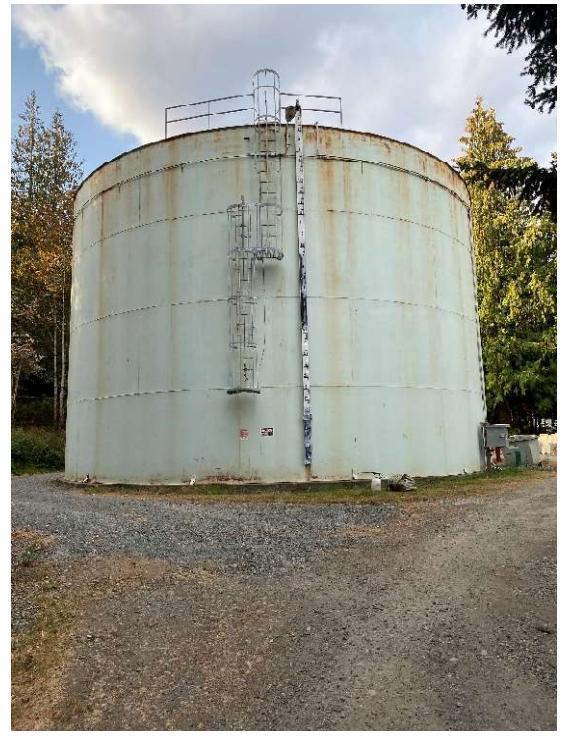
General exterior.

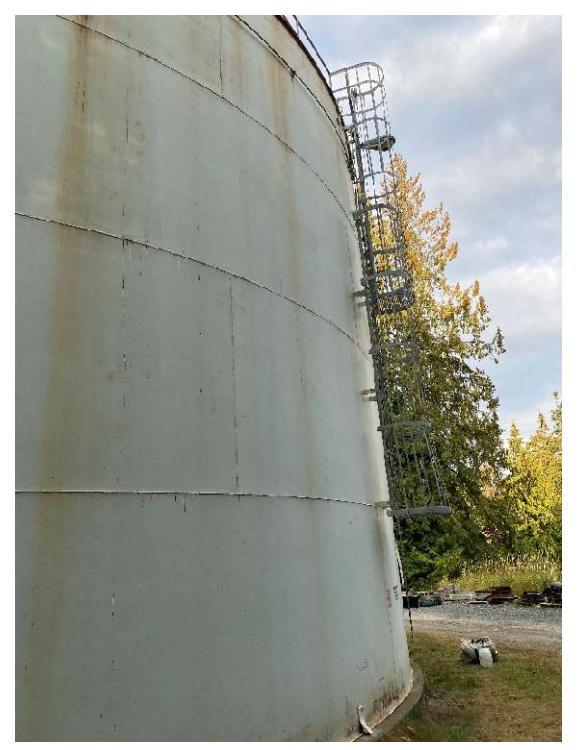
General exterior.

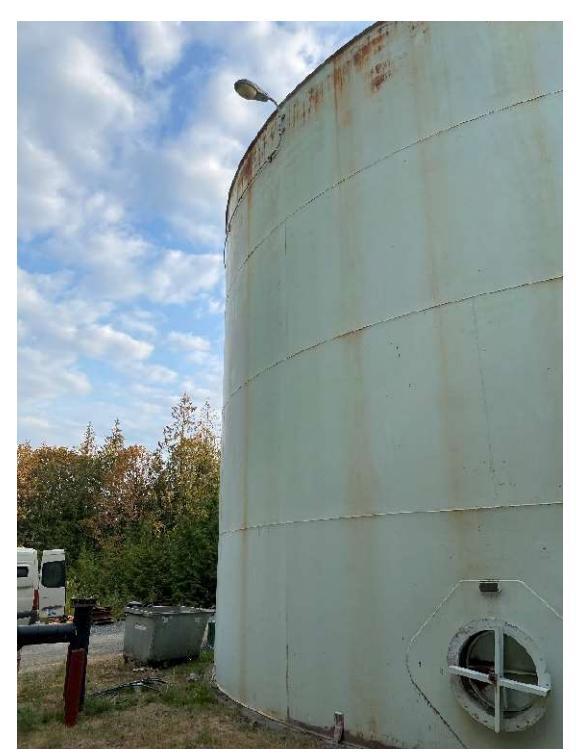
Corrosion beginning at the top of the shell wall. General exterior.

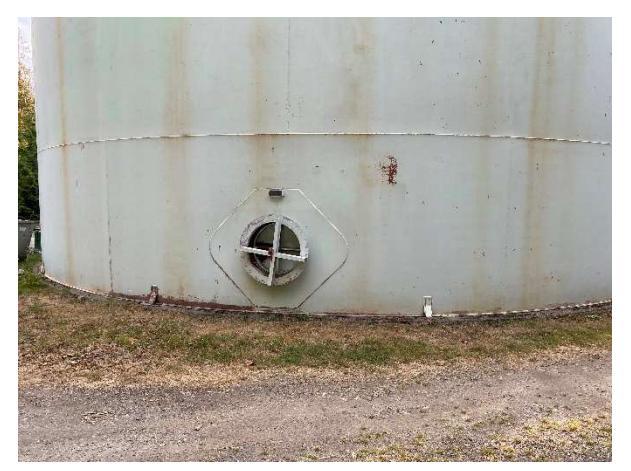
Manway.

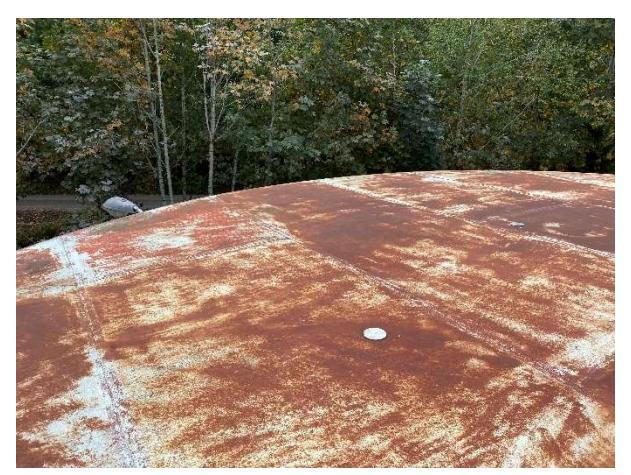
General roof condition.

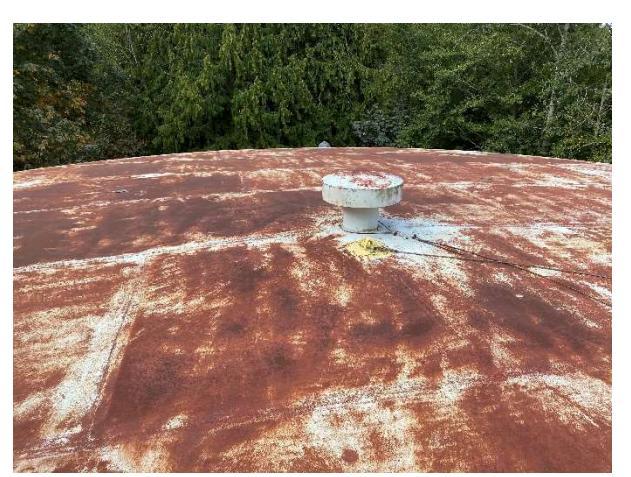
General roof condition.

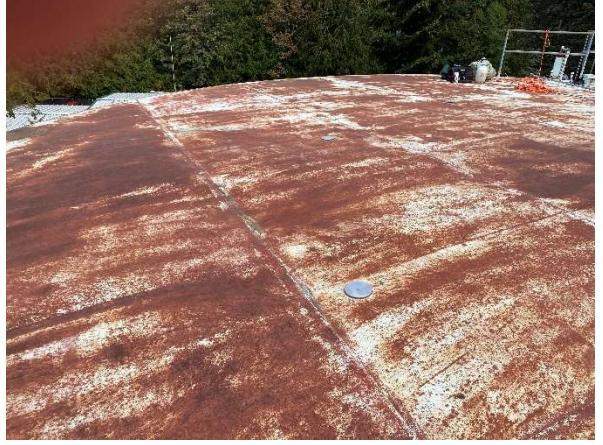
General roof condition.

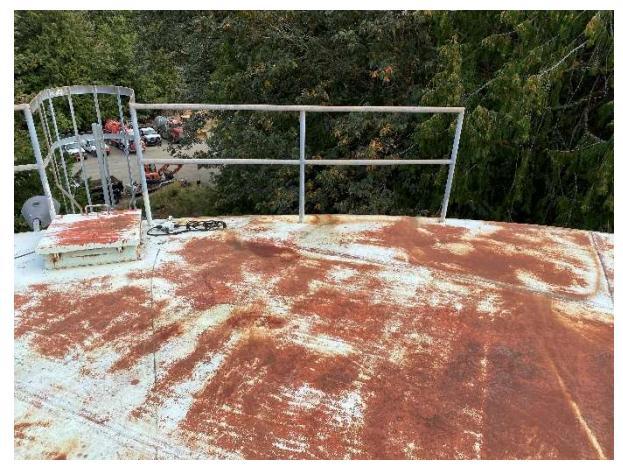
Ladder transition area.

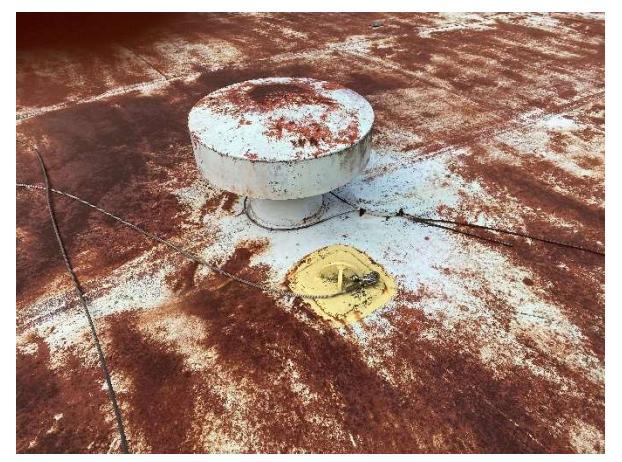
Roof vent and anchor.

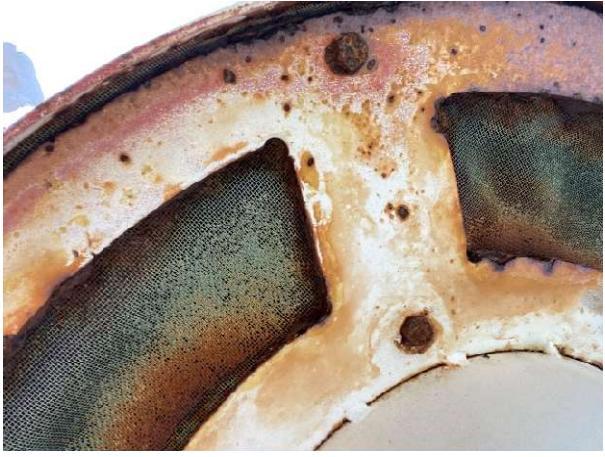
Underside of roof vent.

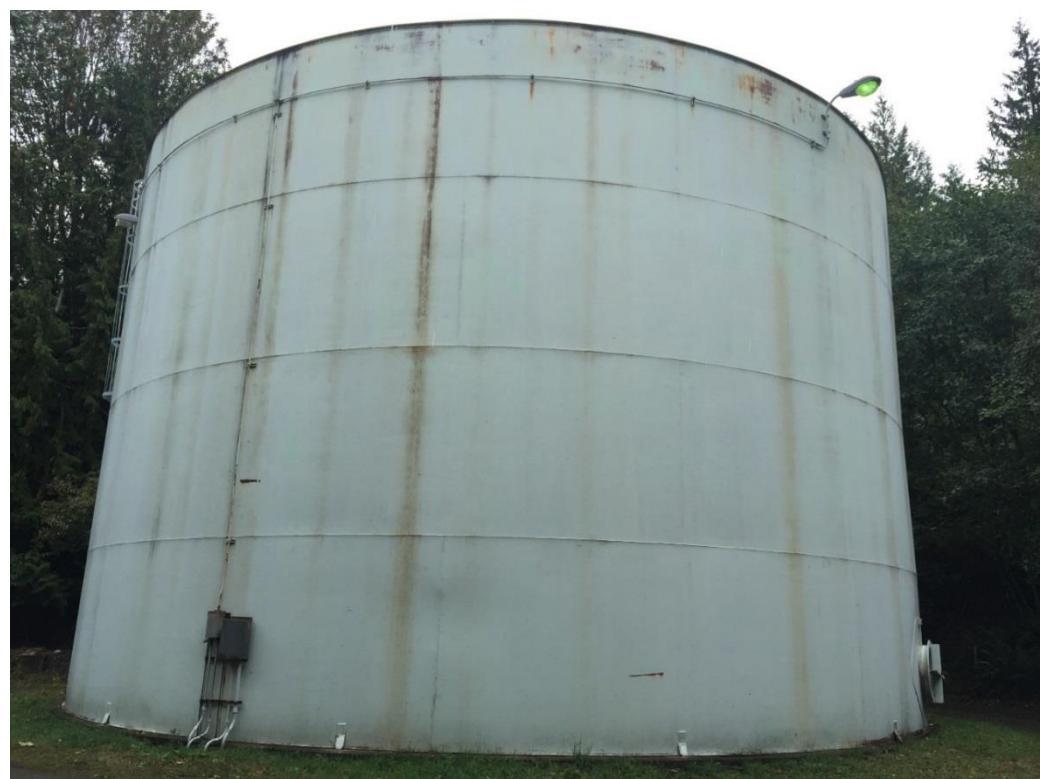
Figure 4 Geneva Reservoir, September 1, 2015

General condition, appurtenances, and site conditions appeared consistent with record information. The tank has a single 30 inch diameter shell manhole, and a 2 feet square roof hatch with partial roof railing. The roof is accessed by caged exterior ladder and an un-caged interior ladder (see Figure 4).

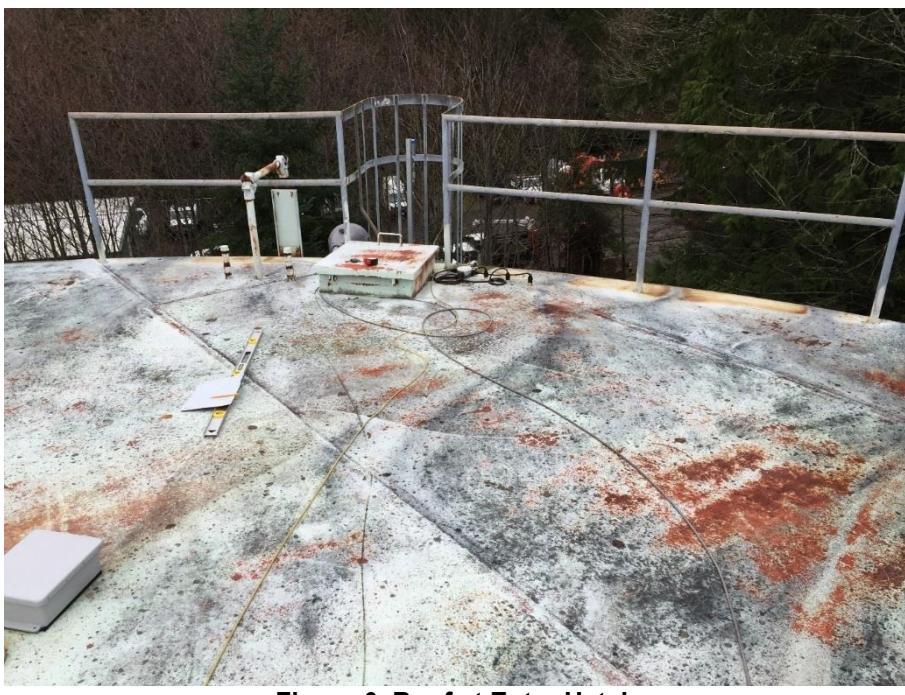
Figure 6 Roof at Entry Hatch

The interior was observed from the roof hatch and photographed without entering. Framing conditions appeared consistent with record information.

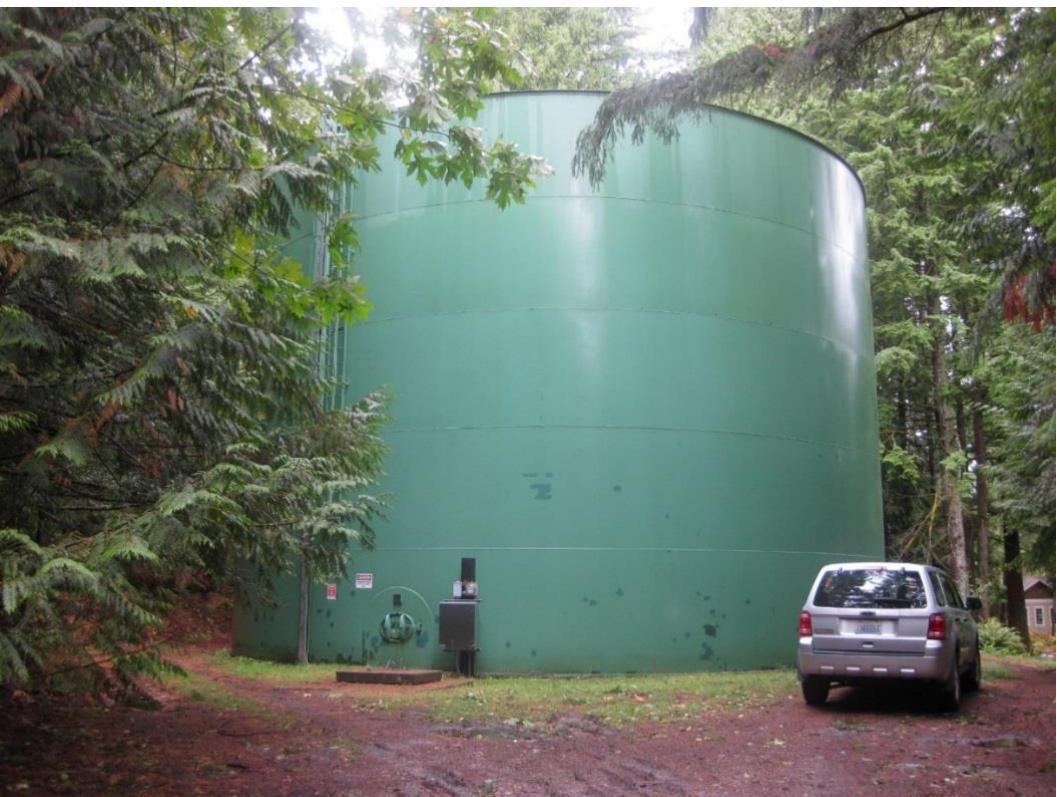
Figure 11 Division 22 Reservoir, September 1, 2015

General condition, appurtenances, and site conditions appeared consistent with record information. The tank has a single 24 inch by 18 inch elliptical shell manhole, and a 24 inch diameter roof hatch with no roof railing. The roof is accessed by a caged exterior ladder and an un-caged interior ladder (see Figure 11).

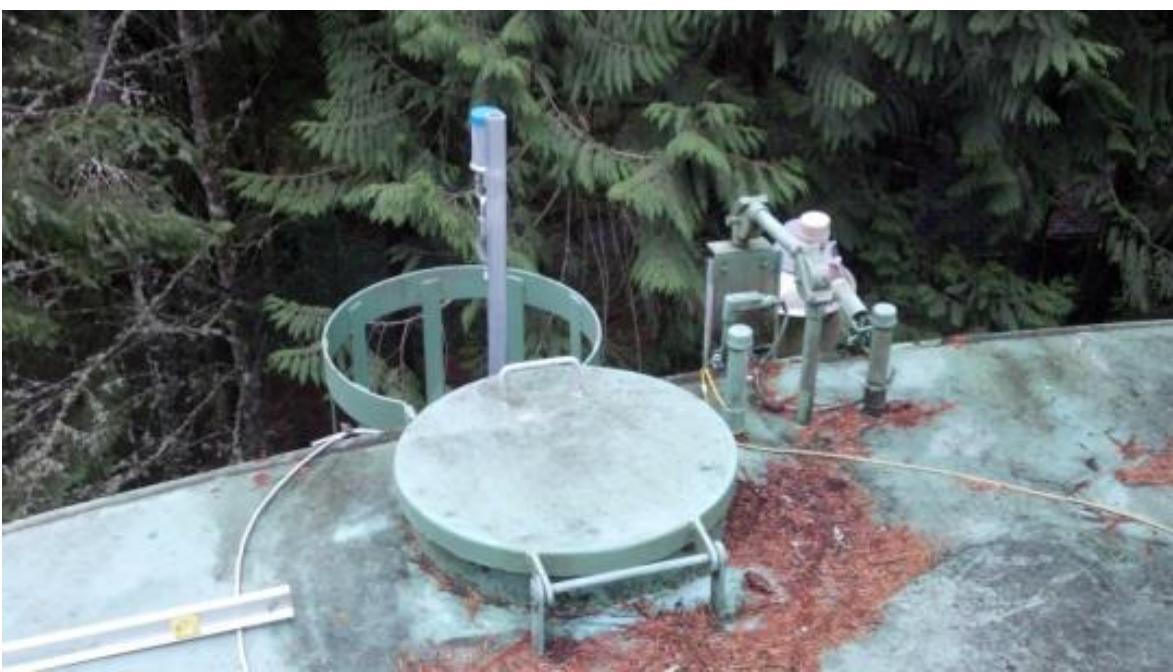
Figure 15 Division 22 Reservoir at Roof Hatch

The interior was observed from the roof hatch and photographed without entering. Conditions appeared consistent with previous video by H2O Solutions.

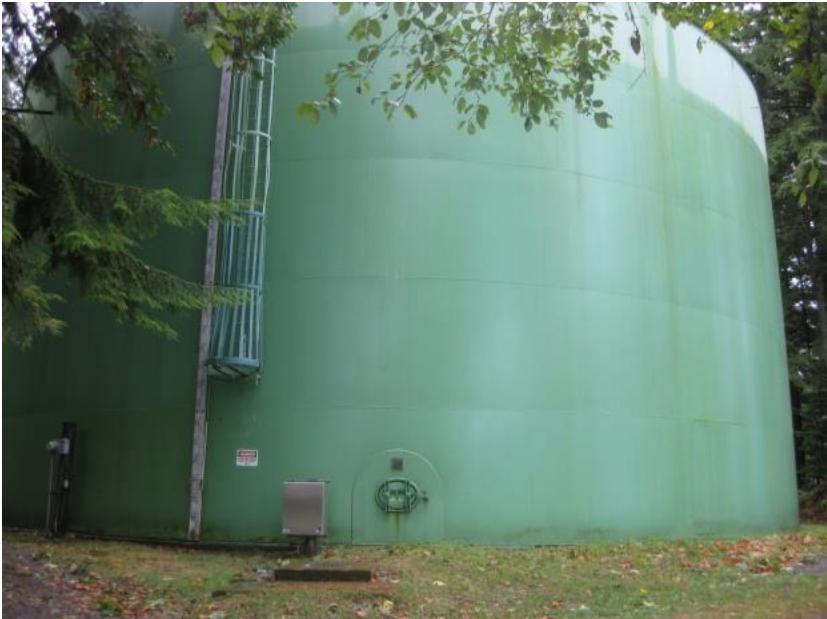
Figure 18 Division 7 Reservoir, September 1, 2015

General condition, appurtenances, and site conditions appeared consistent with record information. The tank has a single 24 inch by 18 inch elliptical shell manhole, and a 24 inch diameter roof hatch with no roof railing. The roof is accessed by a caged exterior ladder and an un-caged interior ladder (see Figure 18).

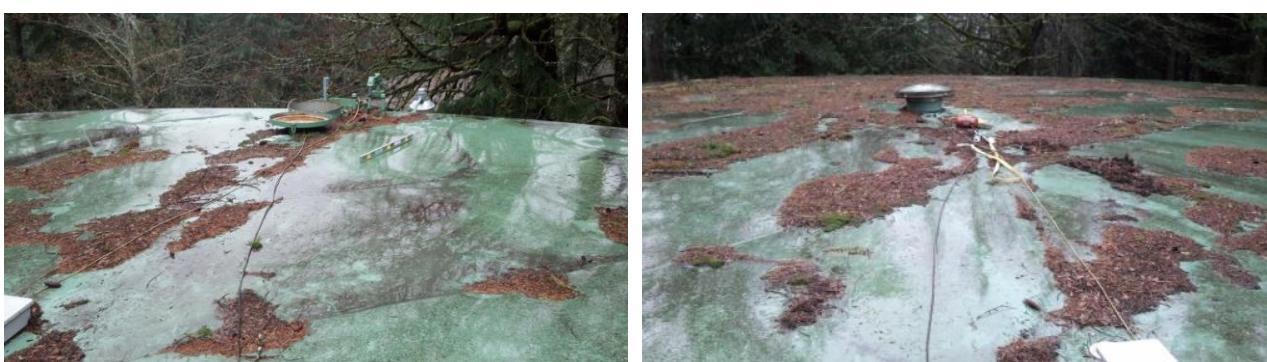
Figures 20 and 21 Division 7 Reservoir at Roof Hatch and Vent

The interior was observed from the roof hatch and photographed without entering. Conditions appeared consistent with previous video by H2O Solutions. The roof was approximately 25 percent covered by branch and needle debris from nearby trees.

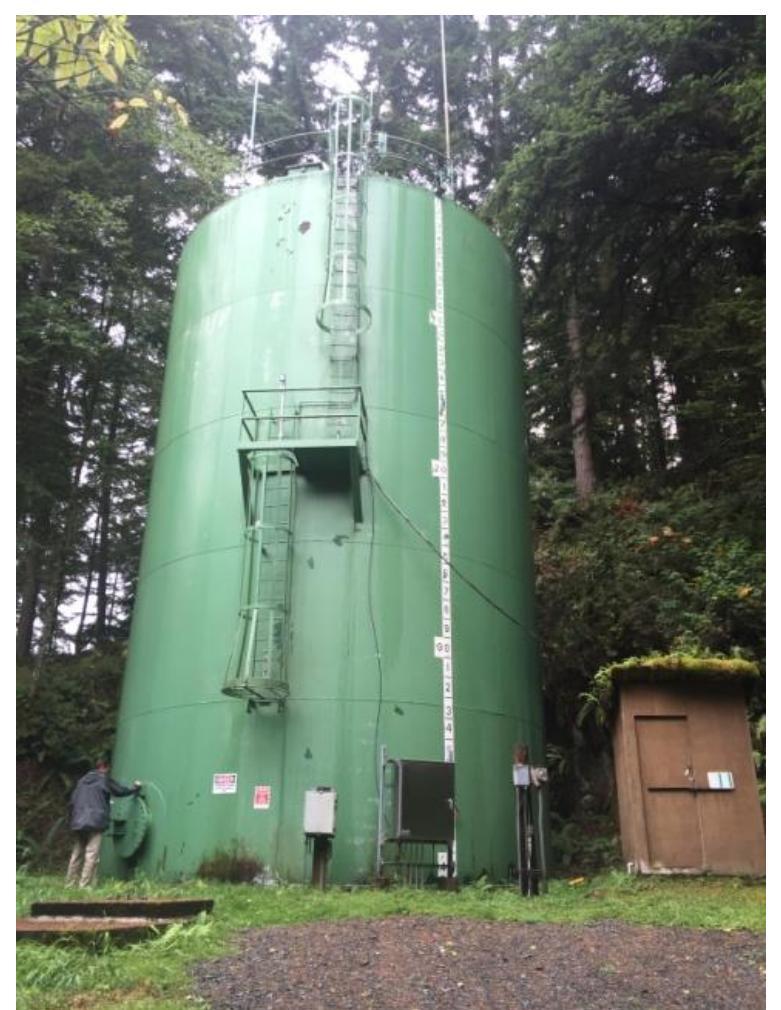
Figure 24 Division 30 Reservoir, September 1, 2015

General condition, appurtenances, and site conditions appeared consistent with record information. The tank has a single 24 inch diameter shell manhole, and a 24 inch square roof hatch with partial roof railing. The roof is accessed by caged exterior and interior ladders. The exterior ladder has an intermediate landing platform (see Figure 24).

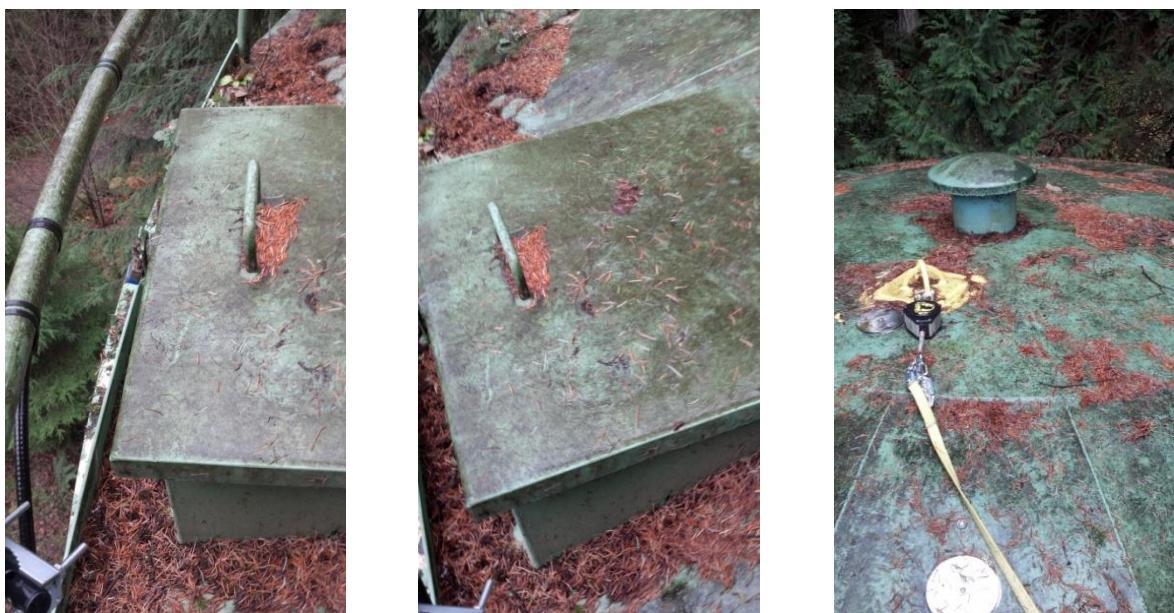
Figures 26, 27, and 28 Division 30 Reservoir at Roof Hatch and Vent

The interior was observed from the roof hatch and photographed without entering. Conditions appeared consistent with previous video by H2O Solutions.

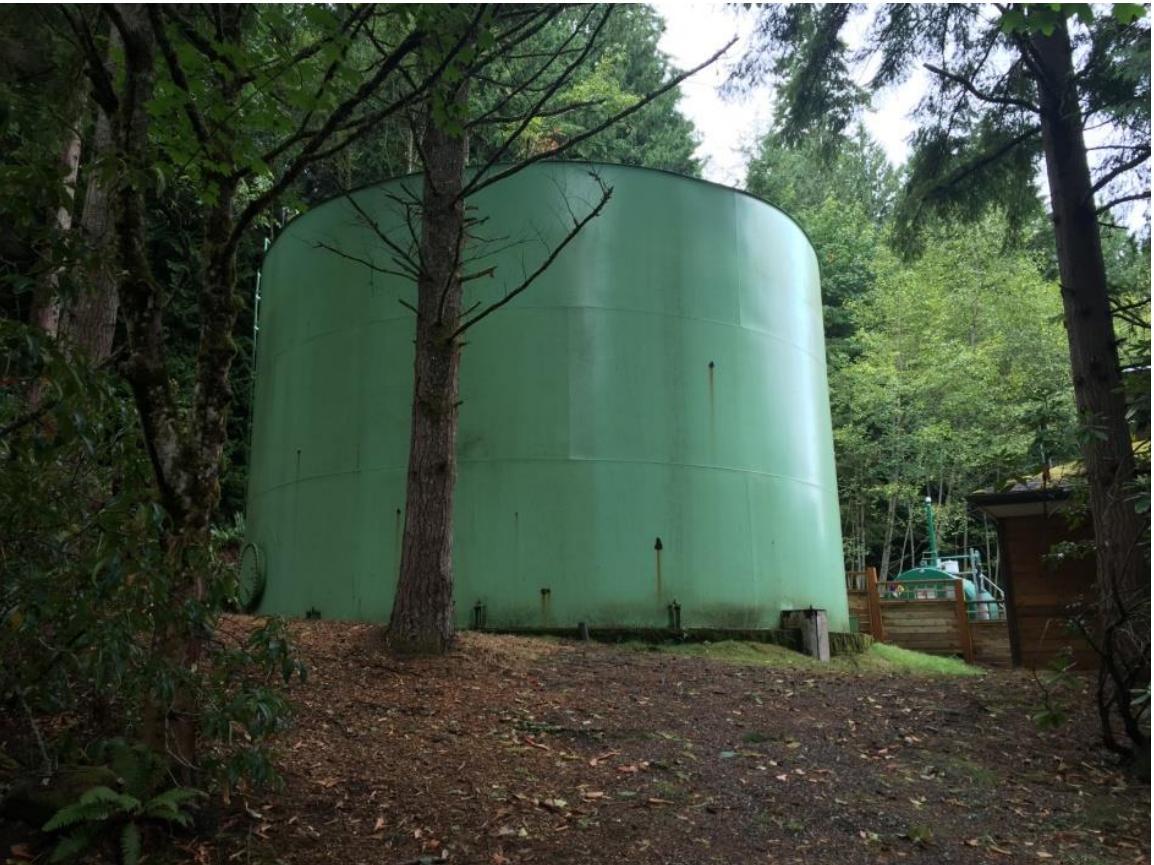
Figure 35 SVWTP Reservoir, September 1, 2015

General condition, appurtenances, and site conditions appeared consistent with record information. The tank has two 36 inch diameter shell manholes, and a 3 feet square roof hatch with partial roof railing. The roof is accessed by caged exterior ladder and an un-caged interior ladder (see Figure 35).

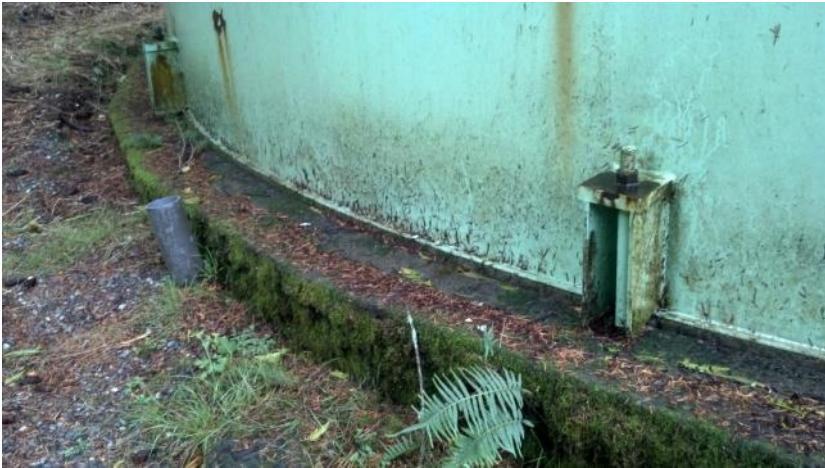
Figure 36 SVWTP Reservoir at Shell to Foundation Interface

A grout layer about 2 inches thick was observed beneath the shell plate and appeared to be in good condition. The ringwall appears to have had its outside face formed with straight rather than curved forms, so the distance from the shell to the outside face varies. Photos from the site visit are shown in Figures 36 and 37.

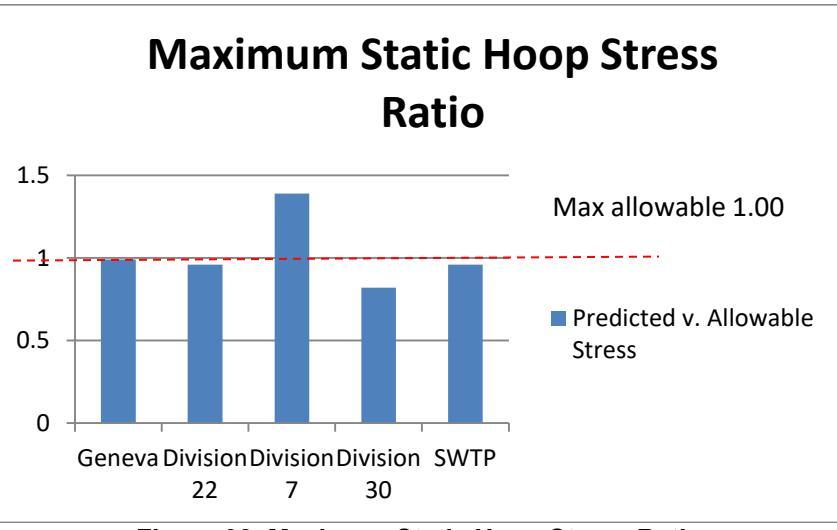
Figure 38 Maximum Static Hoop Stress Ratio

In terms of hoop stress, all tanks except Division 7 and 22 are within limits for both static and seismic loads. The relative maximum stress ratios are shown below in Figures 38 and 39.

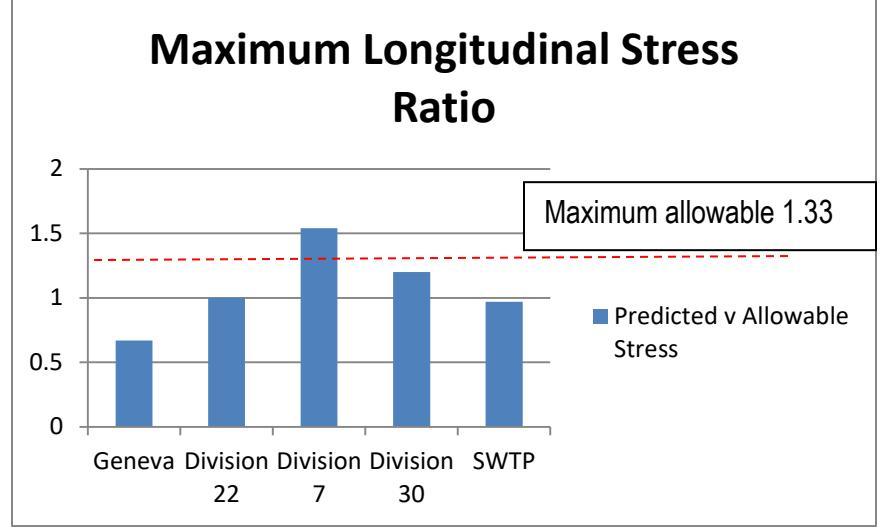
Figure 40 Maximum Longitudinal Stress Ratio

In terms of maximum allowable longitudinal compressive stress in the shell under seismic loading, all the tanks except Division 7 are within allowable limits. In Figure 40, the ratios shown in previous tables have been normalized for the Division 7 and 22 tanks for an allowable ratio of 1.33, due to the slight difference in

the way allowable stresses for unanchored tanks are computed compared to anchored tanks. Excessive longitudinal stress increases the likelihood of tank buckling.

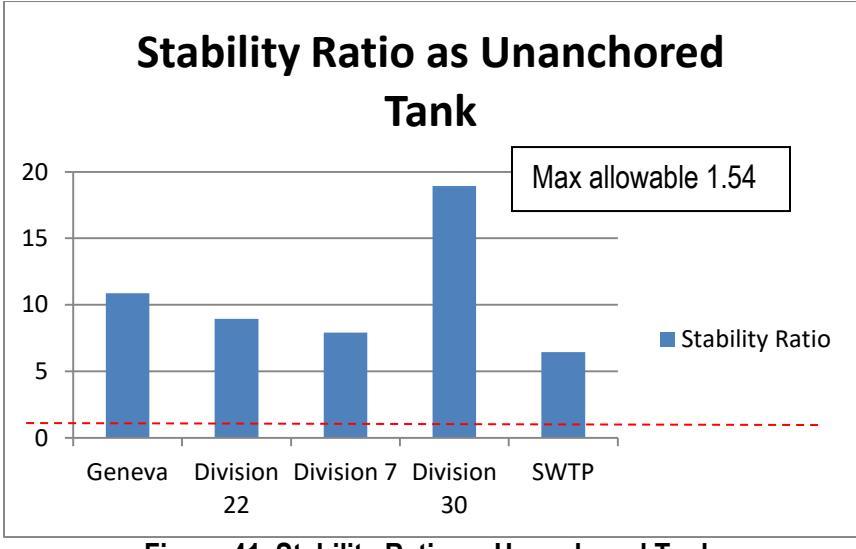
Figure 41 Stability Ratio as Unanchored Tank

The stability ratio indicates whether or not an unanchored tank will be stable under seismic loading. This would apply to the currently unanchored Division 22 and 7 tanks, and to the anchored tanks in case of anchor failure. As shown in Figure 41, the limiting stability ratio of 1.54 is already exceeded in the case of Division 22 and 7 tanks, and would also be exceeded in the case of the others if the anchors failed. All of the tanks need to be anchored to avoid potential rollover and rupture of the shell to bottom plate joint.

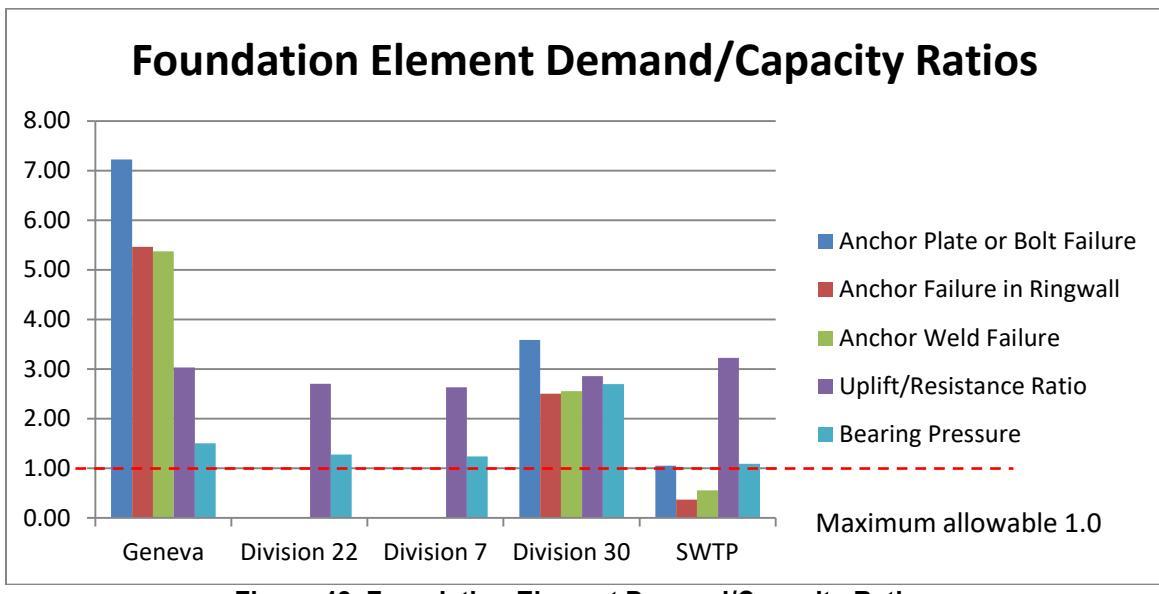
Figure 42 Foundation Element Demand/Capacity Ratios

None of the ringwall foundations, including soil resistance and the weight of water over the interior, are sufficient to prevent uplift, assuming anchorage were provided and adequately designed. Bearing pressure under seismic loading conditions appears to exceed the assumed limits; however, it is probably acceptable for the Division 30 tank if the ringwall is assumed to bear on rock.

Figure 42 below indicates the ratio of load to capacity for various foundation elements. All ratios have been normalized for comparison on an ultimate load to strength basis. All the reservoirs have inadequate foundations, but the SVWTP reservoir is the least problematic and most easily fixed.
