Lake Whatcom Water and Sewer District Division 22-1 Reservoir Replacement

ADDENDUM NO. 2 March 25, 2025

Division 22-1 Reservoir Inspection Report April 1, 2024

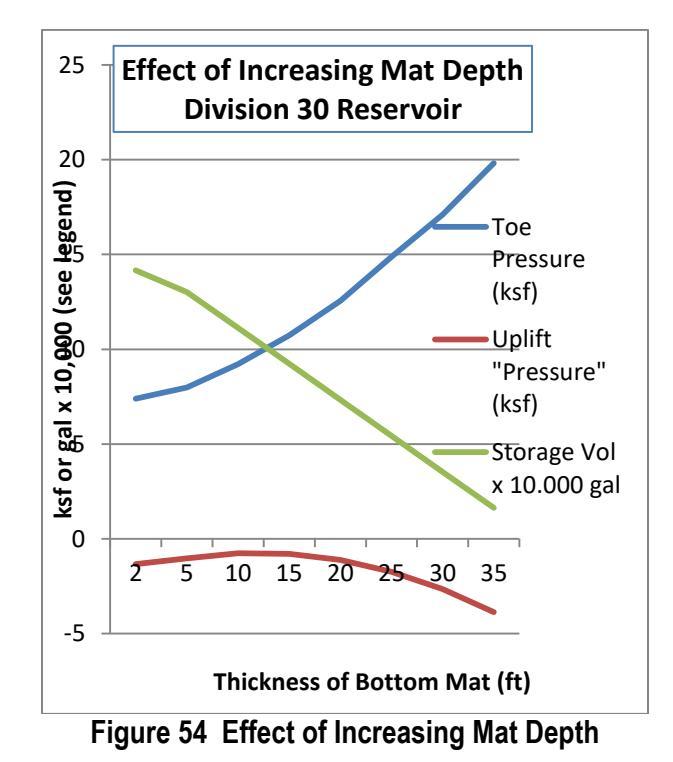
Installing an interior concrete mat is not a feasible option. Although the mat provides a counterweight to tipping forces, as the mat thickness increases to provide more weight, the seismic forces on the mat increase faster than the counterbalancing weight (see Figure 54) and the tank uplifts. In this case, the minimum uplift would occur with mat about 12 feet thick, but there would still be uplift and the tank would rock, probably leading to tipping. Storage volume would be reduced to about 100,000 gallons at the optimum mat thickness; however, since uplift is not prevented, this alternative is not acceptable.

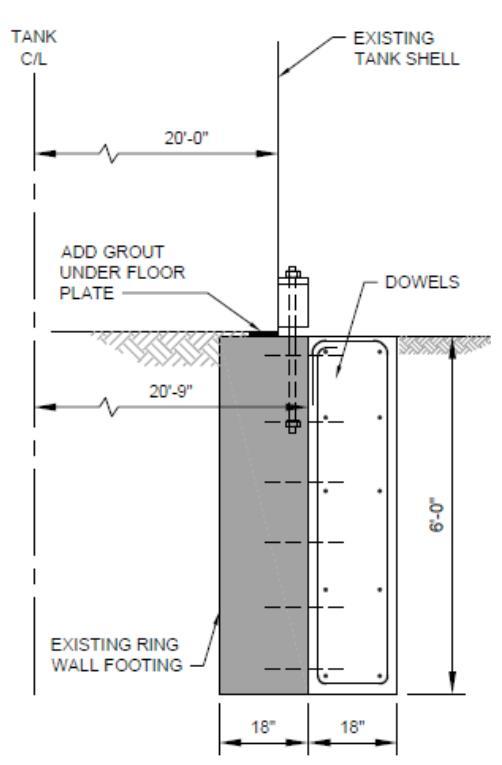
Figure 55 Added Ballast to Existing Ringwall

The shell, foundation, and anchorage appear to be adequate for predicted seismic loading except for insufficient uplift resistance of the foundation. The hold-down deficit can be matched by a widened ringwall without using ground anchors or mat concepts.

This alternate includes construction of an external reinforced concrete ringwall 6 feet high and 18 inches wide at the base, with the base founded at the same elevation as the existing ringwall, connected to the existing ringwall with dowels (see Figure 55).

The new ring would not cover the existing shell manways or impact other appurtenances. This option would involve 58 cubic yards of concrete and 549 cubic yards of excavation and would cost approximately \$156,000 and is the recommended retrofit approach.
